**The Great Northern Warehouse**

**Survey 2022**

**Great Northern Warehouse & Deansgate Terraces, Manchester**

**Condition Survey**

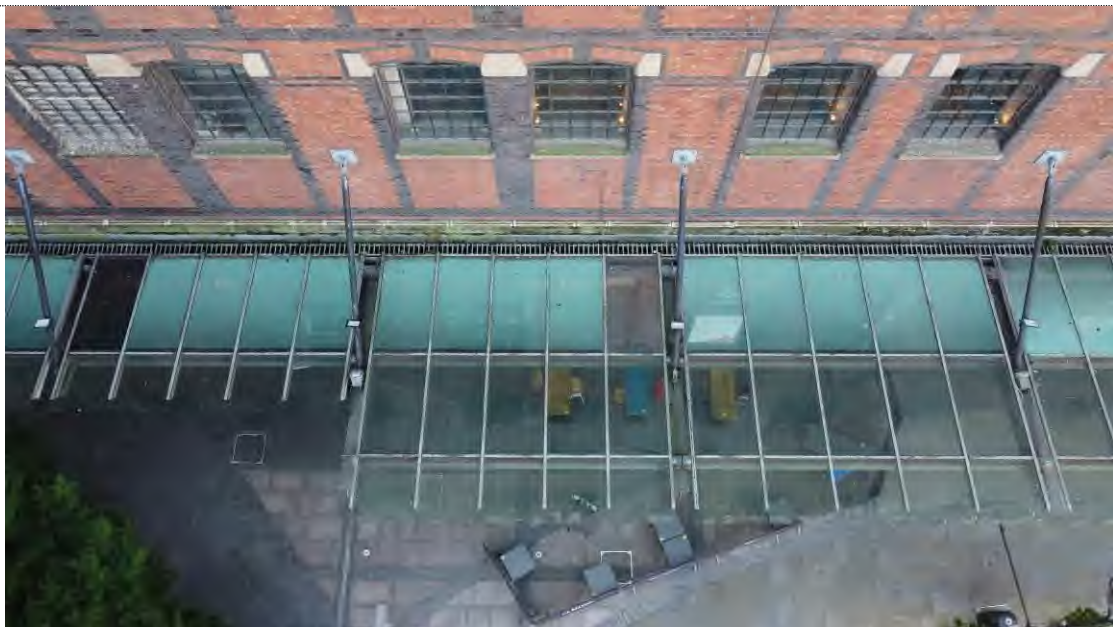
| Photograph: | 49 |

| Description: | General clean and replace of defective brickwork and stonework. (North facing elevation) |

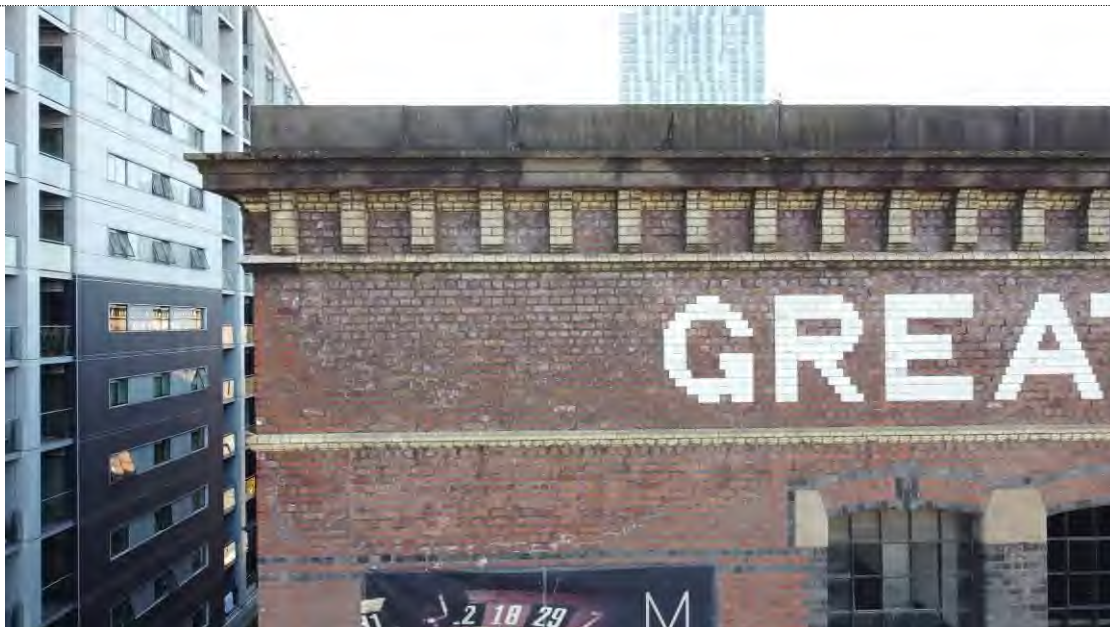
| Photograph: | 51 |

| Description: | General clean and replace of defective brickwork and stonework. (North facing elevation) |

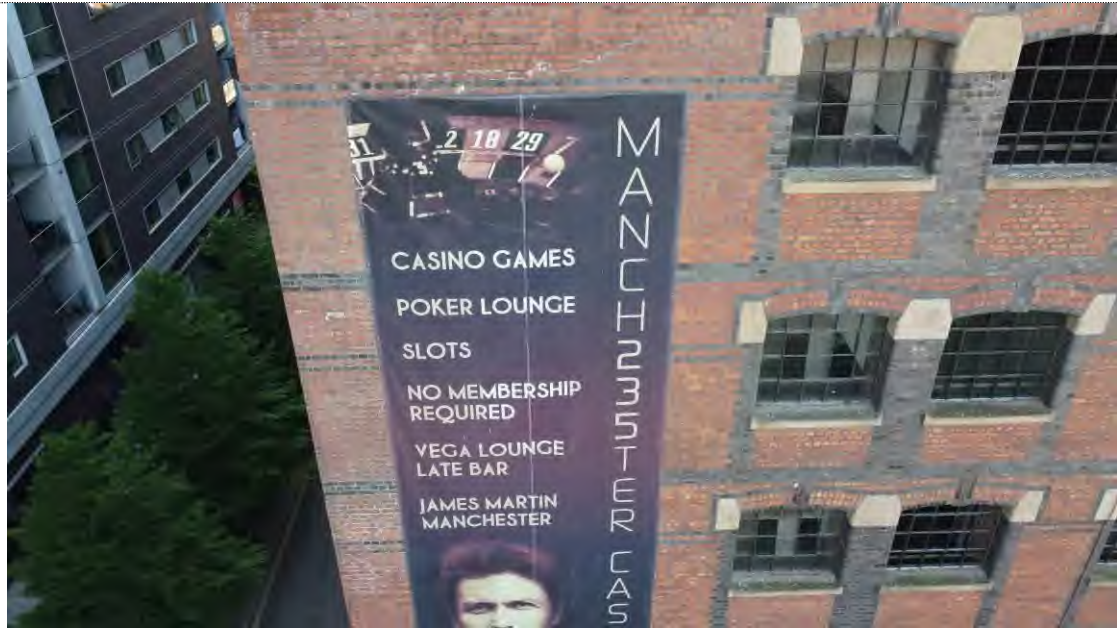
| Photograph: | 52 |

| Description: | General clean and replace of defective brickwork and stonework. (North facing elevation) |

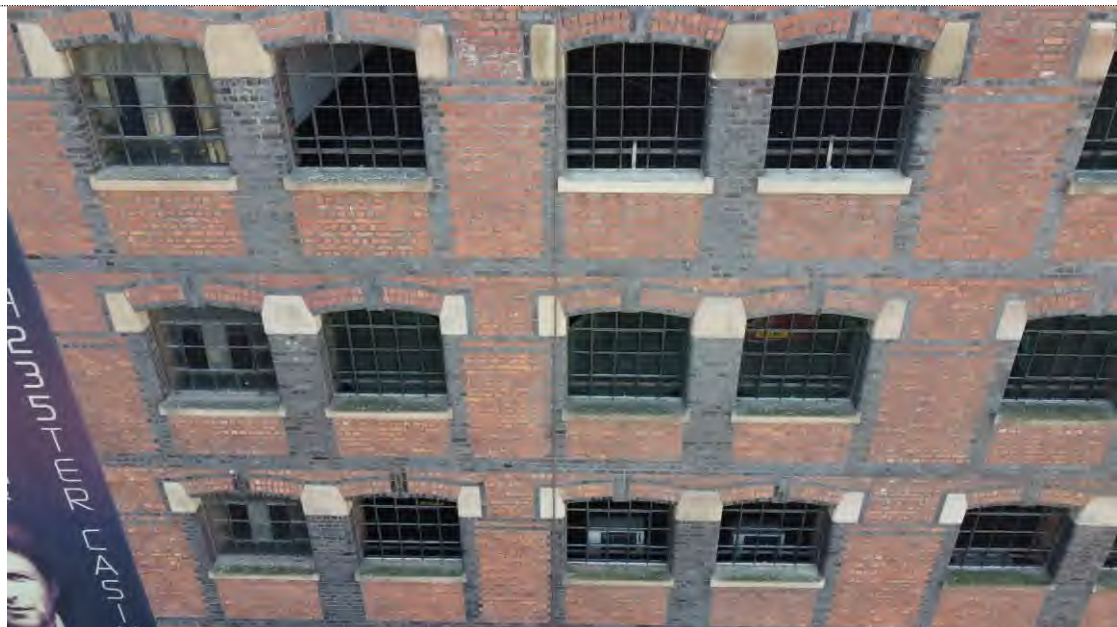
| Photograph: | 53 |

| Description: | General clean and replace of defective brickwork and stonework. (North facing elevation) |

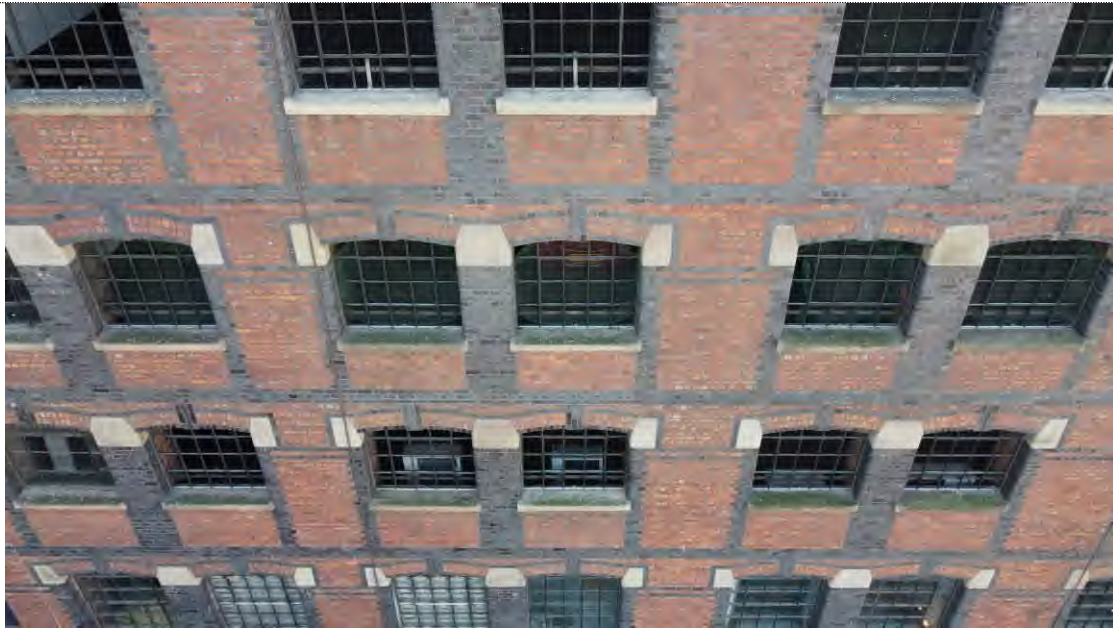
| Photograph: | 54 |

| Description: | General clean and replace of defective brickwork and stonework. (North facing elevation) |

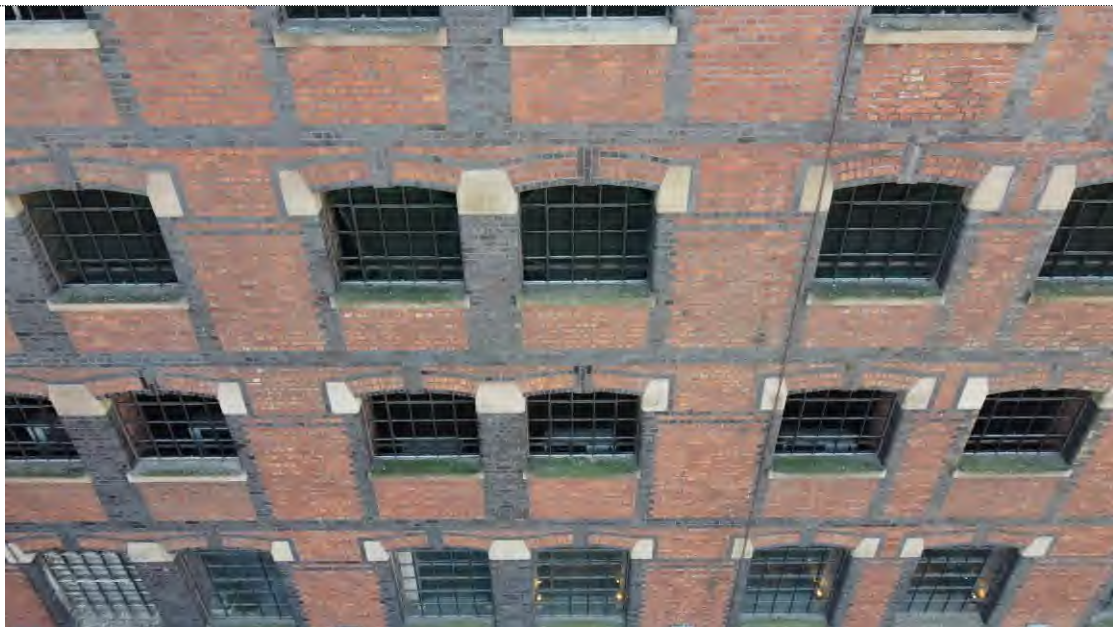
| Photograph: | 55 |

| Description: | General clean and replace of defective brickwork and stonework. (North facing elevation) |

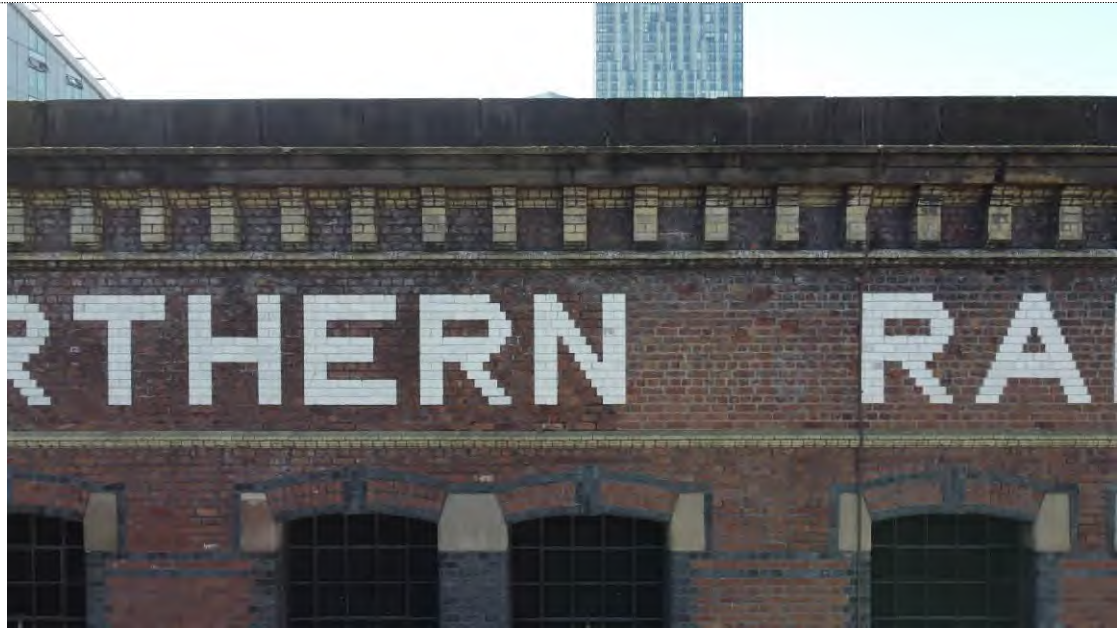
| Photograph: | 56 |

| Description: | General clean and replace of defective brickwork and stonework. (North facing elevation) |

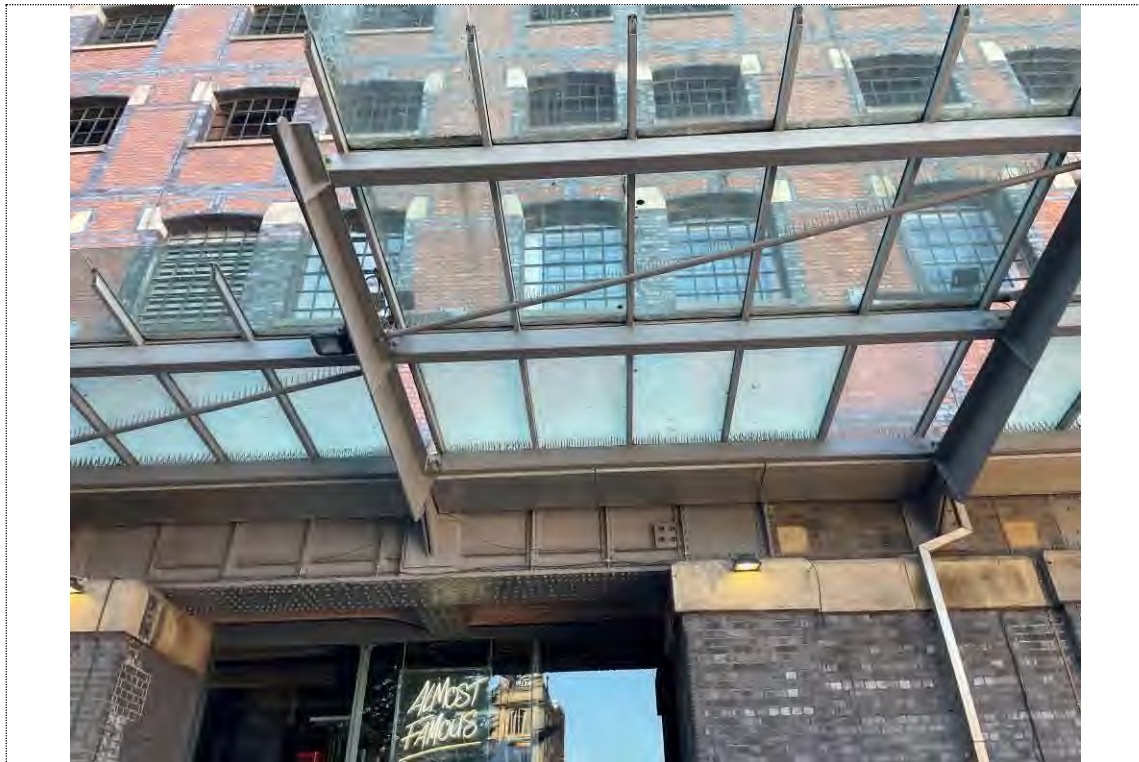
| Photograph: | 60 |

| Description: | Evidence of brick replacement and salt damage. Doff clean all areas of brickwork and stonework. |

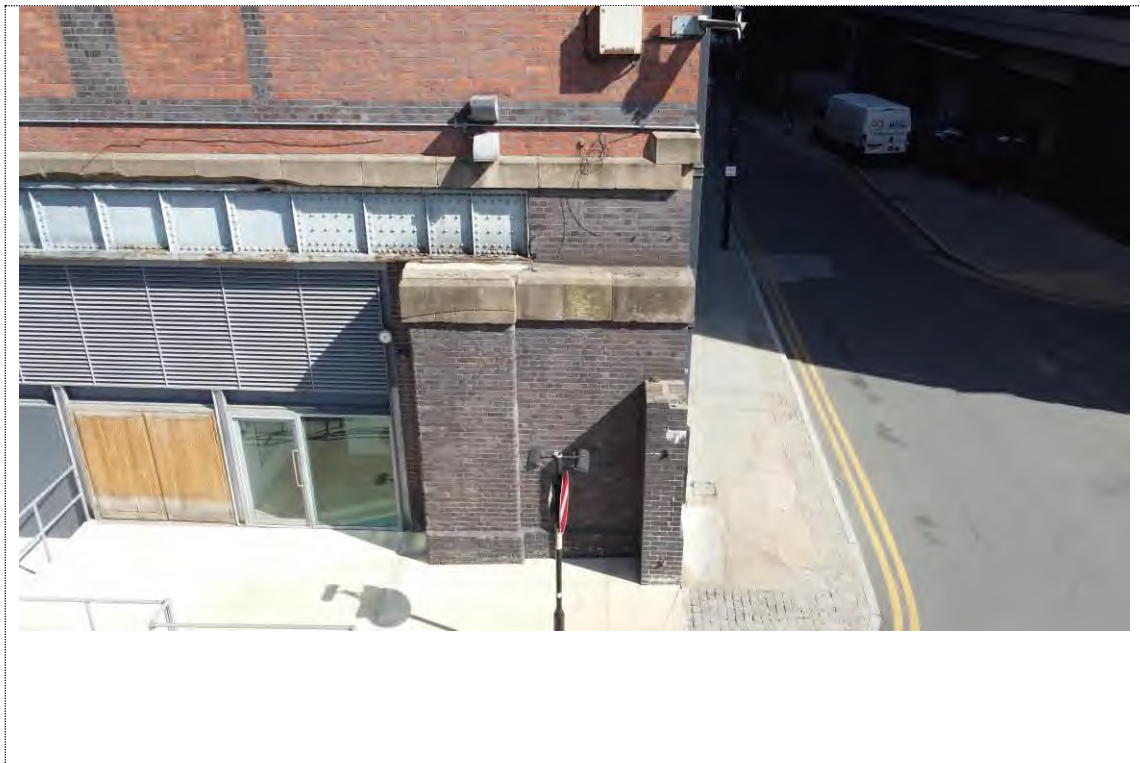
| Photograph: | 73 |

| Description: | General clean and replace of defective brickwork and stonework. Evidence of corrosion to steels. (South facing) |

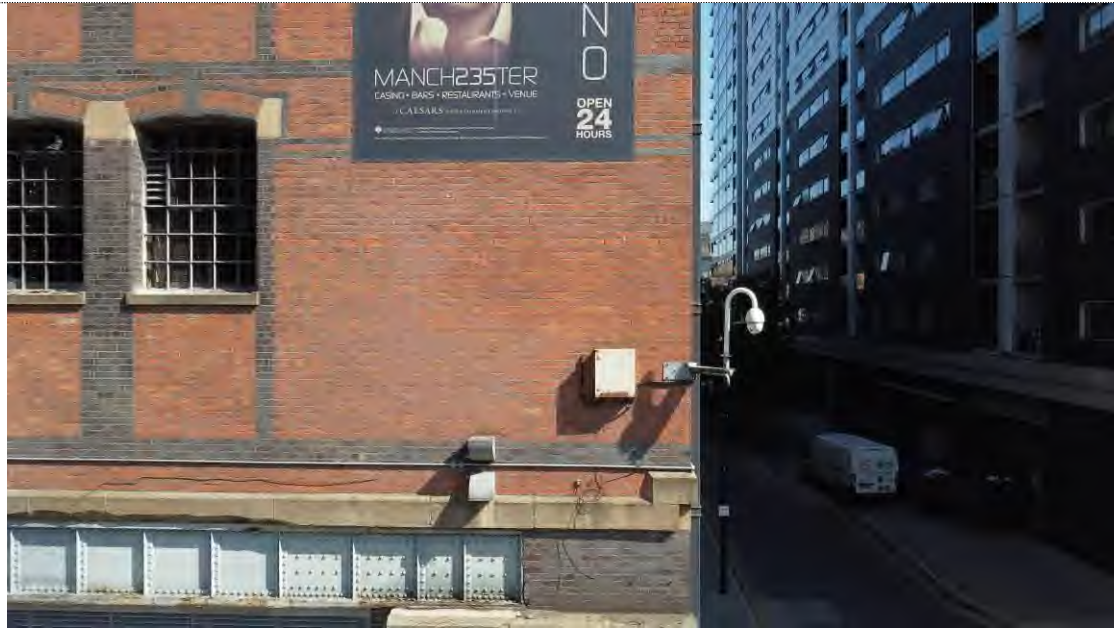
| Photograph: | 74 |

| Description: | General clean and replace of defective brickwork and stonework. (South facing) |

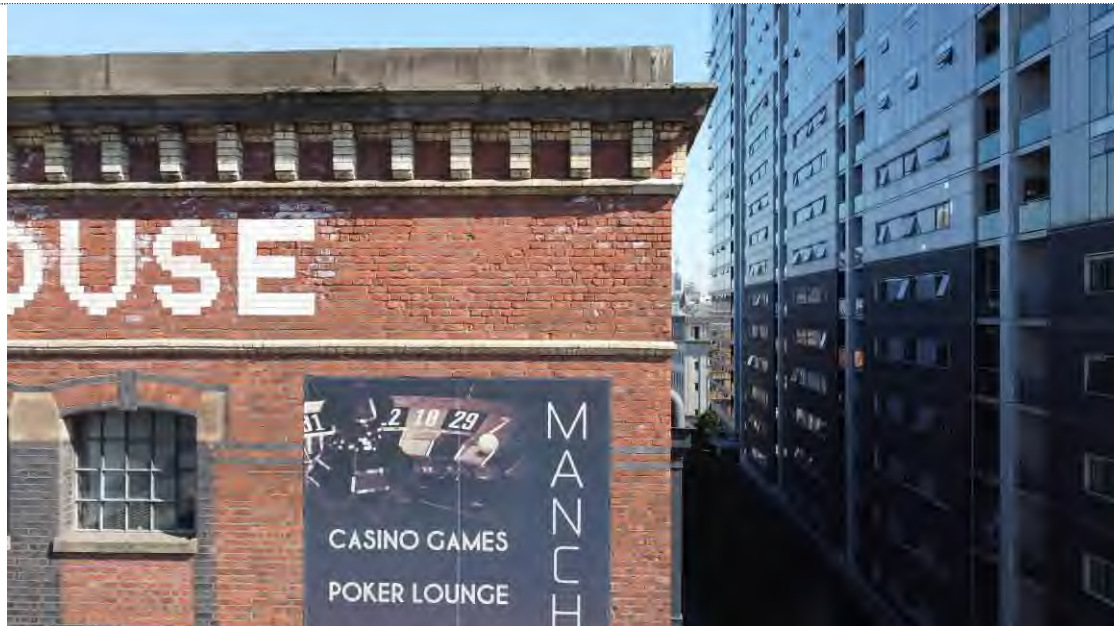
| Photograph: | 75 |

| Description: | General clean and replace of defective brickwork and stonework. (South facing) |

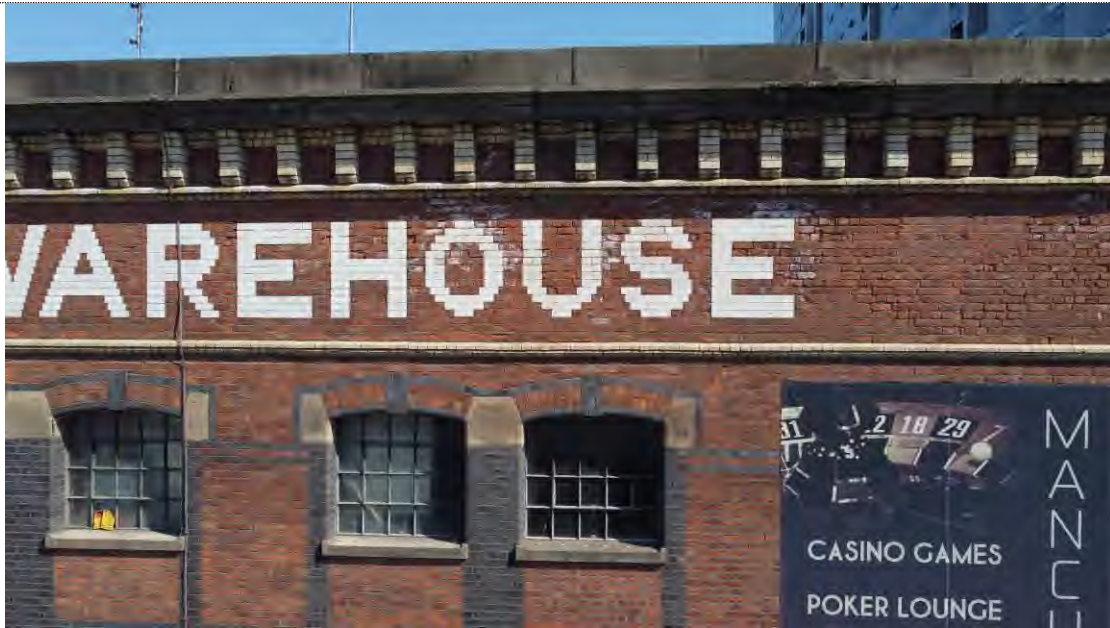
| Photograph: | 76 |

| Description: | General clean and replace of defective brickwork and stonework. (South facing) |

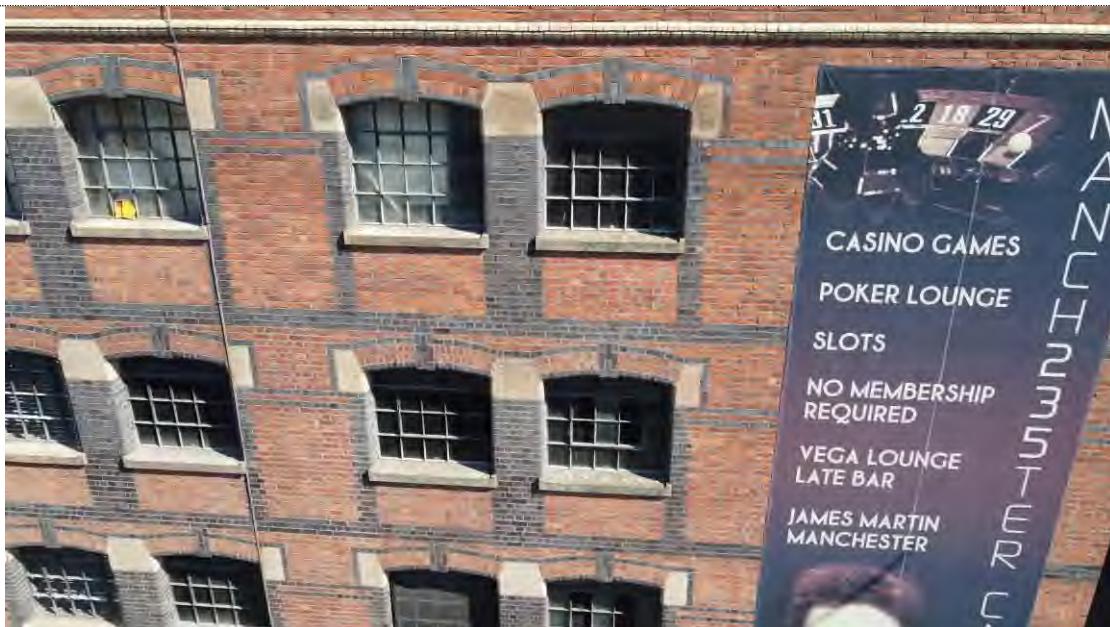
| Photograph: | 77 |

| Description: | General clean and replace of defective brickwork and stonework. Evidence of salt damage. (South facing) |

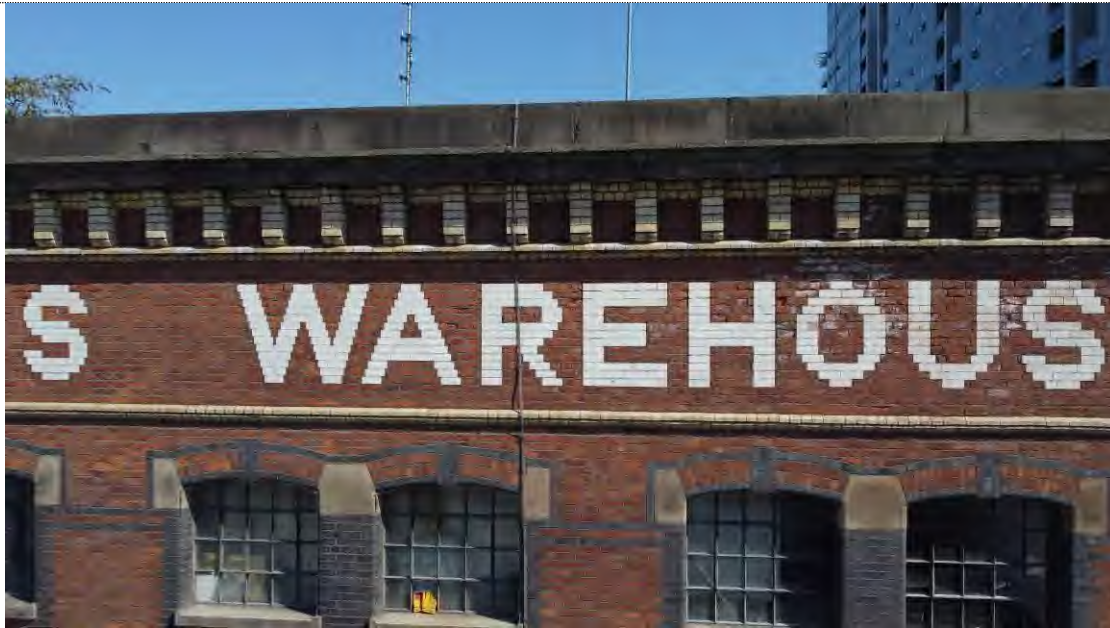
| Photograph: | 78 |

| Description: | General clean and replace of defective brickwork and stonework. (South facing) |

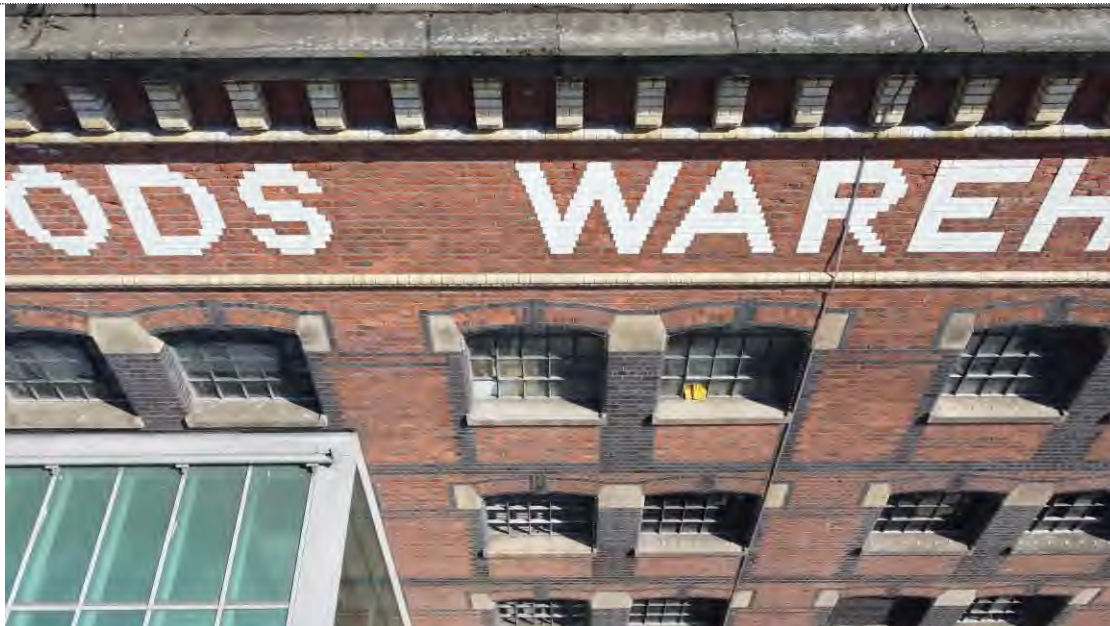
| Photograph: | 79 |

| Description: | General clean and replace of defective brickwork and stonework. (South facing) |

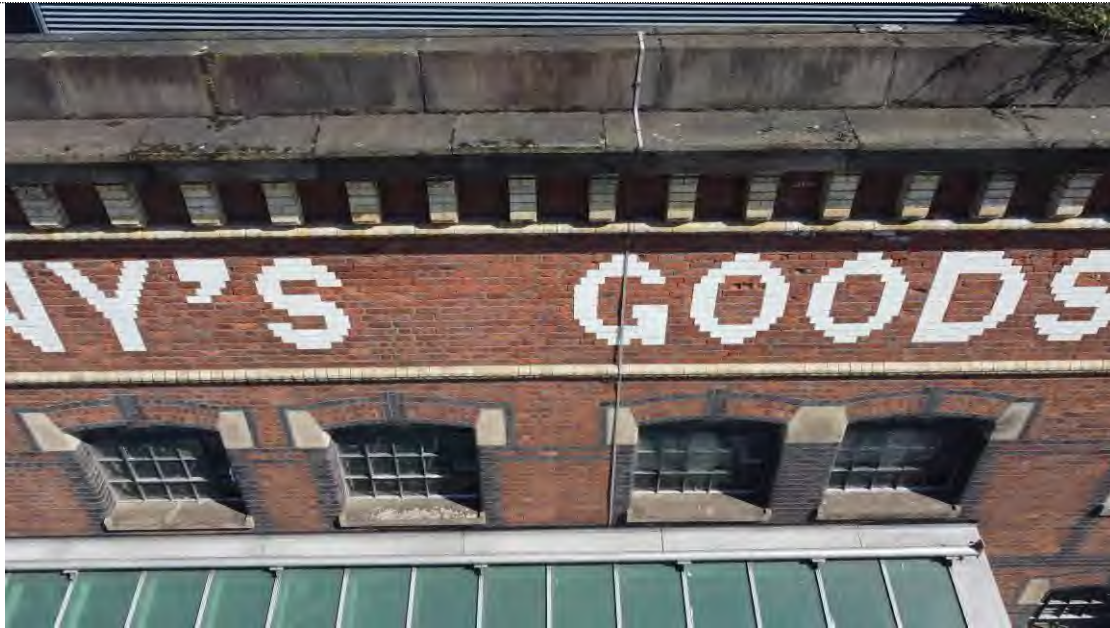
| Photograph: | 80 |

| Description: | General clean and replace of defective brickwork and stonework. (South facing) |

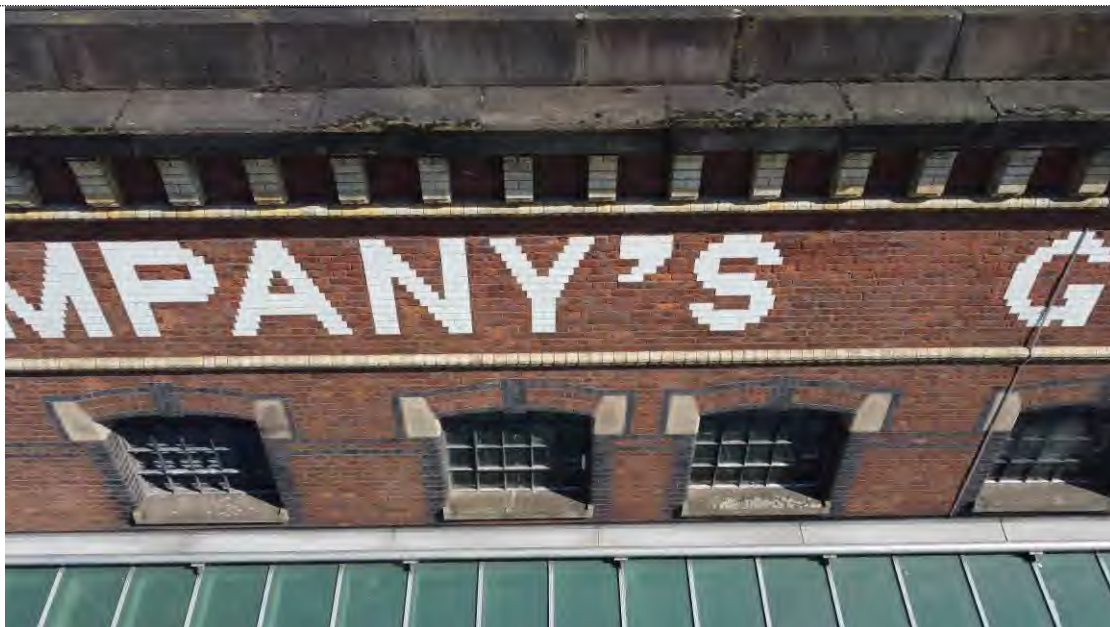
| Photograph: | 81 |

| Description: | General clean and replace of defective brickwork and stonework. Vegetation growth. (South facing) |

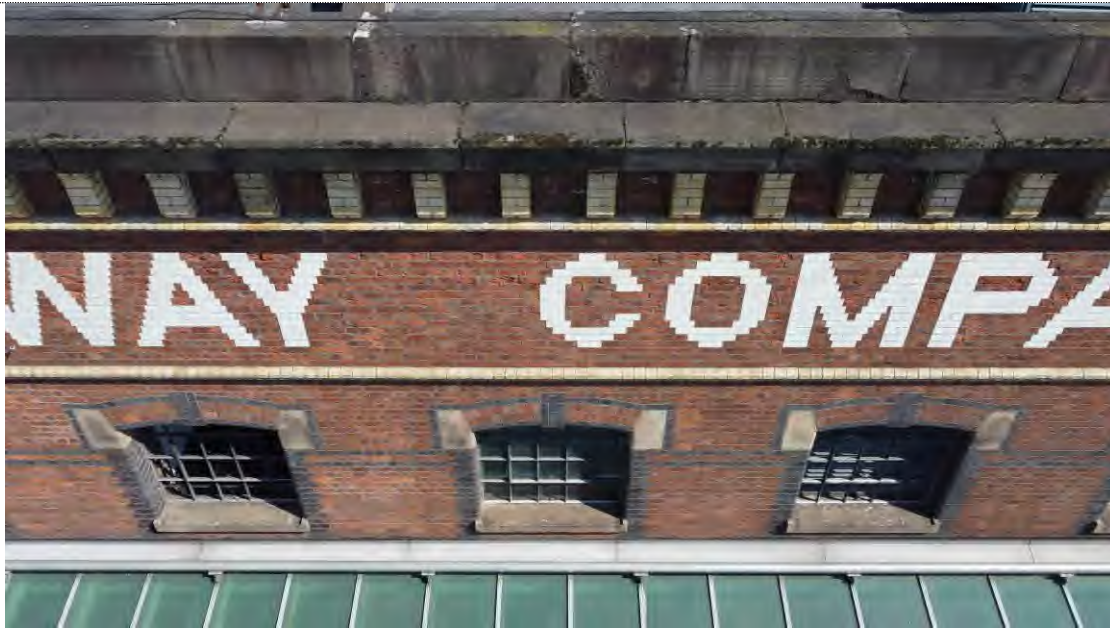
| Photograph: | 82 |

| Description: | General clean and replace of defective brickwork and stonework. Vegetation growth. (South facing) |

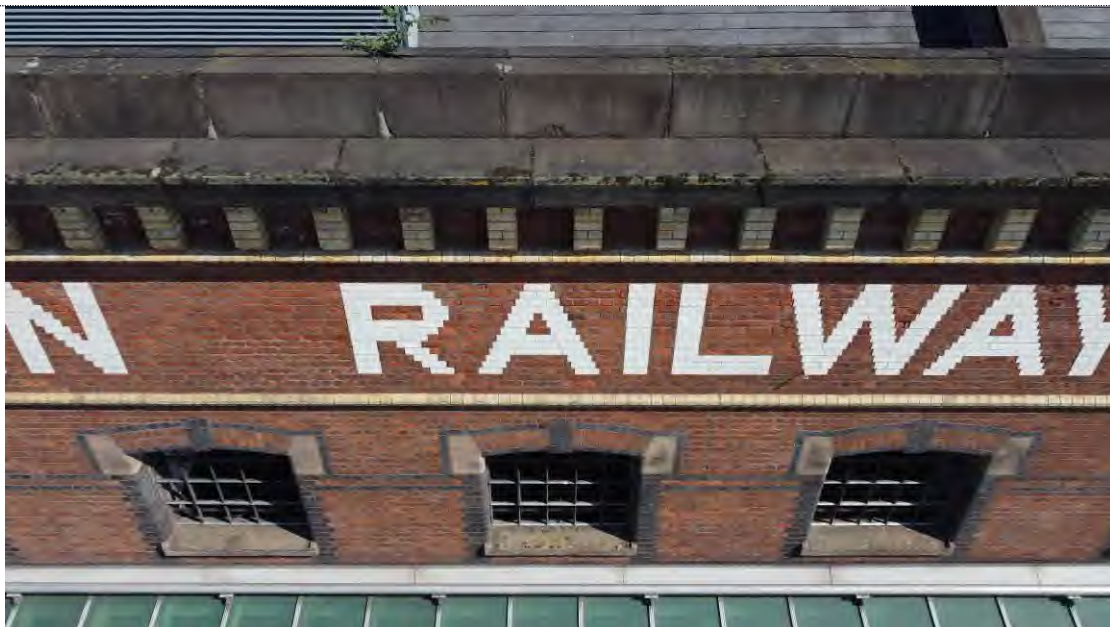
| Photograph: | 83 |

| Description: | General clean and replace of defective brickwork and stonework. Vegetation growth. (South facing) |

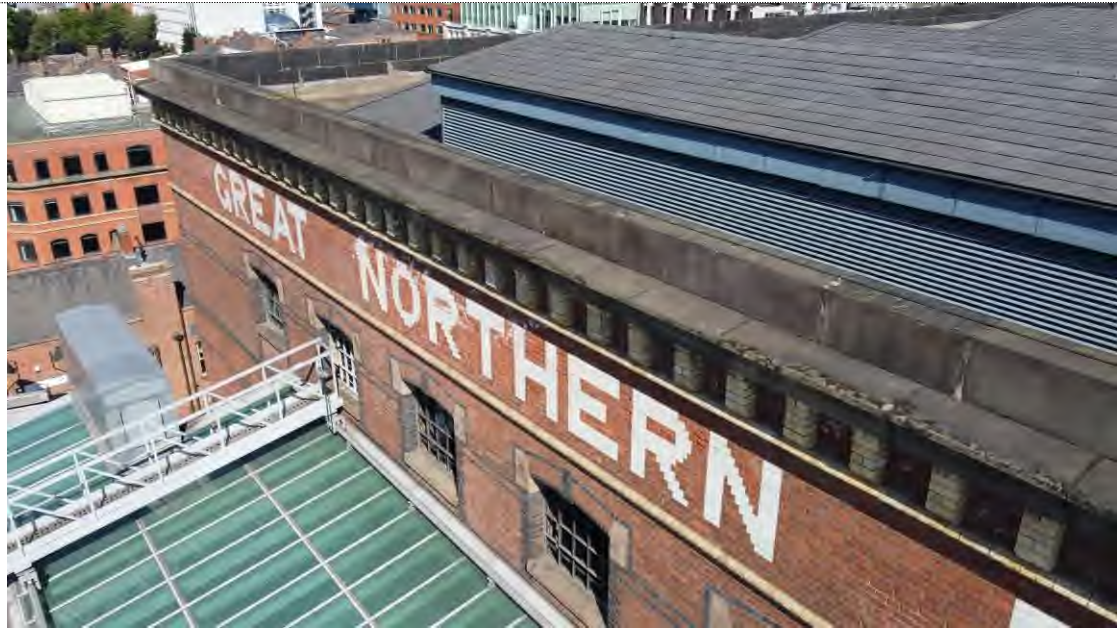
| Photograph: | 84 |

| Description: | General clean and replace of defective brickwork and stonework. Vegetation growth. (South facing) |

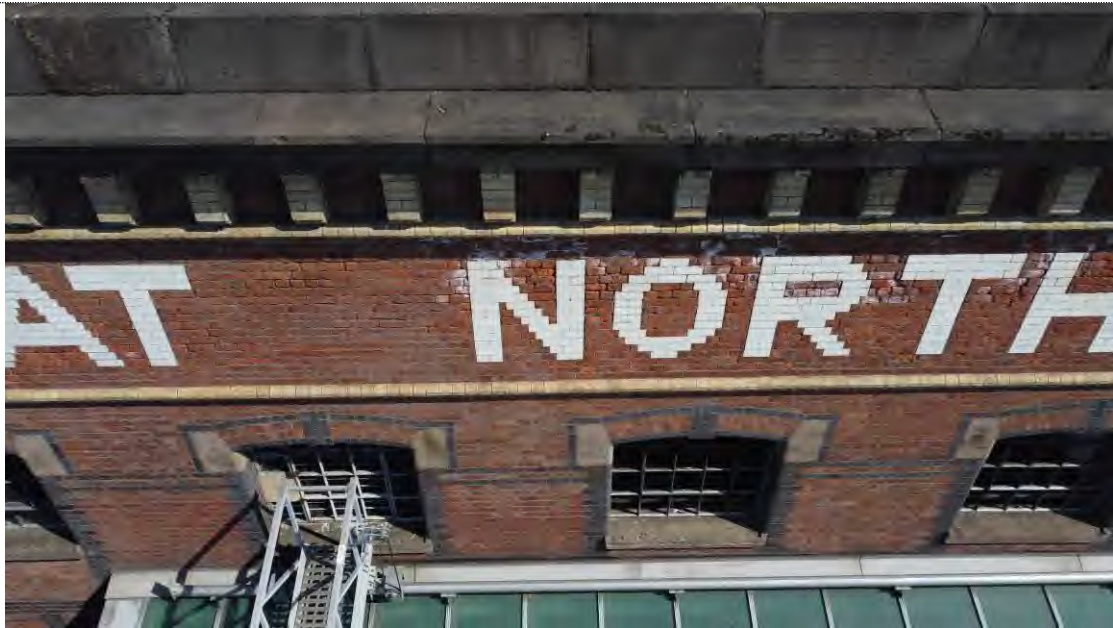
| Photograph: | 86 |

| Description: | General clean and replace of defective brickwork and stonework. (South facing) |

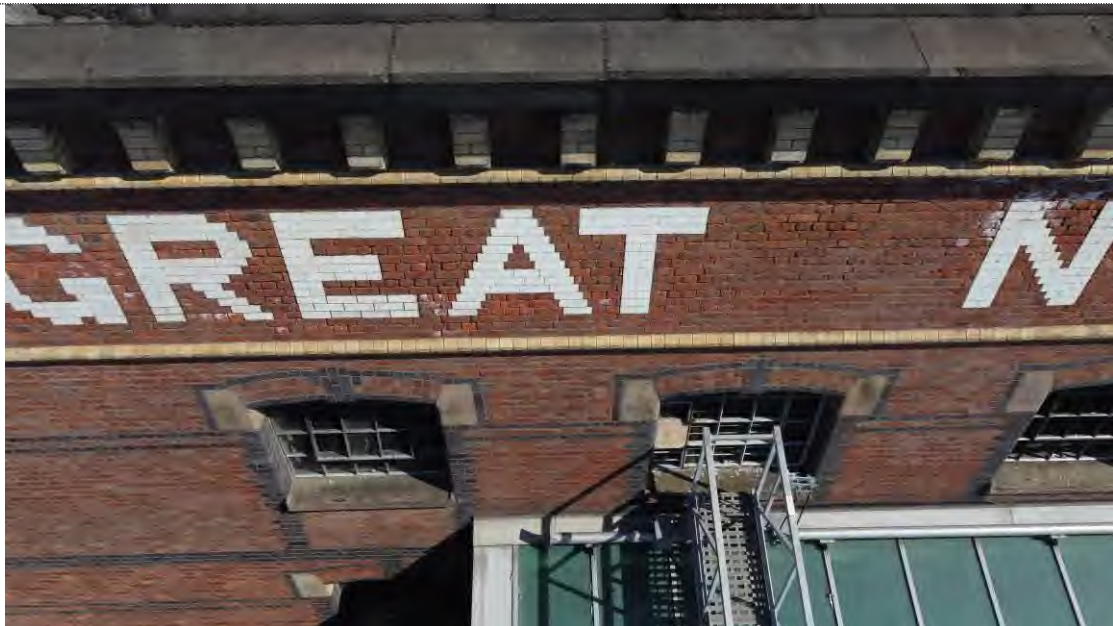
| Photograph: | 87 |

| Description: | General clean and replace of defective brickwork and stonework. (South facing) |

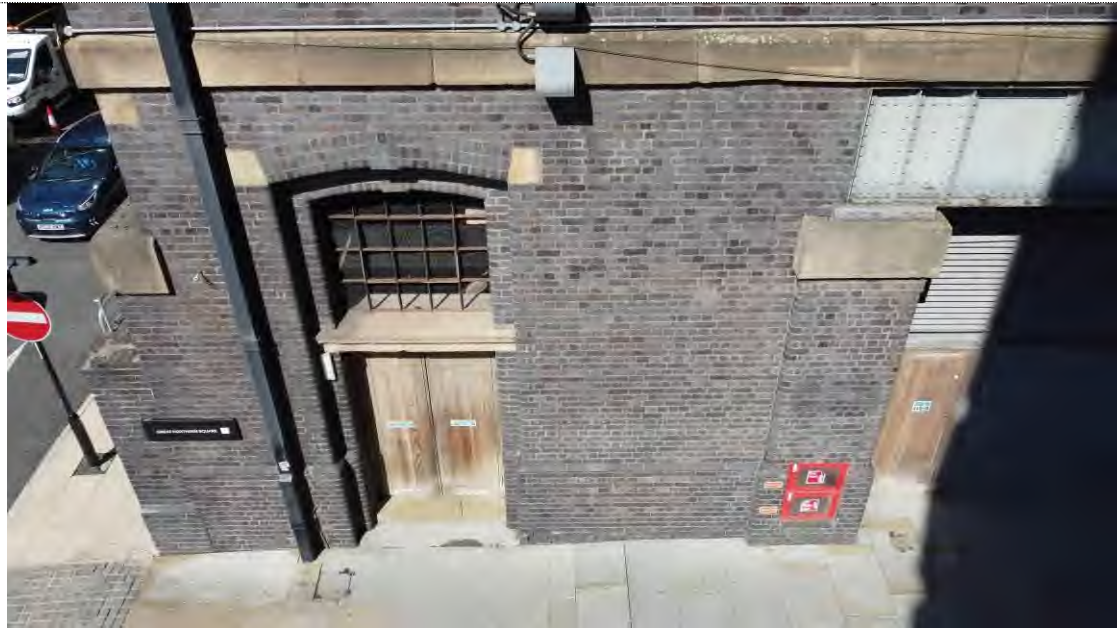
| Photograph: | 88 |

| Description: | General clean and replace of defective brickwork and stonework. (South facing) |

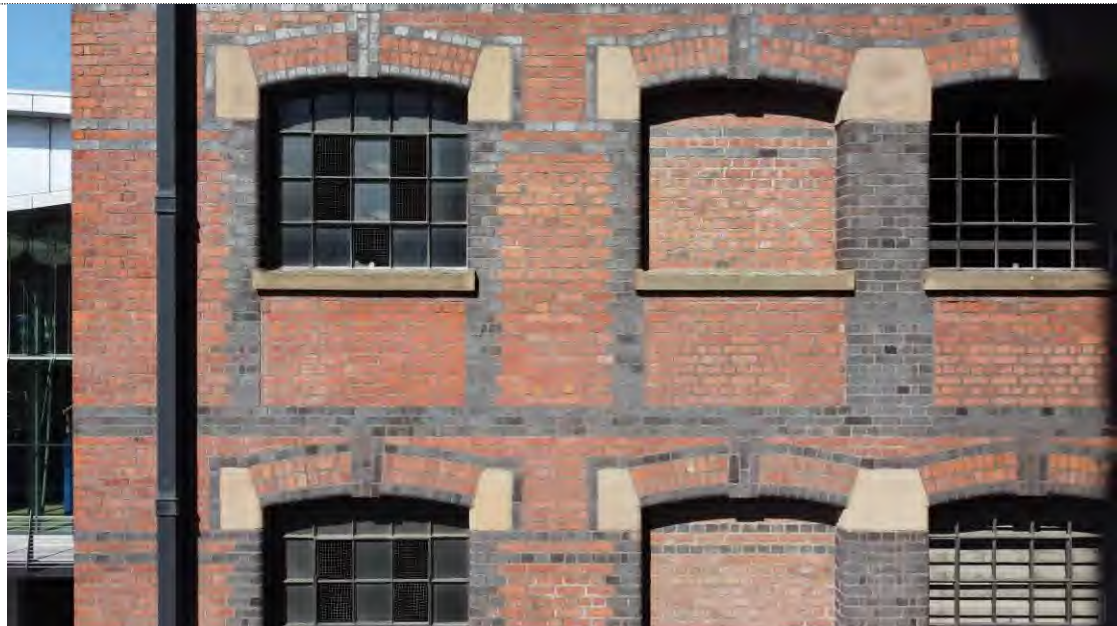
| Photograph: | 89 |

| Description: | General clean and repointing of defective brickwork. (East facing) |

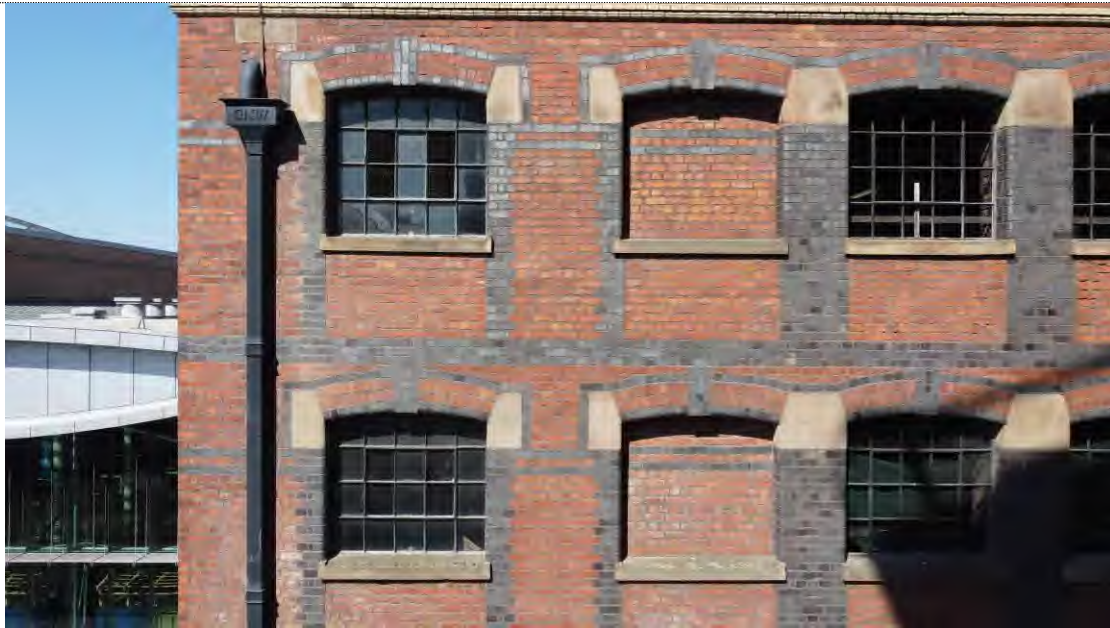
| Photograph: | 90 |

| Description: | General clean and repointing of defective brickwork. (East facing) |

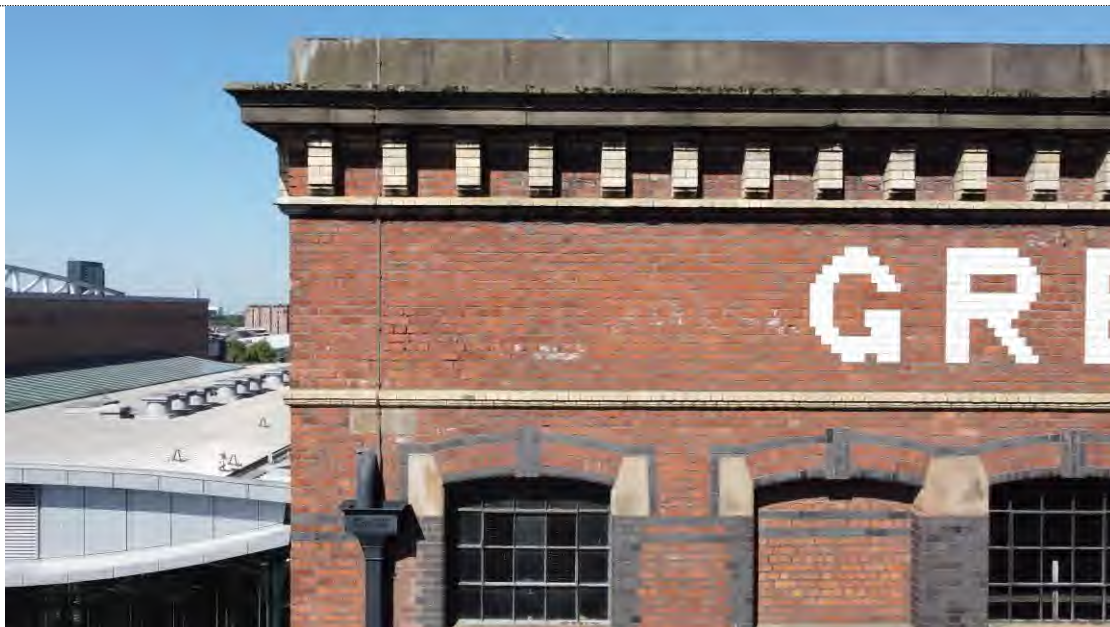
| Photograph: | 91 |

| Description: | General clean and repointing of defective brickwork. Evidence of salt damage. (East facing) |

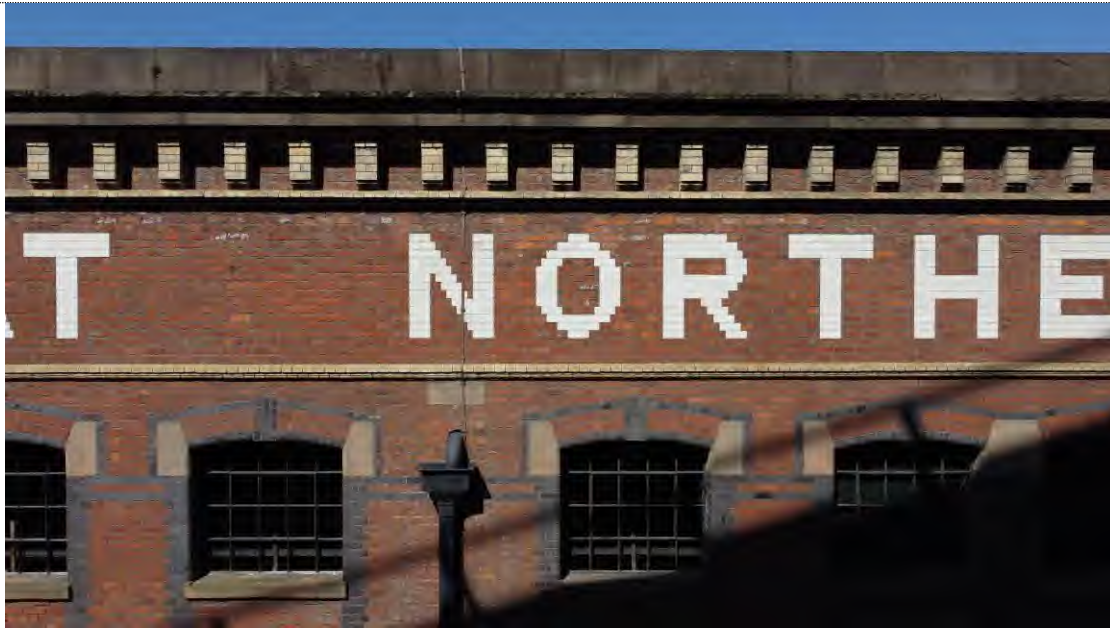
| Photograph: | 92 |

| Description: | General clean and repointing of defective brickwork. Algae growth to stonework. (East facing) |

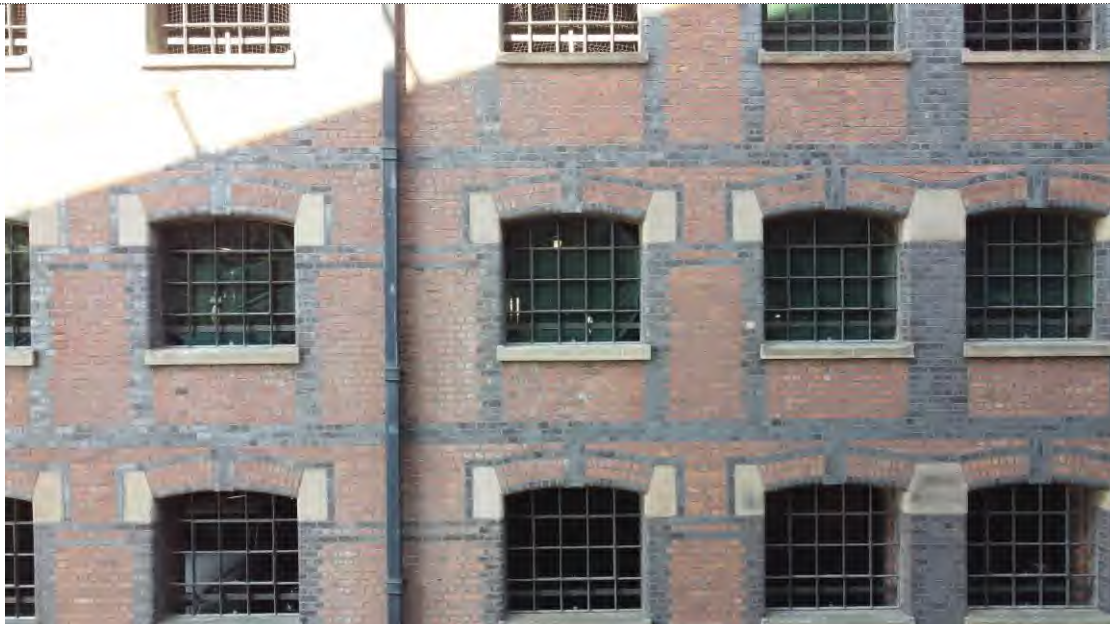
| Photograph: | 93 |

| Description: | General clean and repointing of defective brickwork. (East facing) |

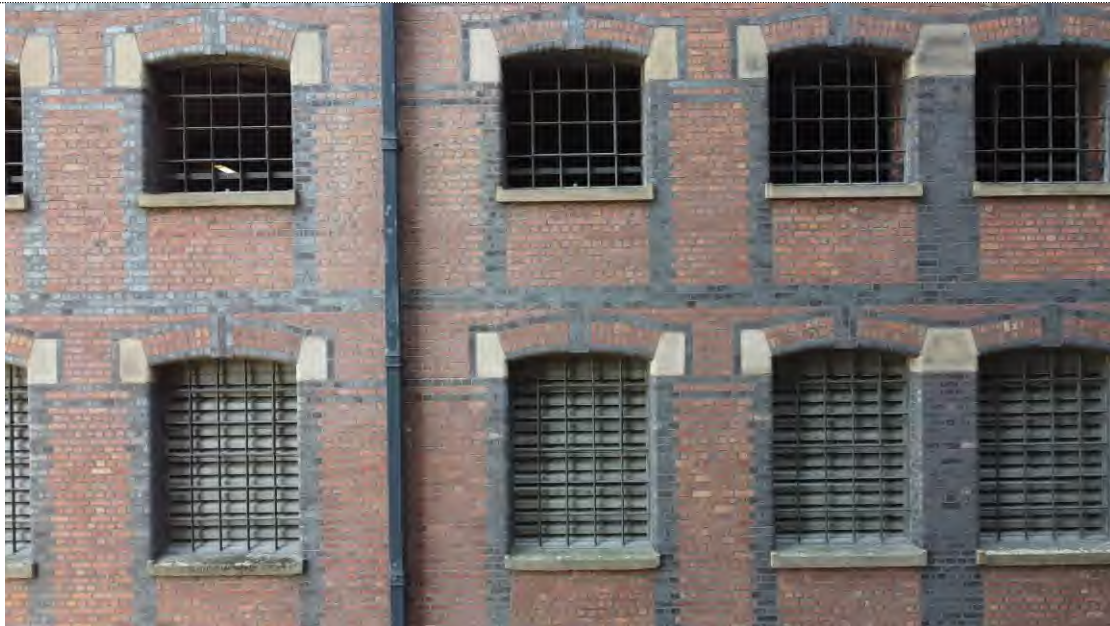
| Photograph: | 94 |

| Description: | General clean and repointing of defective brickwork. (East facing) |

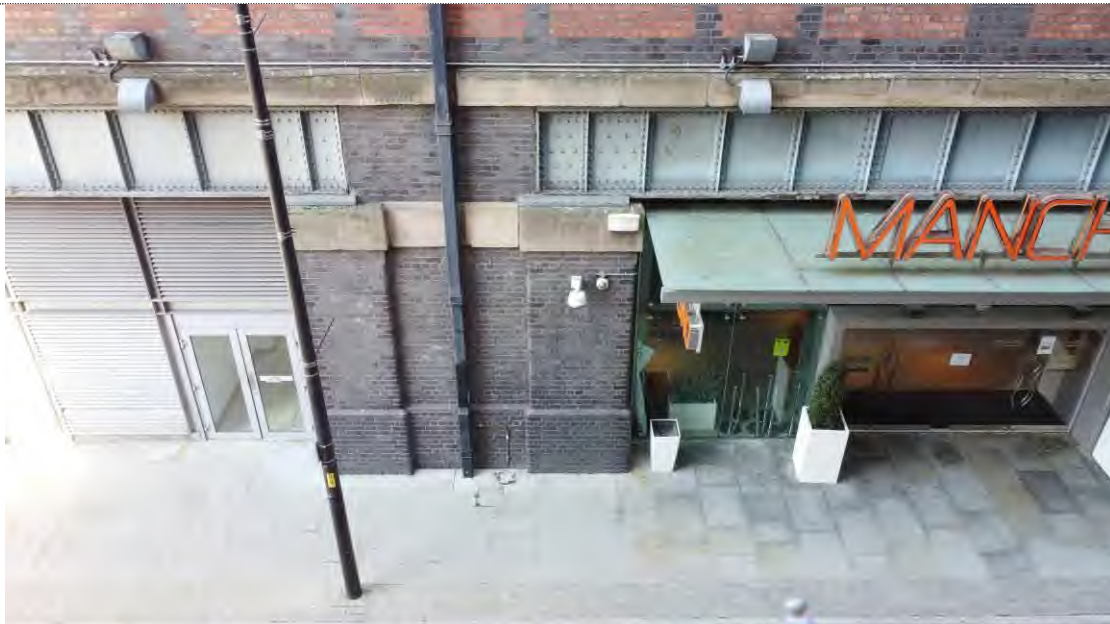
| Photograph: | 95 |

| Description: | General clean and repointing of defective brickwork. (East facing) |

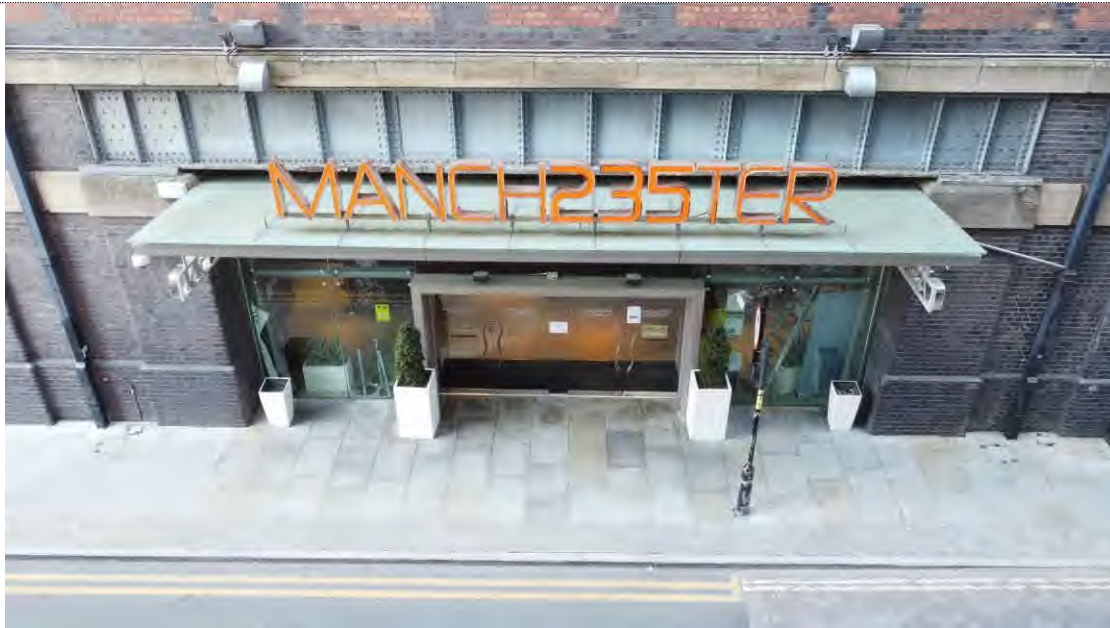
| Photograph: | 96 |

| Description: | General clean and repointing of defective brickwork and stonework. (East facing) |
