**The Great Northern Warehouse**

**Survey 2022**

**Great Northern Warehouse & Deansgate Terraces, Manchester**

**Condition Survey**

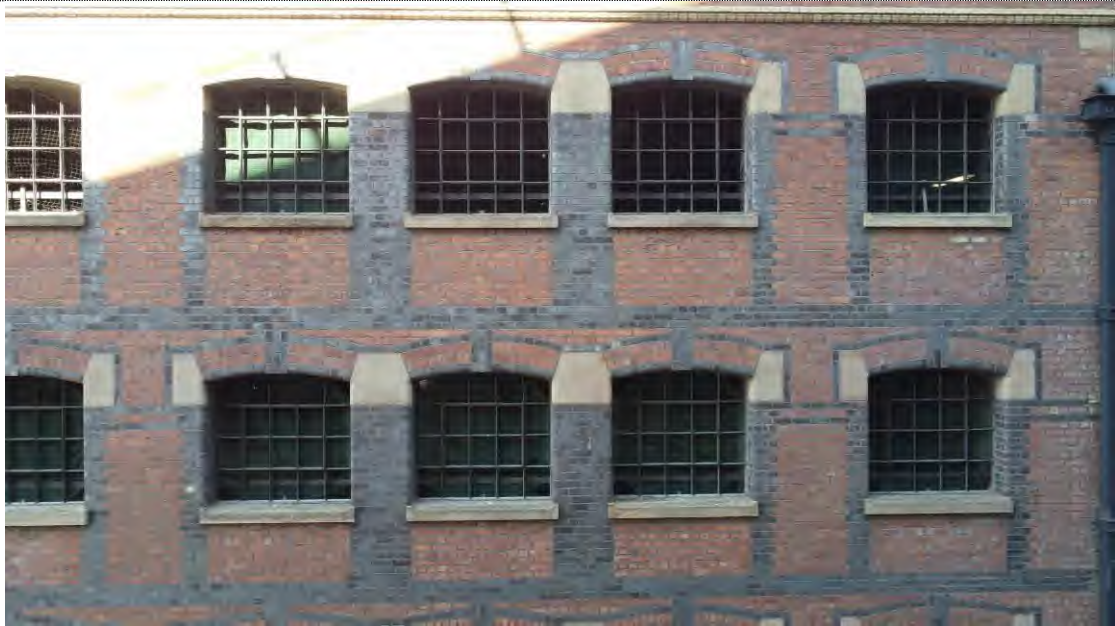
| Photograph: | 98 |

| Description: | General clean and repointing of defective brickwork. (East facing) |

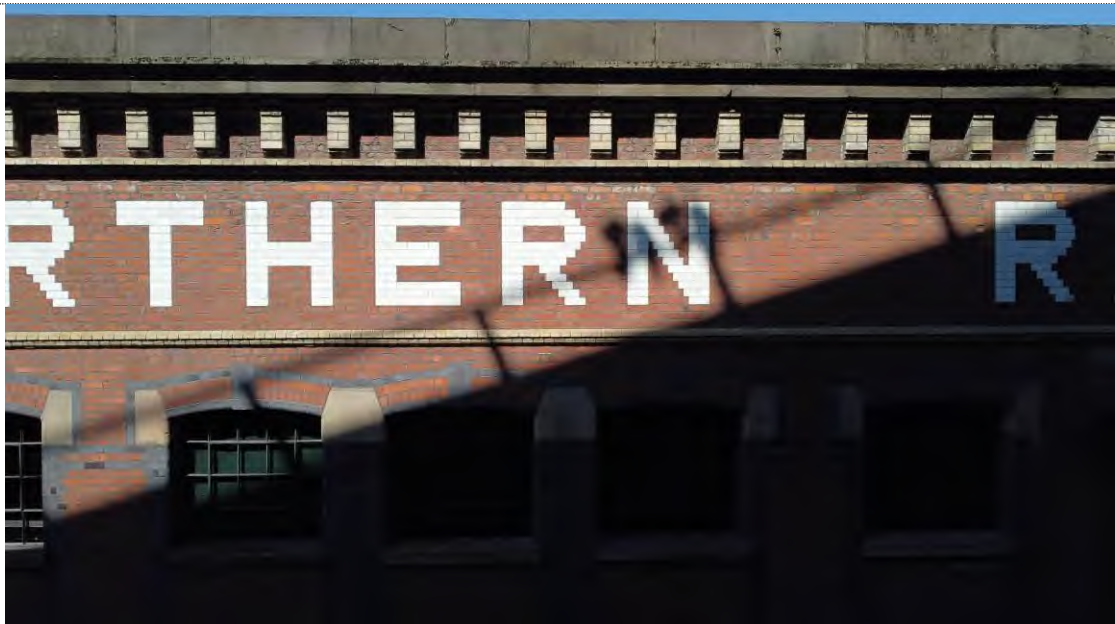
| Photograph: | 99 |

| Description: | General clean and repointing of defective brickwork. (East facing) |

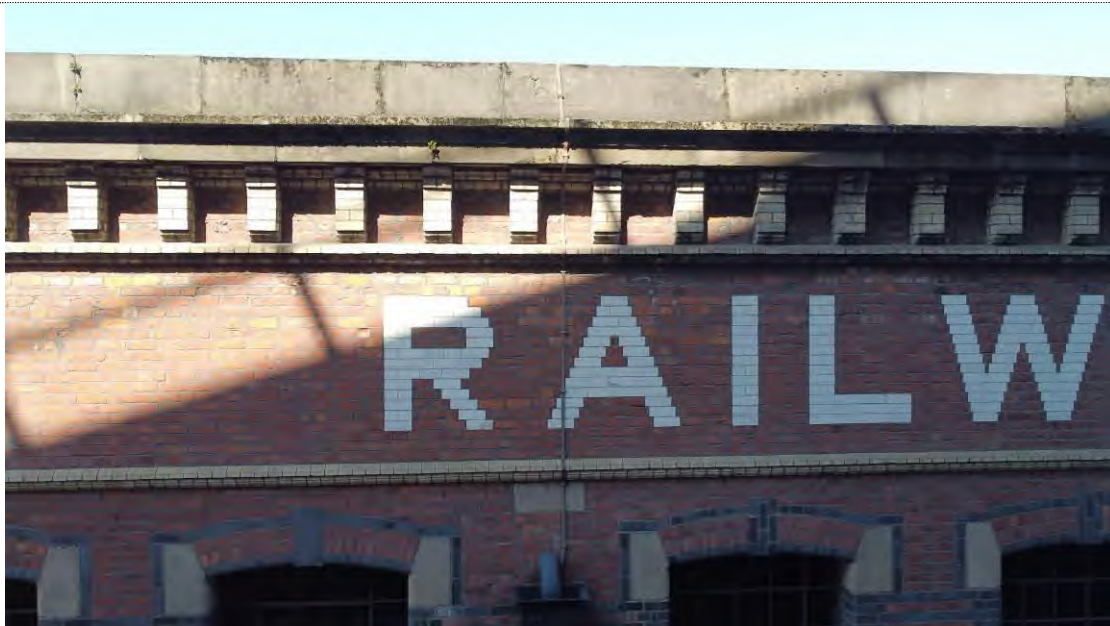
| Photograph: | 100 |

| Description: | General clean and repointing of defective brickwork. (East facing) |

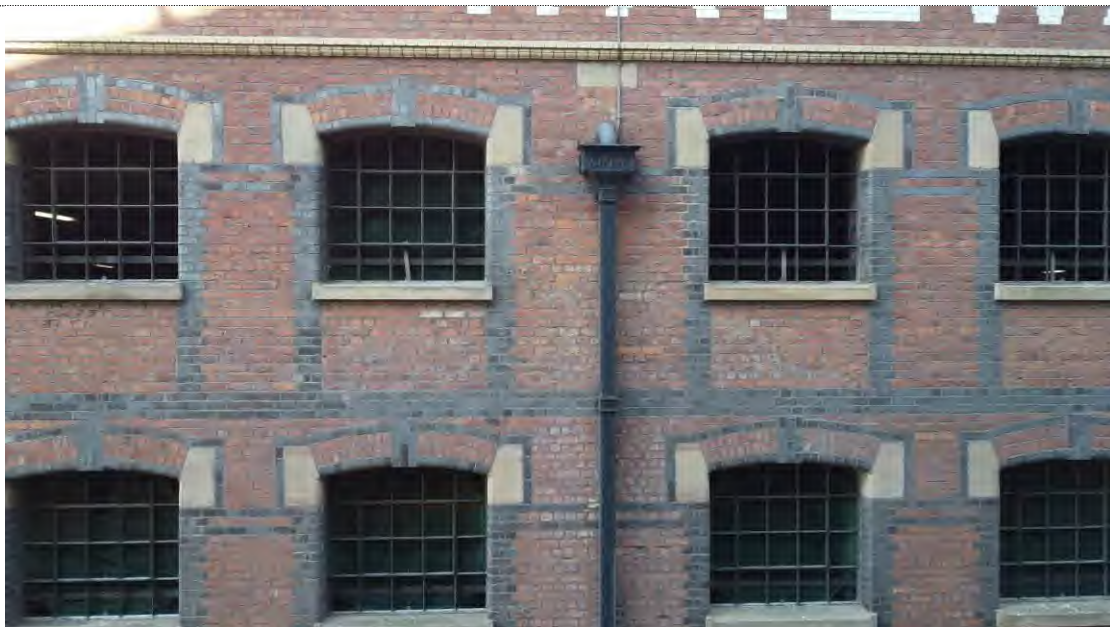
| Photograph: | 101 |

| Description: | General clean and repointing of defective brickwork. Vegetation growth. (East facing) |

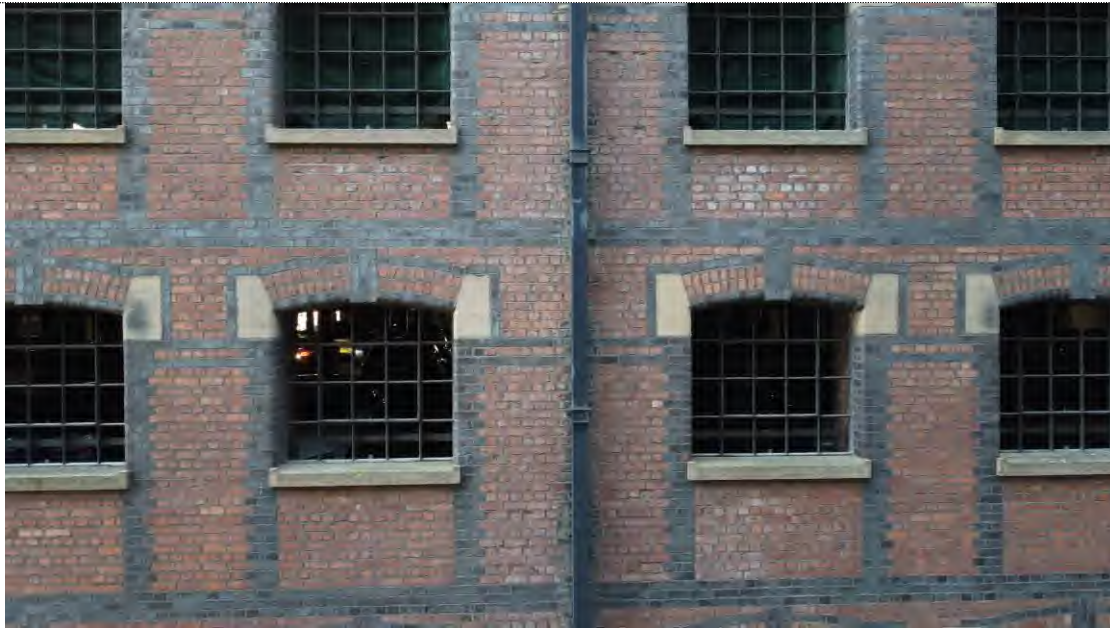
| Photograph: | 102 |

| Description: | General clean and repointing of defective brickwork. (East facing) |

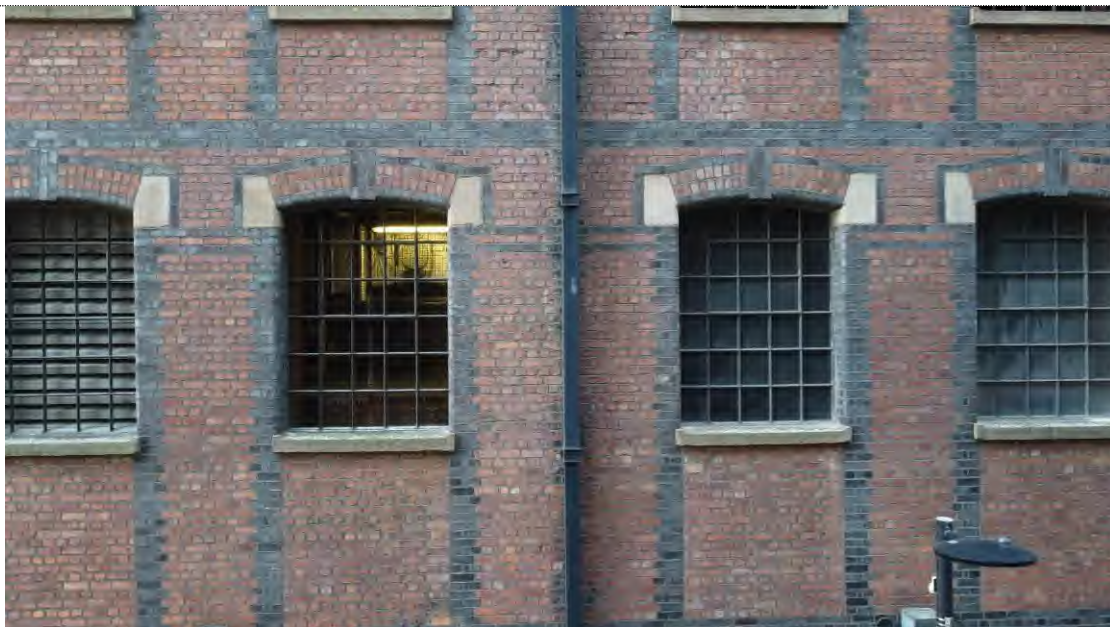
| Photograph: | 103 |

| Description: | General clean and repointing of defective brickwork. Evidence of salt damage. (East facing) |

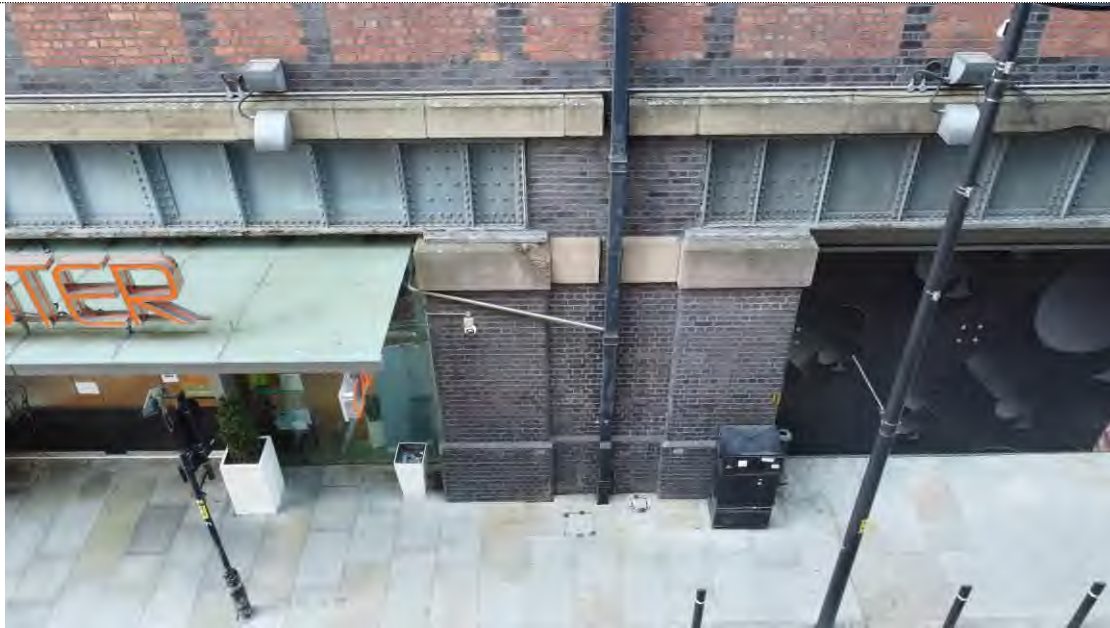
| Photograph: | 104 |

| Description: | General clean and repointing of defective brickwork. Evidence of salt damage. (East facing) |

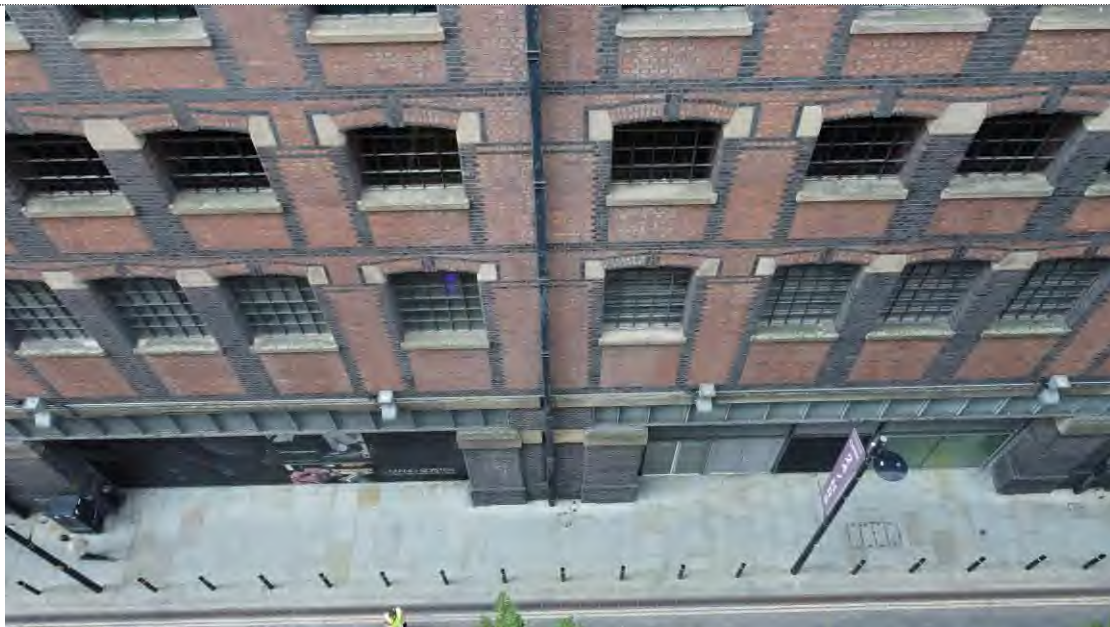
| Photograph: | 105 |

| Description: | General clean and repointing of defective brickwork and stonework. (East facing) |

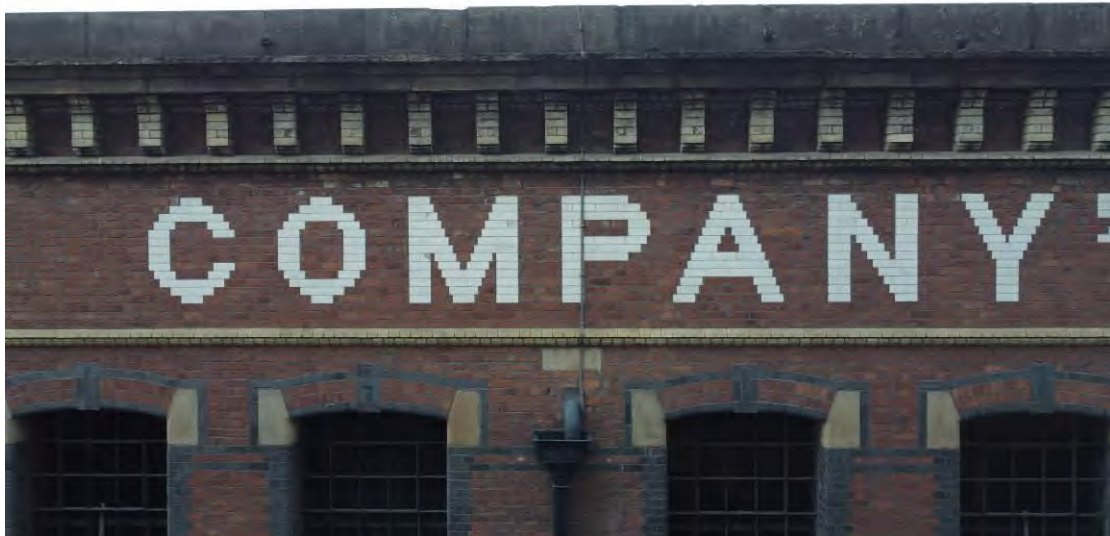
| Photograph: | 108 |

| Description: | General clean and repointing of defective brickwork. (East facing) |

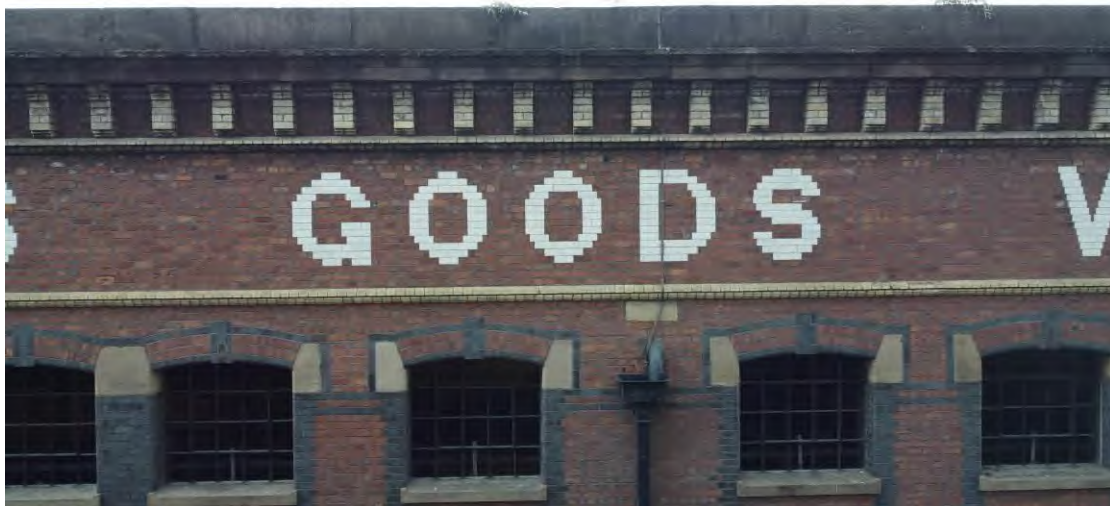
| Photograph: | 109 |

| Description: | General clean and repointing of defective brickwork. Algae growth to stonework. (East facing) |

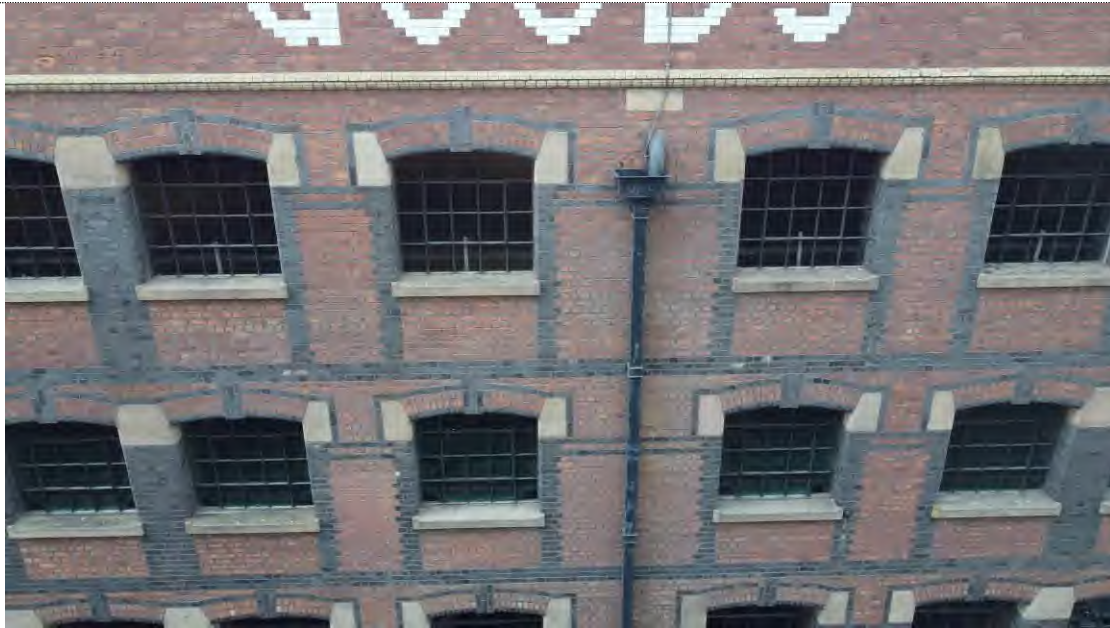
| Photograph: | 110 |

| Description: | General clean and repointing of defective brickwork. Vegetation growth to stonework. (East facing) |

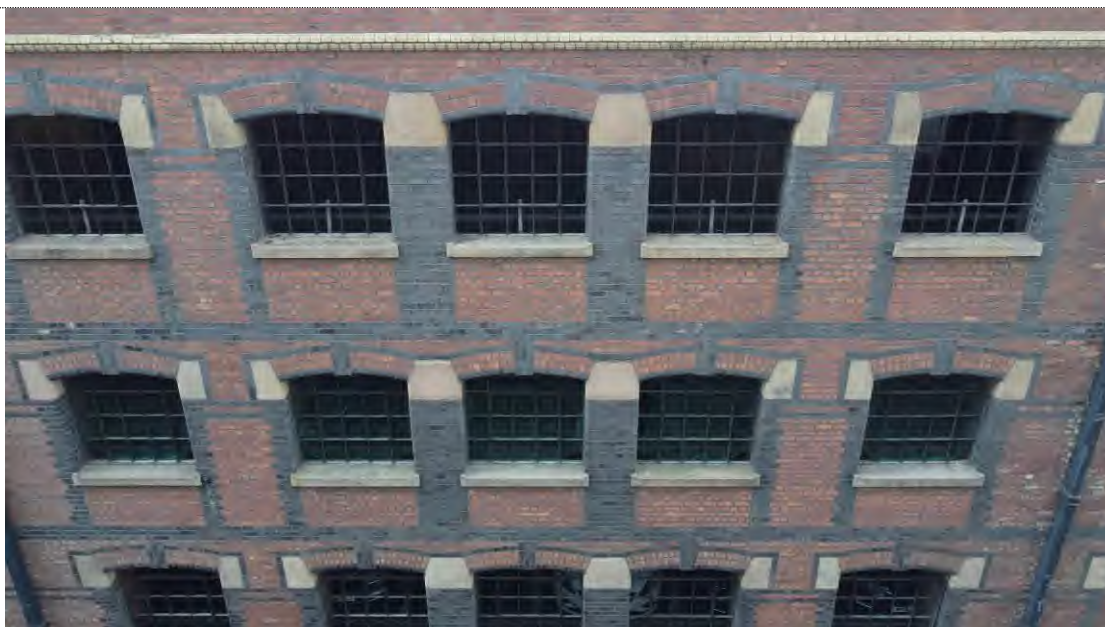
| Photograph: | 113 |

| Description: | General clean and repointing of defective brickwork. Vegetation growth to stonework. (East facing) |

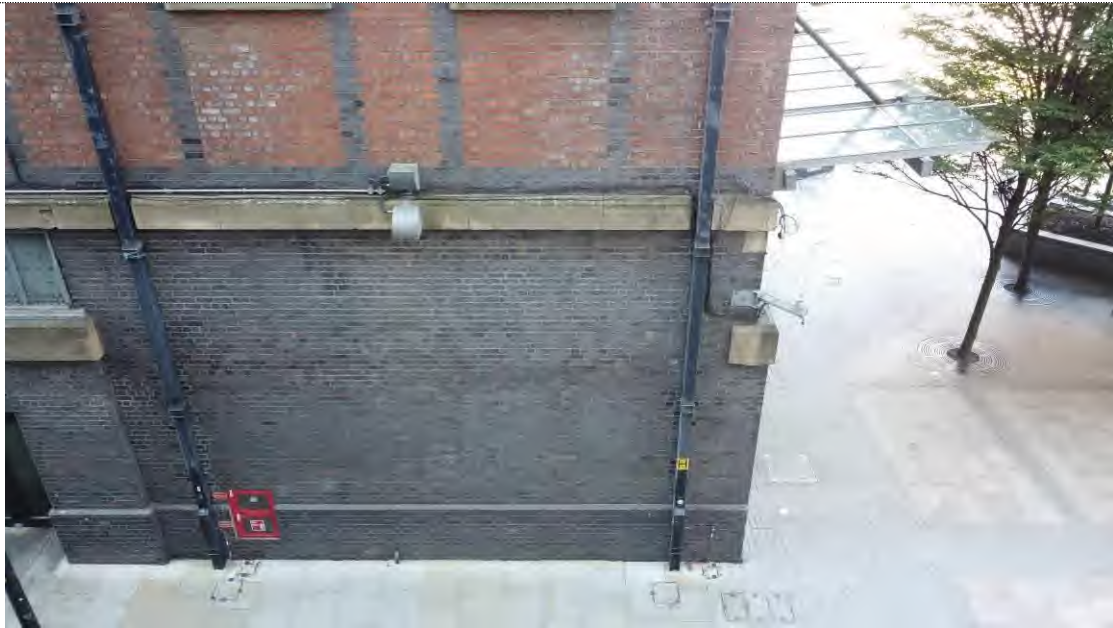
| Photograph: | 118 |

| Description: | General view of the east facing elevation. Evidence of salt damage. |

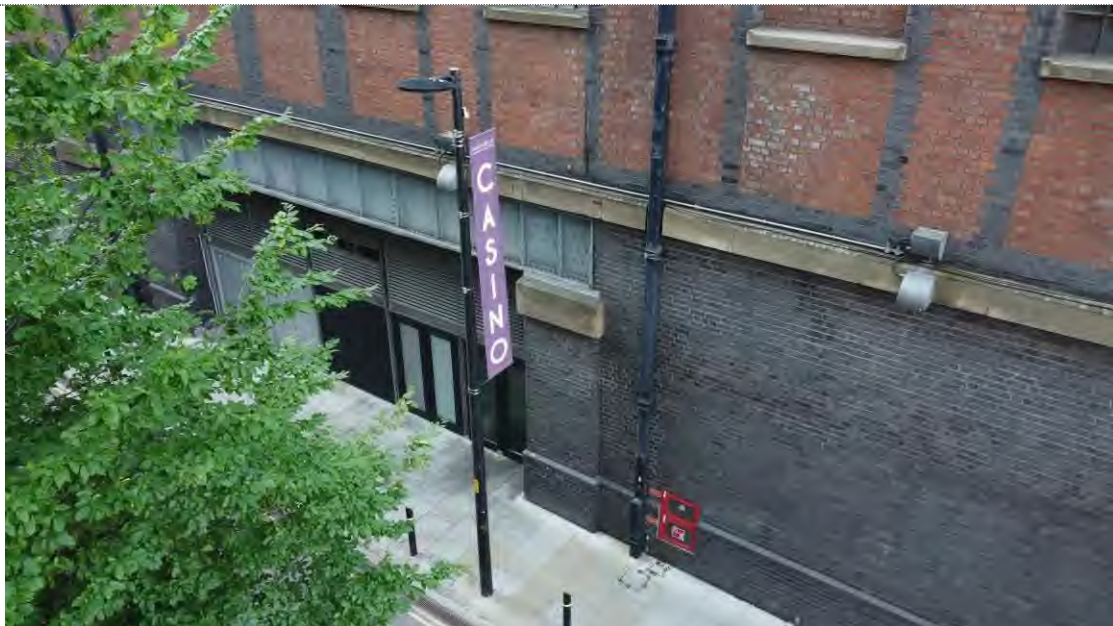
| Photograph: | 119 |

| Description: | General clean and repointing of defective brickwork and stonework. (East facing) |

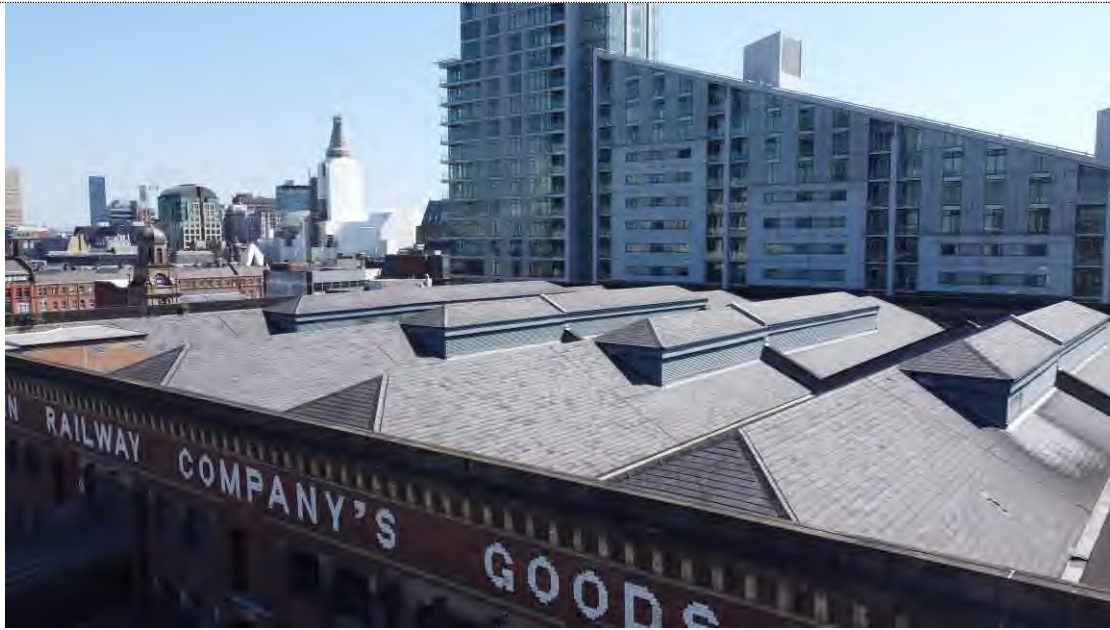
| Photograph: | 120 |

| Description: | General clean and replace of defective brickwork. (East facing) |

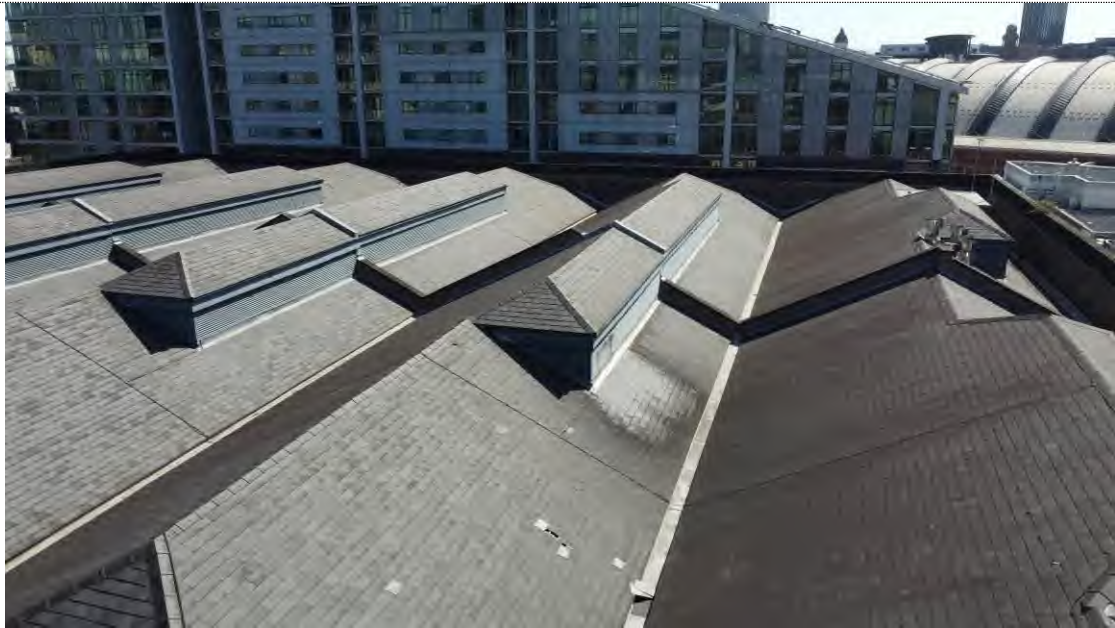
| Photograph: | 122 |

| Description: | Slipped and broken roof slates. |

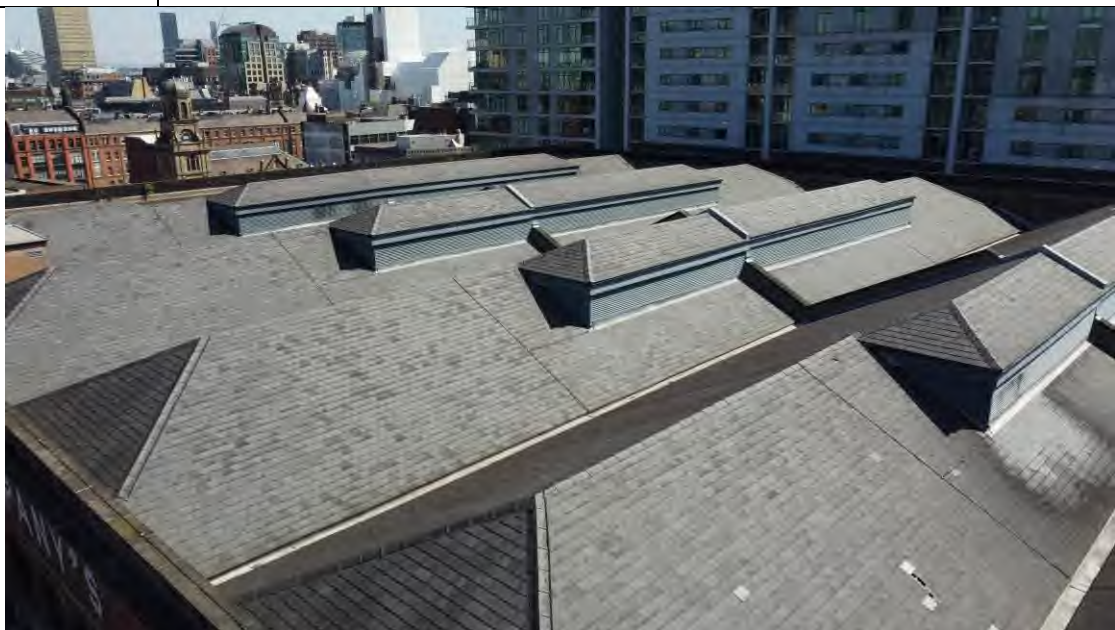
| Photograph: | 123 |

| Description: | Slipped and missing roof slates. Evidence of extensive damage to roof slates. |

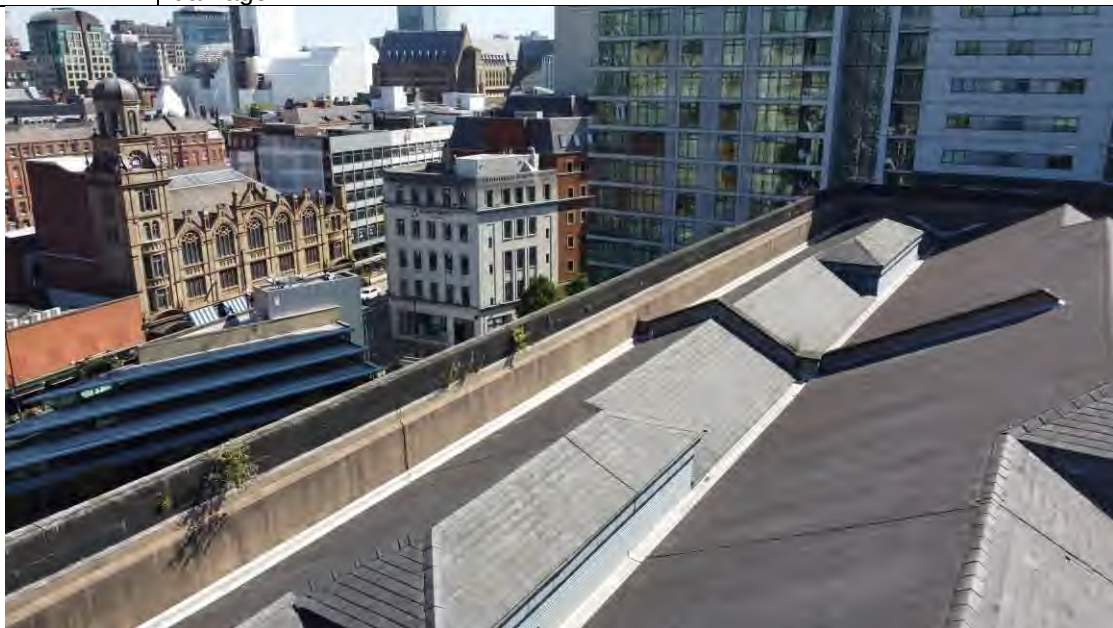
| Photograph: | 127 |

| Description: | General view of the roof. Slipped slates in roof gully. Evidence of water damage. |

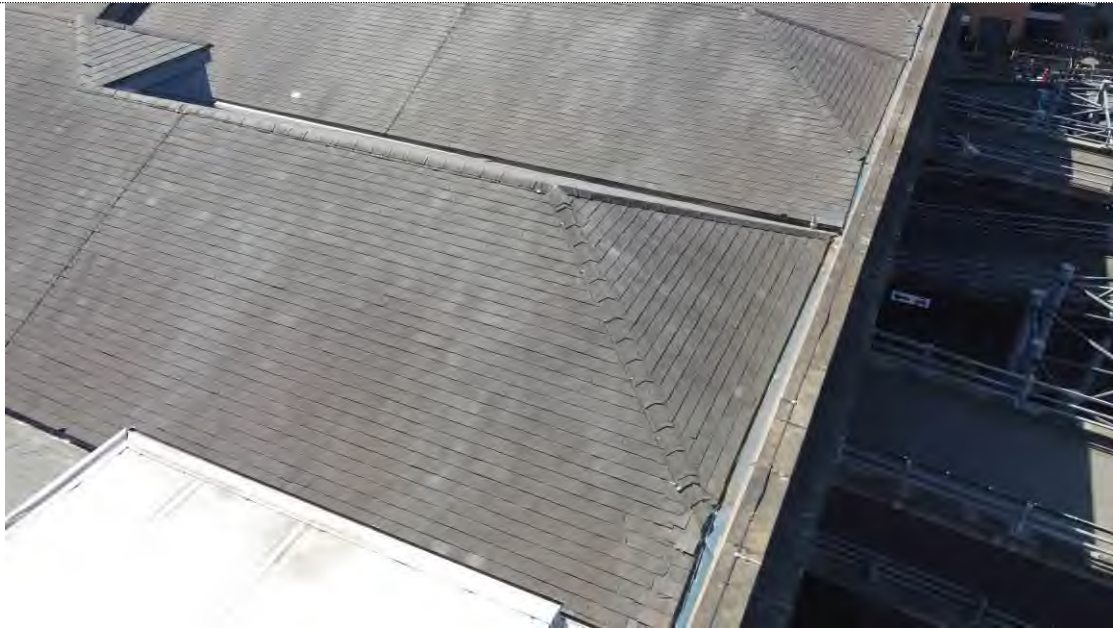
| Photograph: | 128 |

| Description: | Vegetation growth in the stonework. |

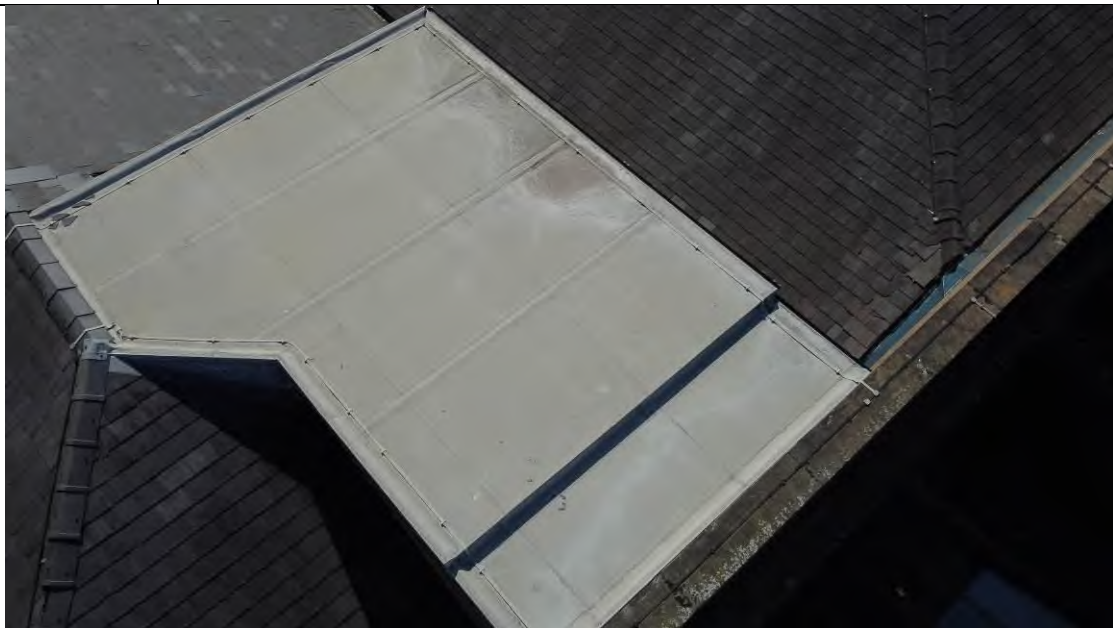
| Photograph: | 129 |

| Description: | Loose and cracked roof slates. |

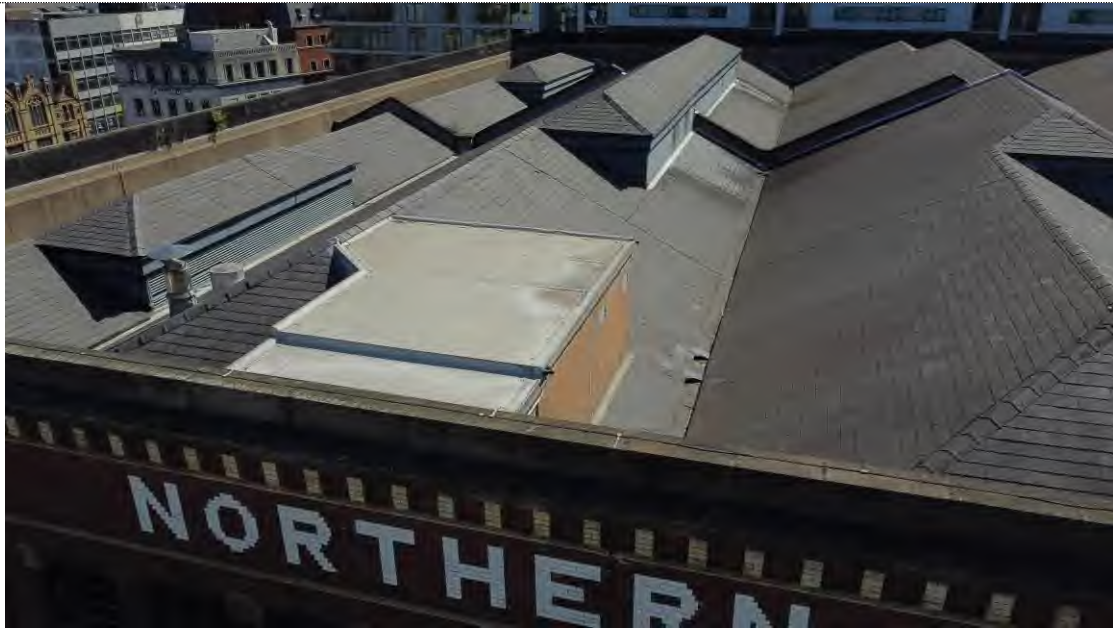
| Photograph: | 130 |

| Description: | Flat roof, evidence of ponding water. Broken sections of roof slates. |

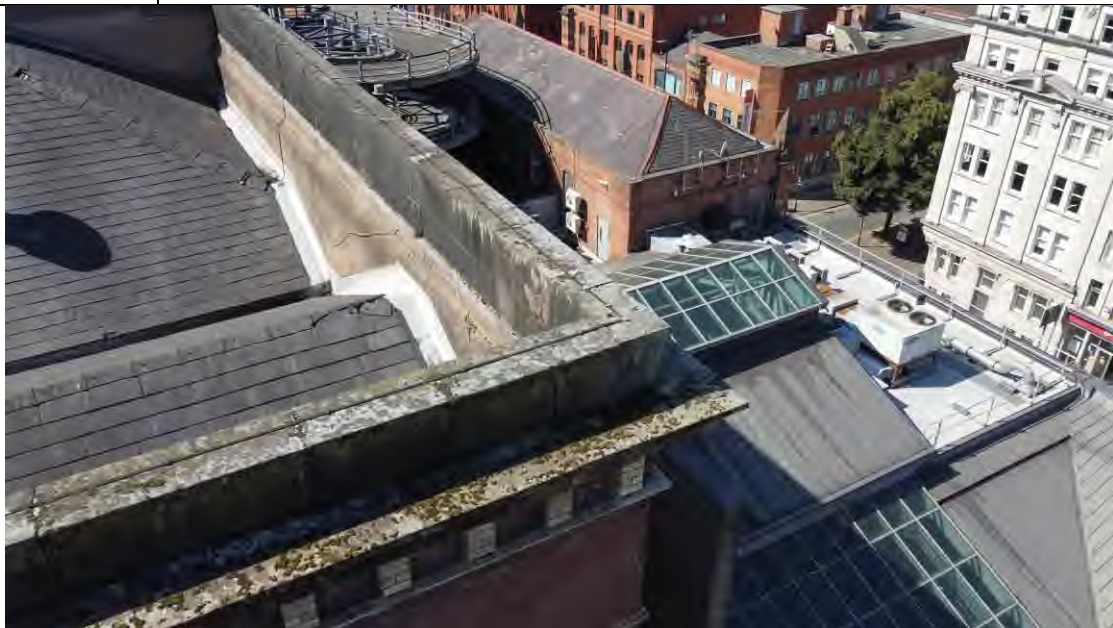
| Photograph: | 131 |

| Description: | Slipped slates in the roof gully. Evidence of water damage at ventilation exhaust |

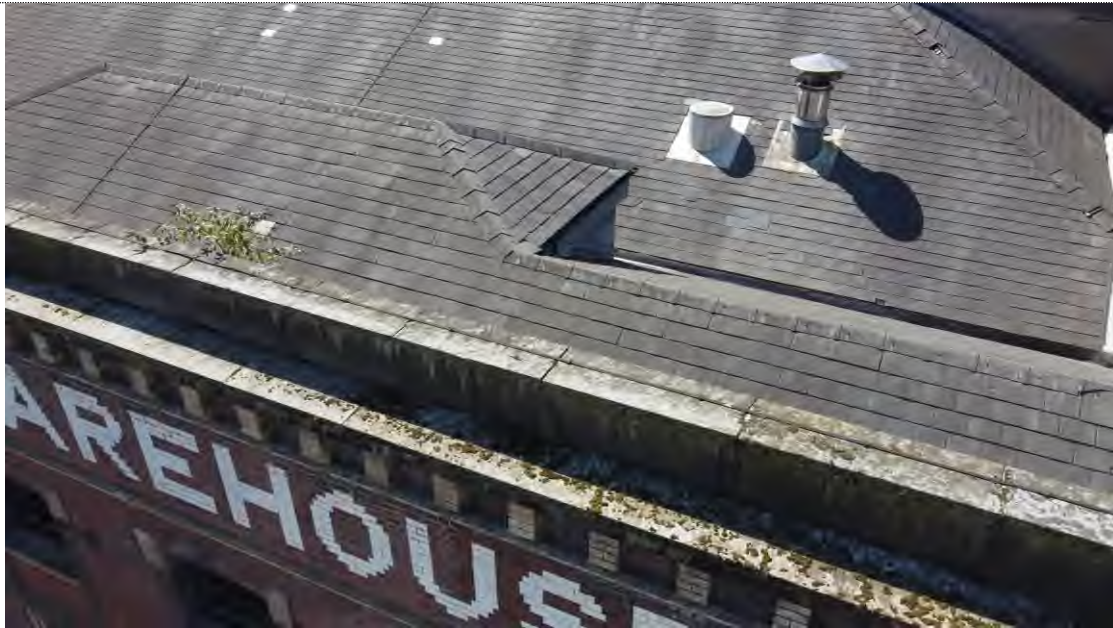
| Photograph: | 132 |

| Description: | Algae growth. Broken and missing roof slates. |

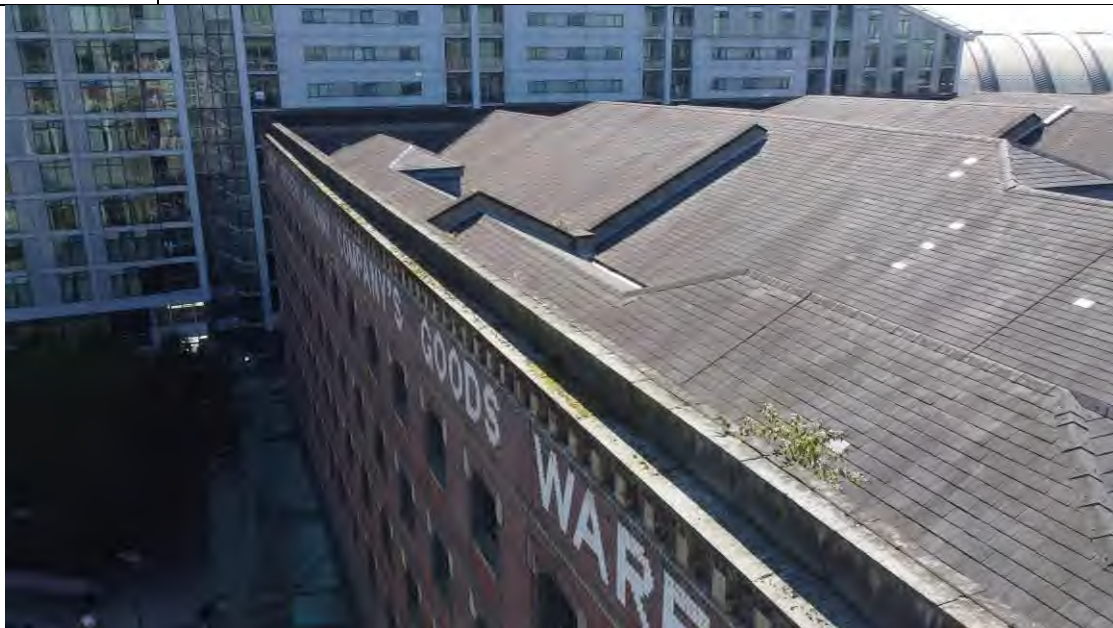
| Photograph: | 133 |

| Description: | Vegetation growth on the stonework. Slipped and broken roof slates. |

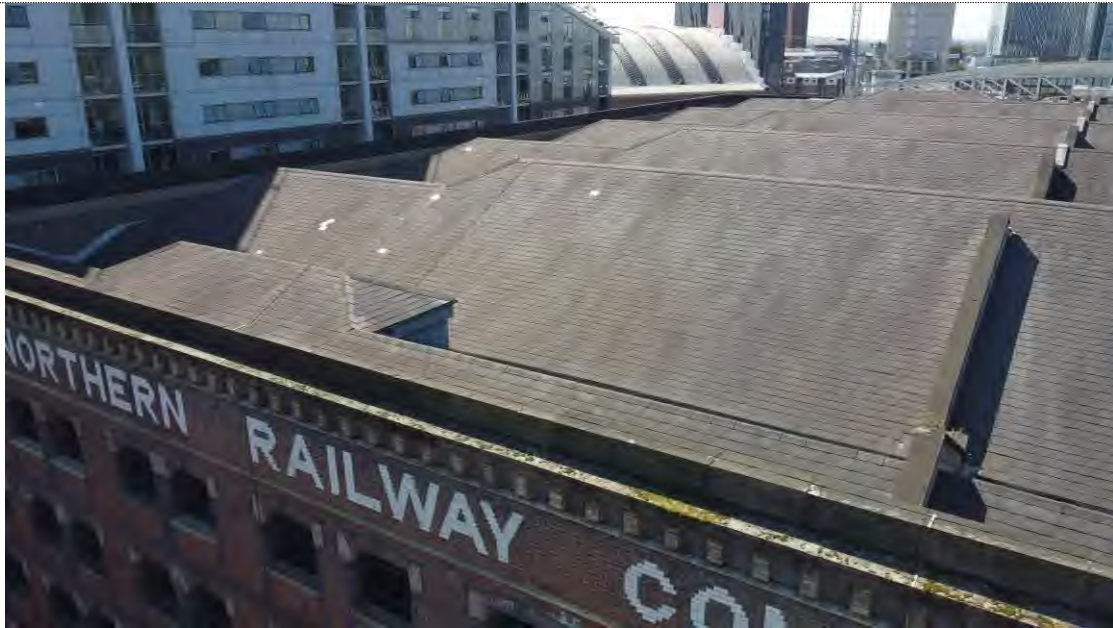
| Photograph: | 134 |

| Description: | Vegetation growth and algae growth in the stonework. |

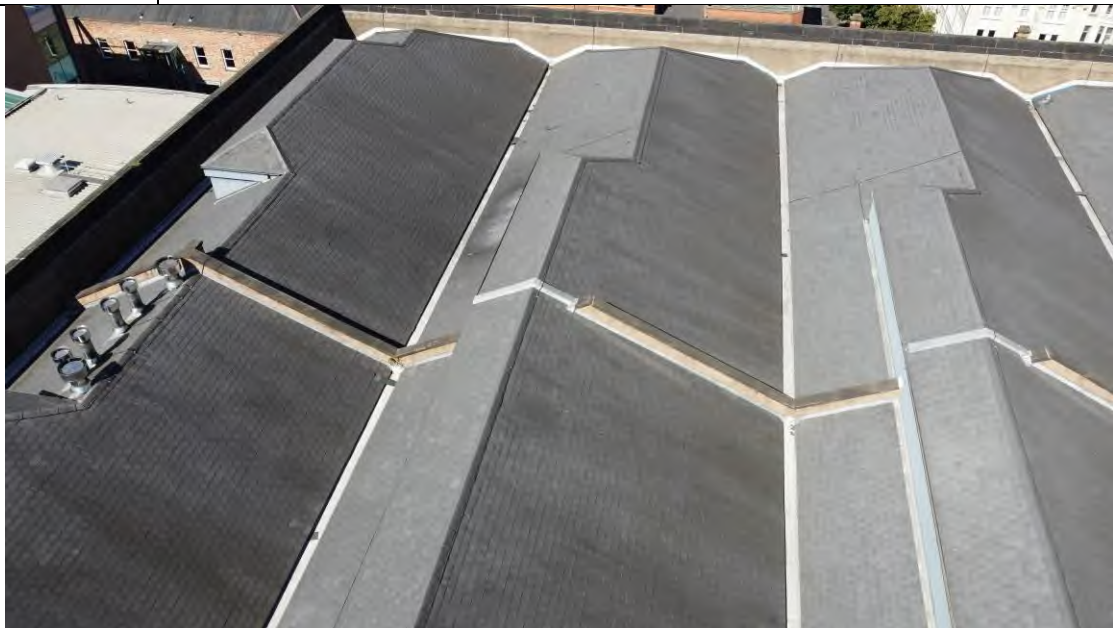
| Photograph: | 135 |

| Description: | Vegetation growth and algae growth on the stonework. |

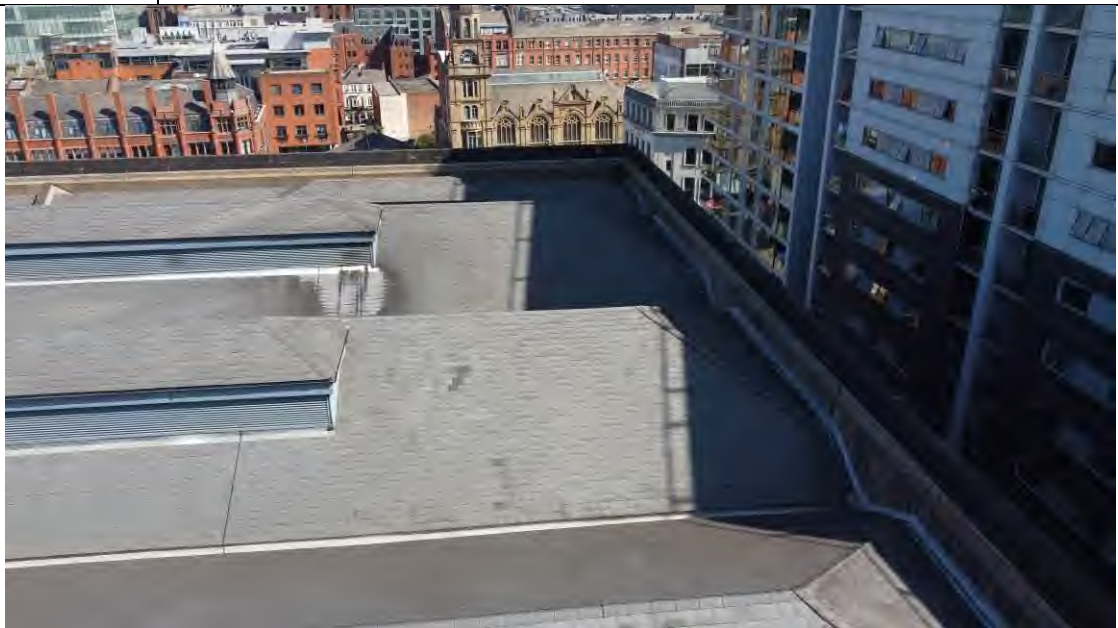
| Photograph: | 137 |

| Description: | General view of the roof. Slipped and missing roof slates. |

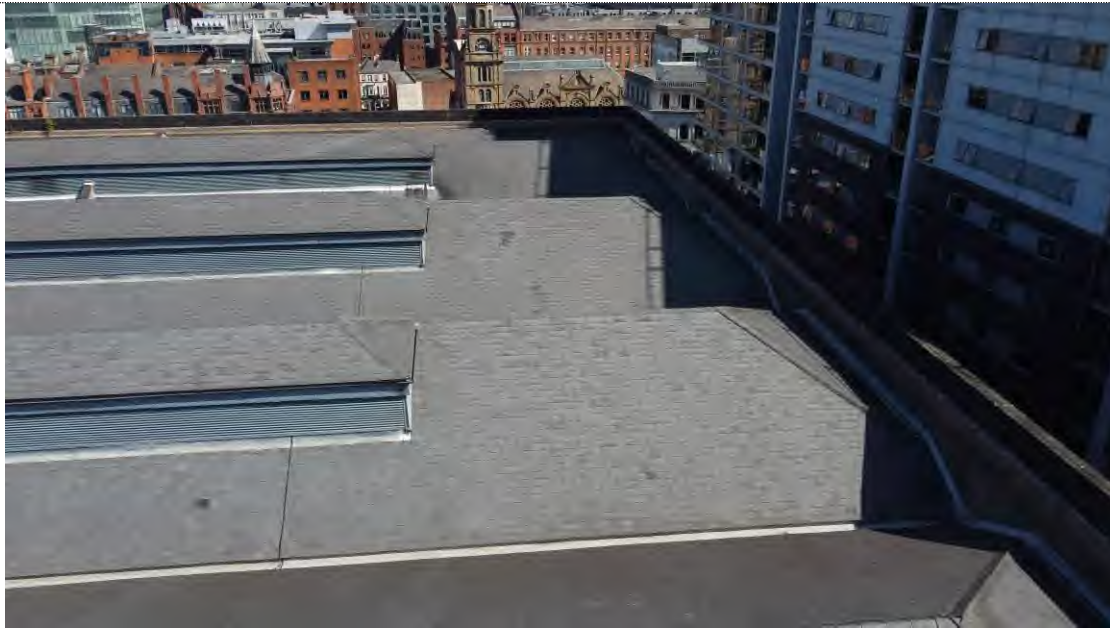
| Photograph: | 138 |

| Description: | Evidence of replacement roof slates and water damage. Corrosion staining. |

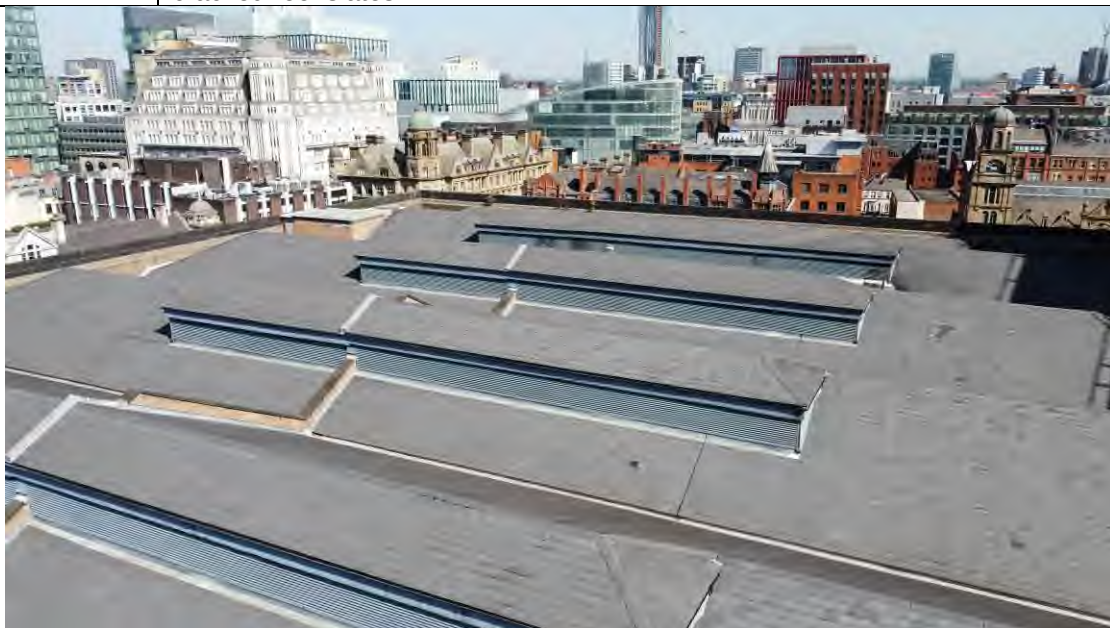
| Photograph: | 139 |

| Description: | General view of the roof. Evidence of replacement roof slates. Loose and cracked roof slates |

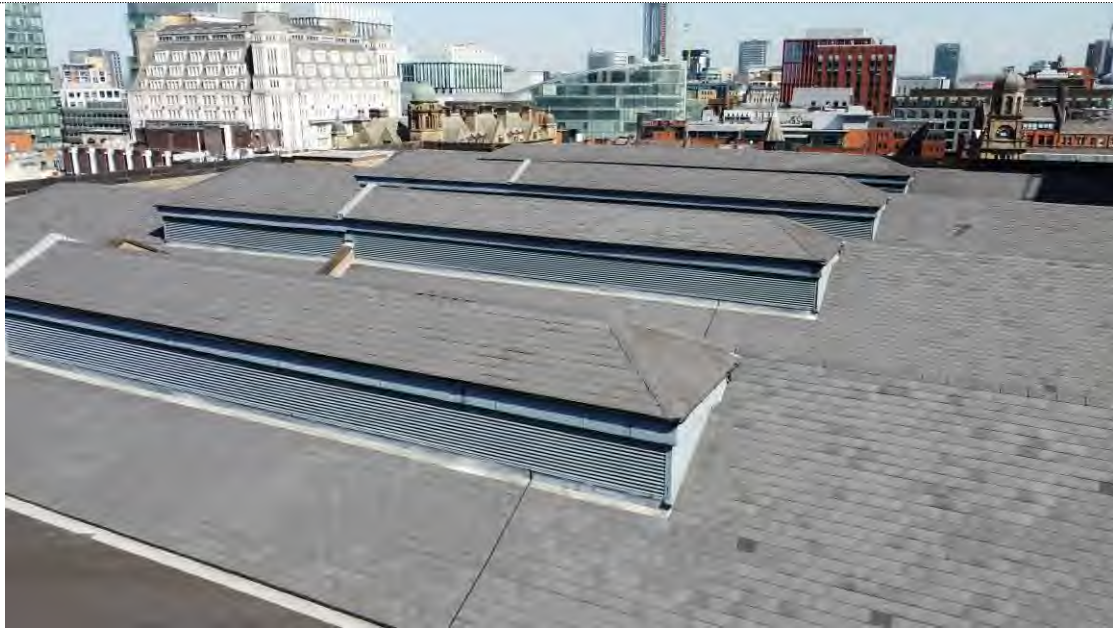
| Photograph: | 140 |

| Description: | General view of the roof. Missing roof slates exposing void beneath. |

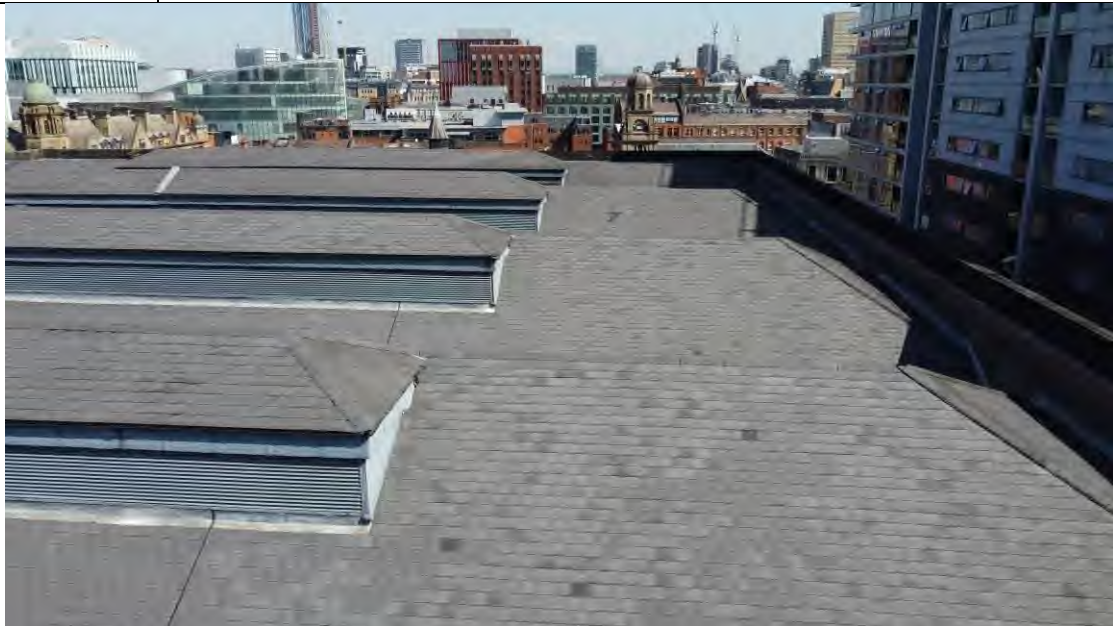
| Photograph: | 141 |

| Description: | Missing and slipped roof slates. Cracked roof slates. |

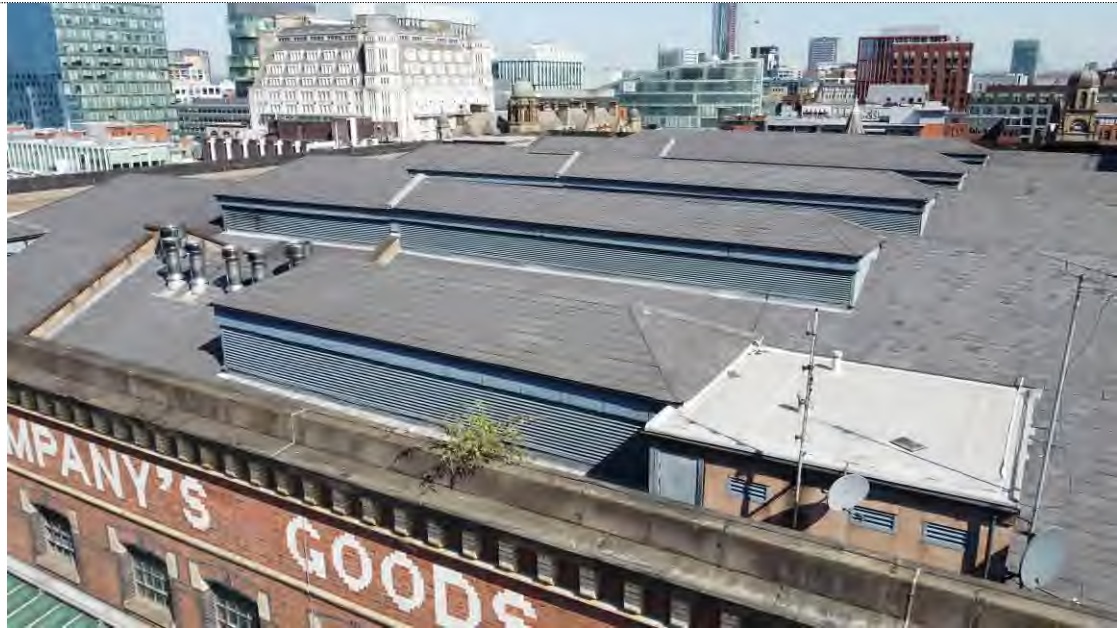
| Photograph: | 143 |

| Description: | Vegetation growth. Slipped and missing roof slates. Spalling stonework. |
