**The Great Northern Warehouse**

**Survey 2022**

**Great Northern Warehouse & Deansgate Terraces, Manchester**

**Condition Survey**

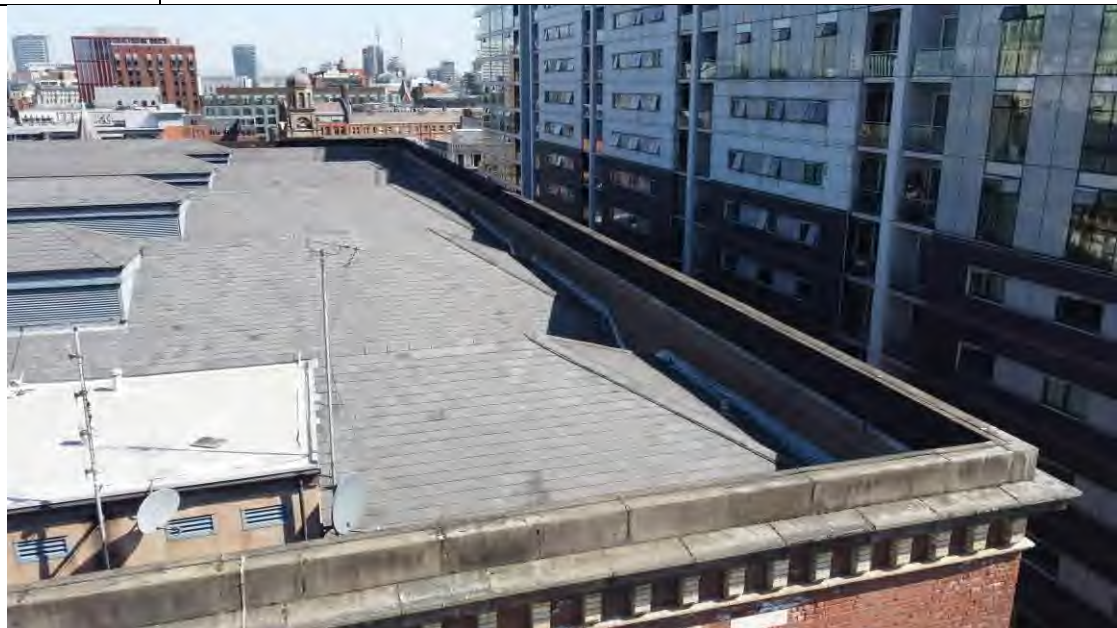
| Photograph: | 144 |

| Description: | Slipped and broken roof slates. Spalling stonework. |
