GROUND FLOOR | WINDOWS

| snookarchitects | | project: | rev. | date | description |
|---|---|---|---|---|---|
| 89 Wood Street | Liverpool | bridgewater house | | | |
| t: 0151 707 0100 | | dwg title: | | window survey [1 of 16] | |

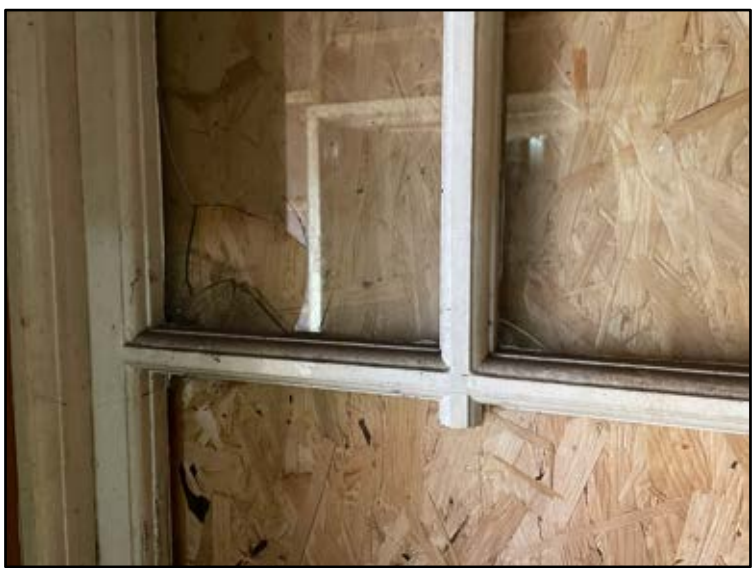
WINDOW WG.02

- Unable to open
- Single glazing
- Modern glass
- Non original frame (probably)
- Damaged frame

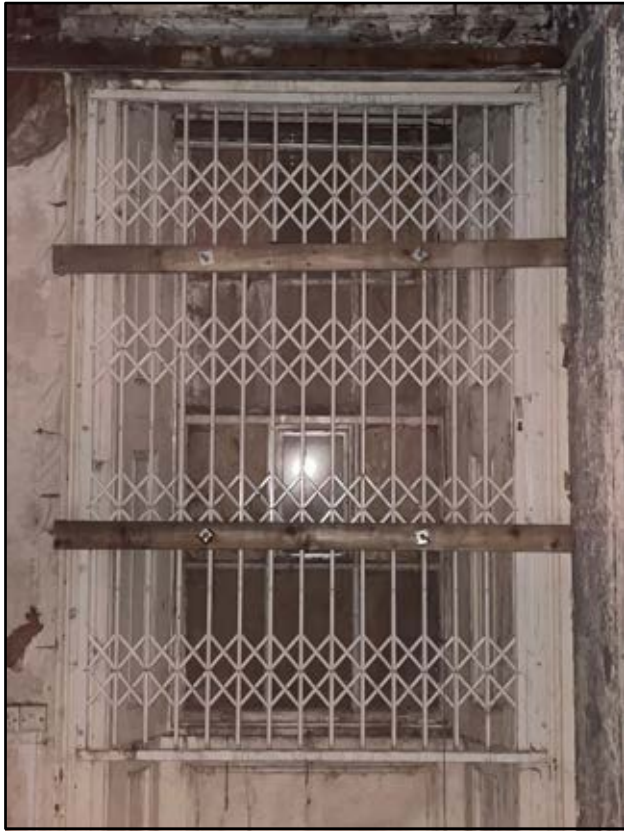
WINDOW **WG.19**

- Restricted access - Window is inaccessible due to collapsed ceiling and/or unsafe floor structure
- Photo taken from a distance
- Frame looks damaged
- Glass looks broken

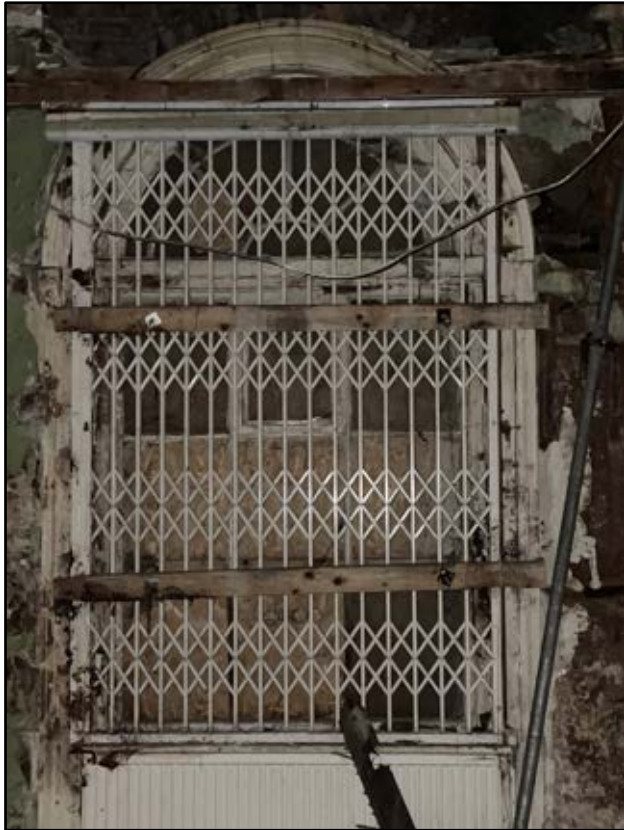
WINDOW **WG.20**

- Restricted access - Window is inaccessible due to collapsed ceiling and/or unsafe floor structure
- Photo taken from a distance
- Frame looks damaged
- Glass looks broken

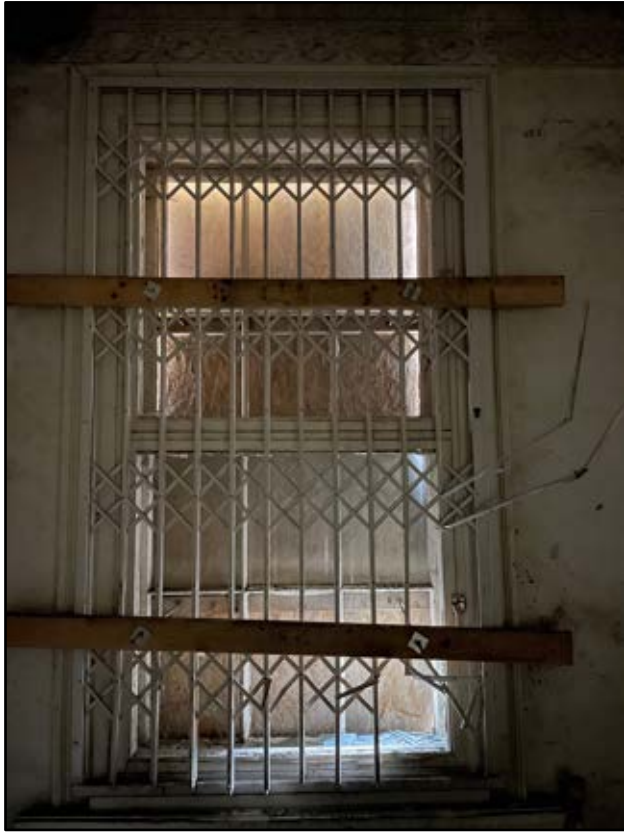
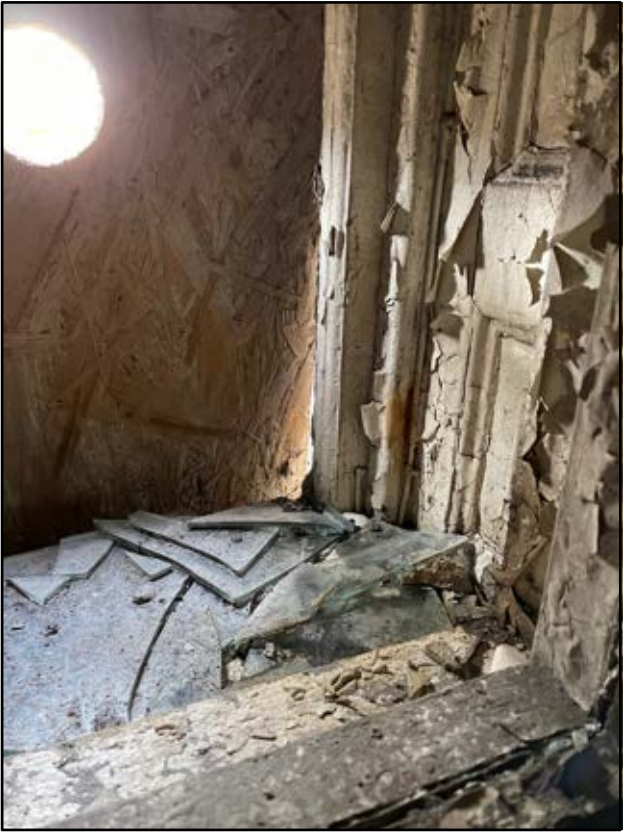
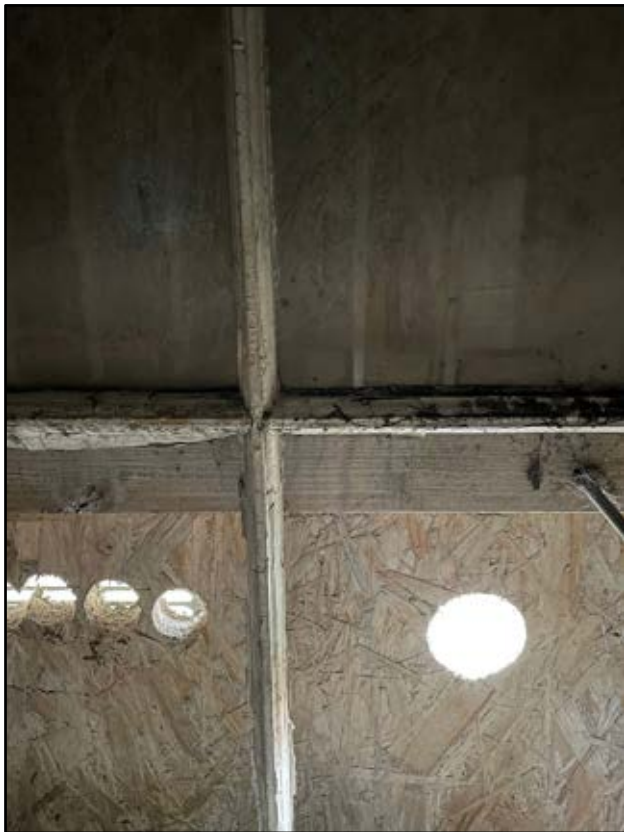
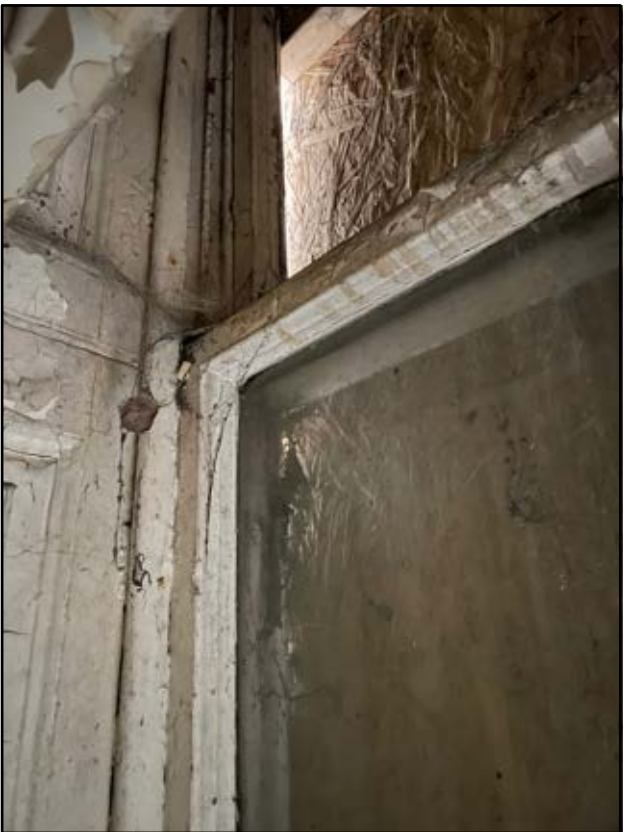
WINDOW WG.25

- Unable to open
- Original frame
- Damaged frame
- No glass (mostly broken)
- Non original glass

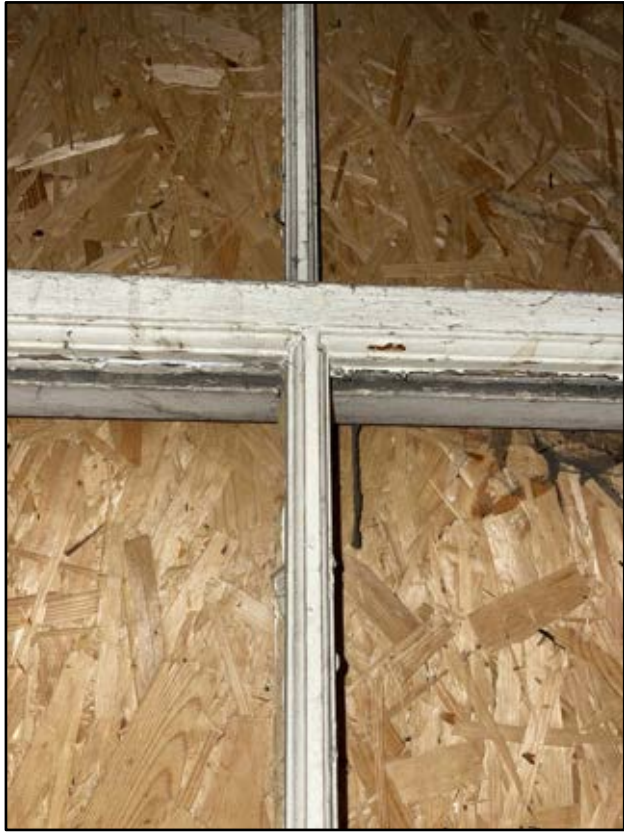
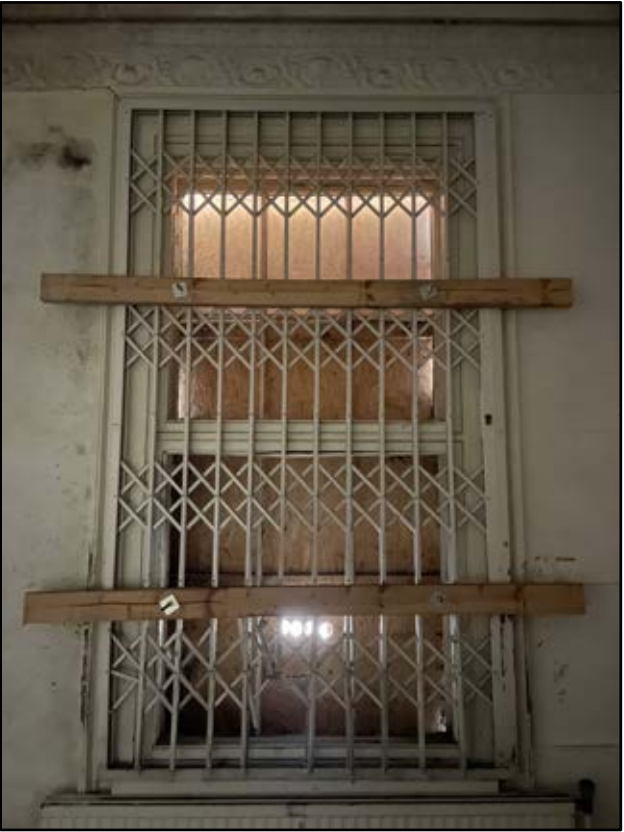
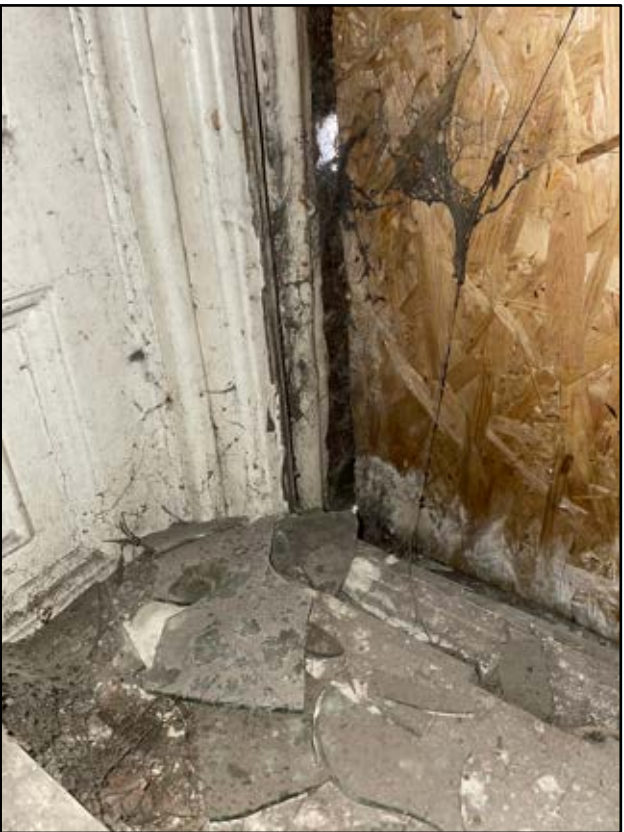
WINDOW WG.26

- Unable to open
- Original frame
- Damaged frame
- No glass (mostly broken)
- Non original glass

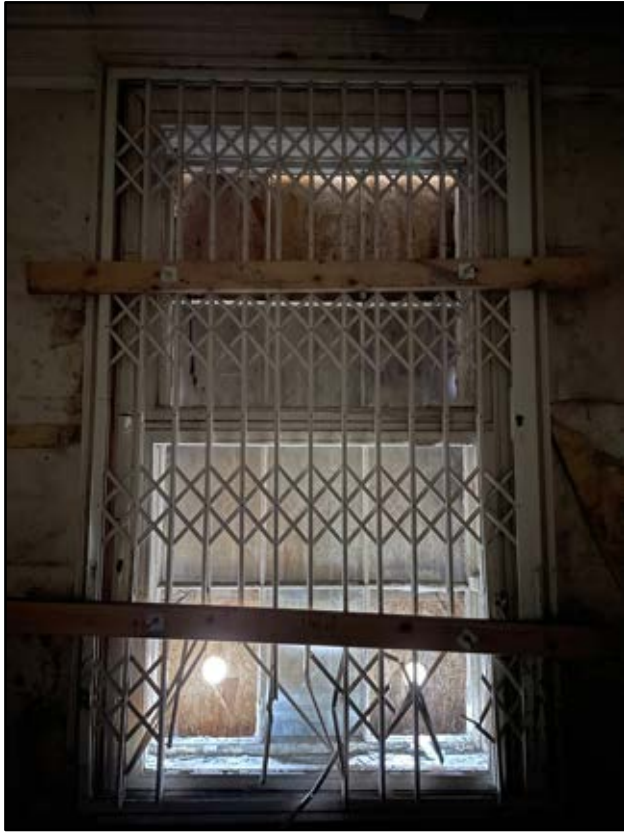
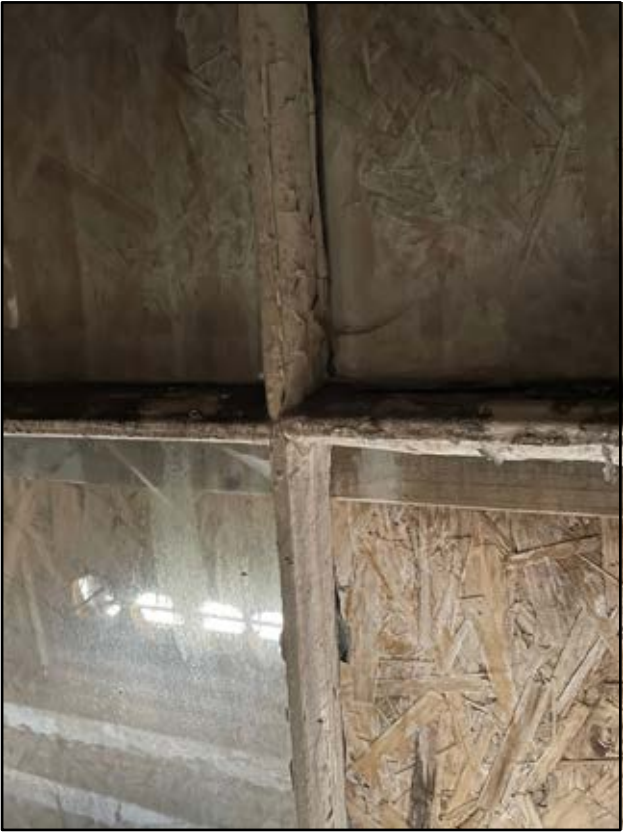
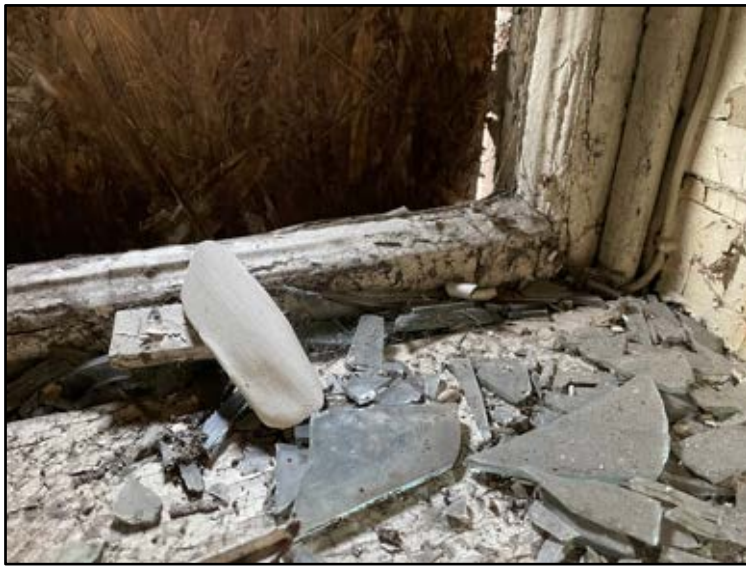
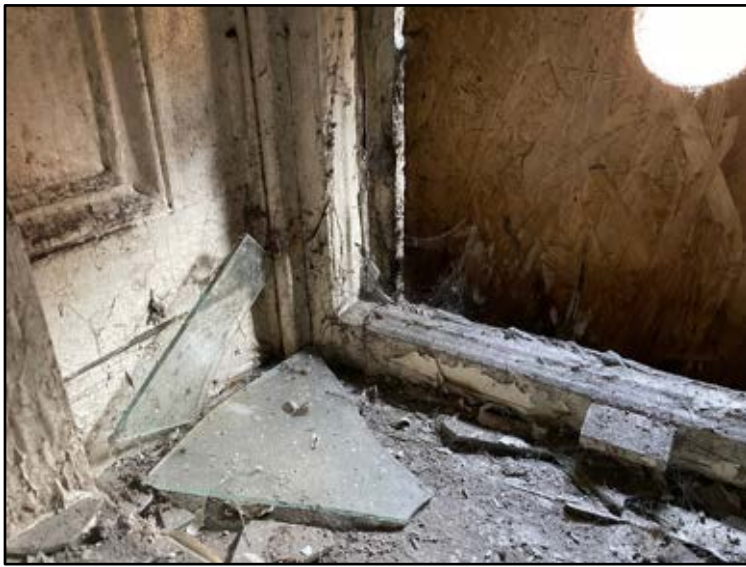
WINDOW **WG.34**

- Restricted access - Window is inaccessible due to collapsed ceiling and/or unsafe floor structure
- Photo taken from a distance
- Frame looks badly damaged

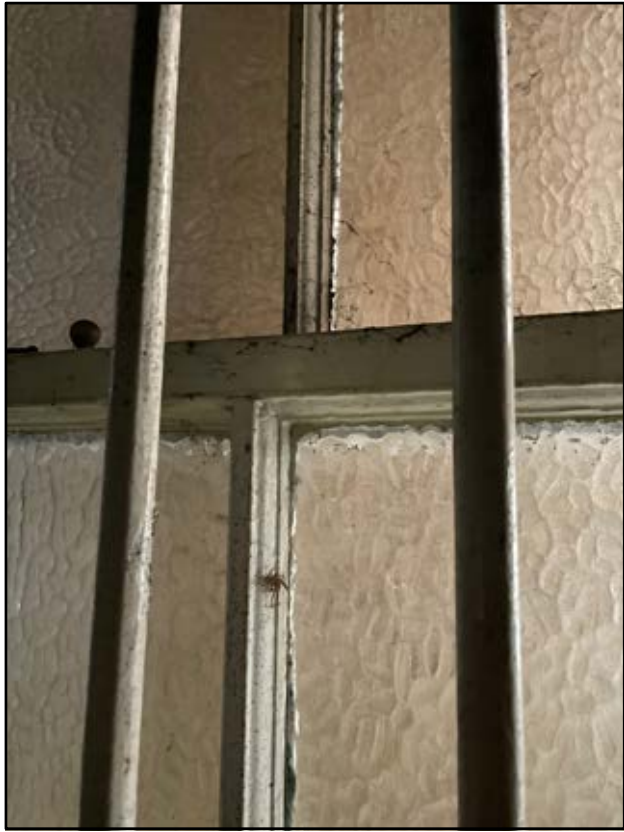
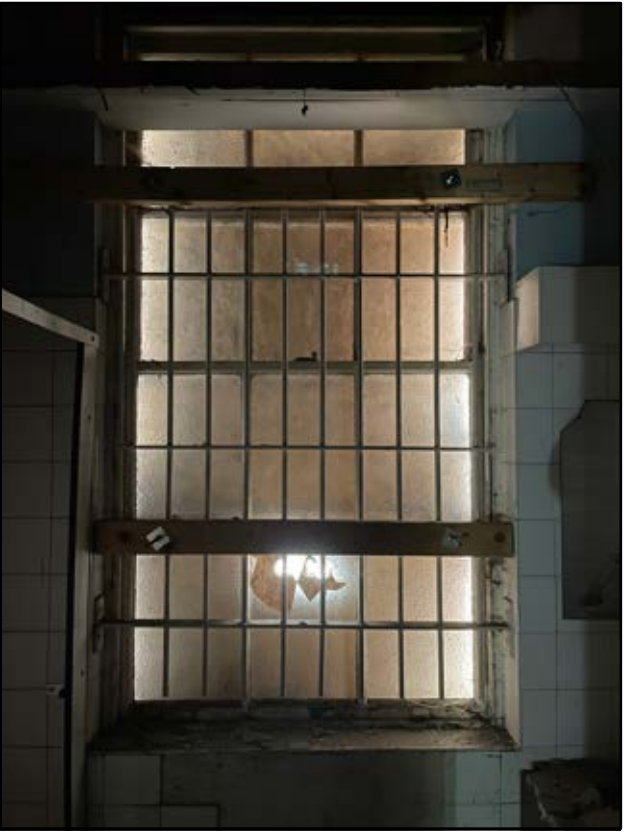
WINDOW **WG.39**

- Unable to open
- Original frame
- Damaged frame
- Non original glass

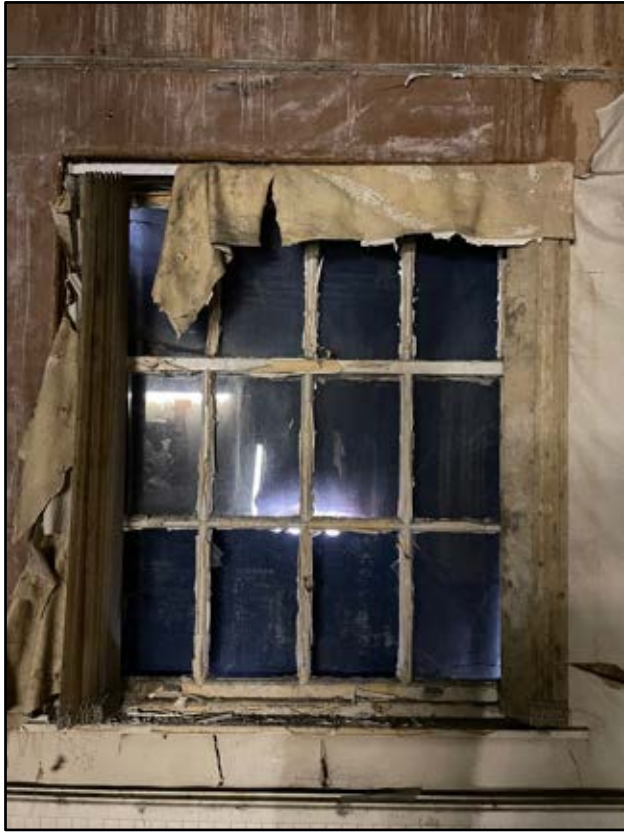
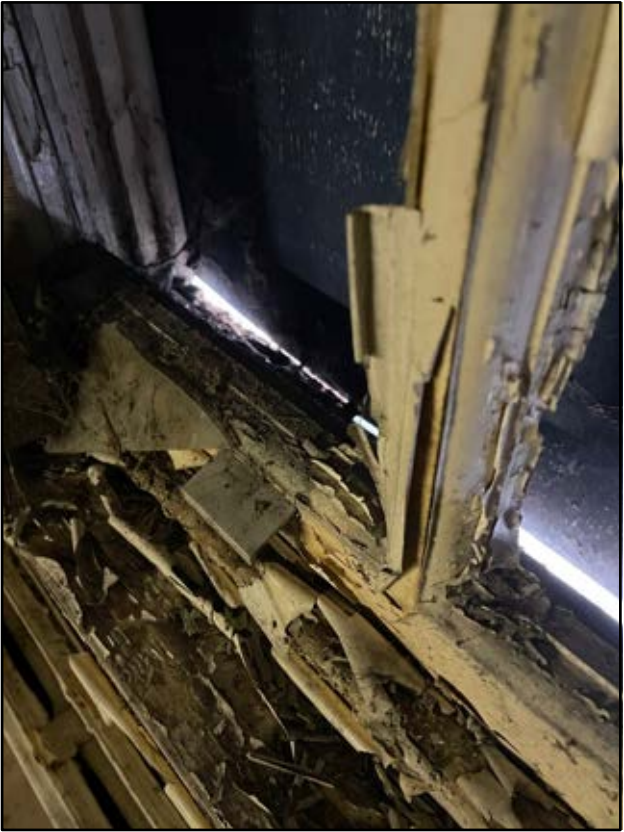
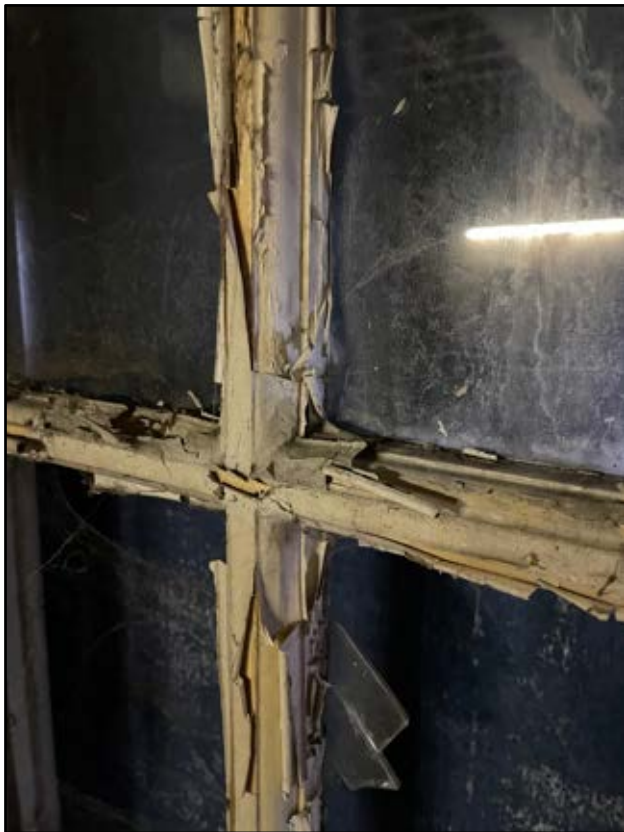
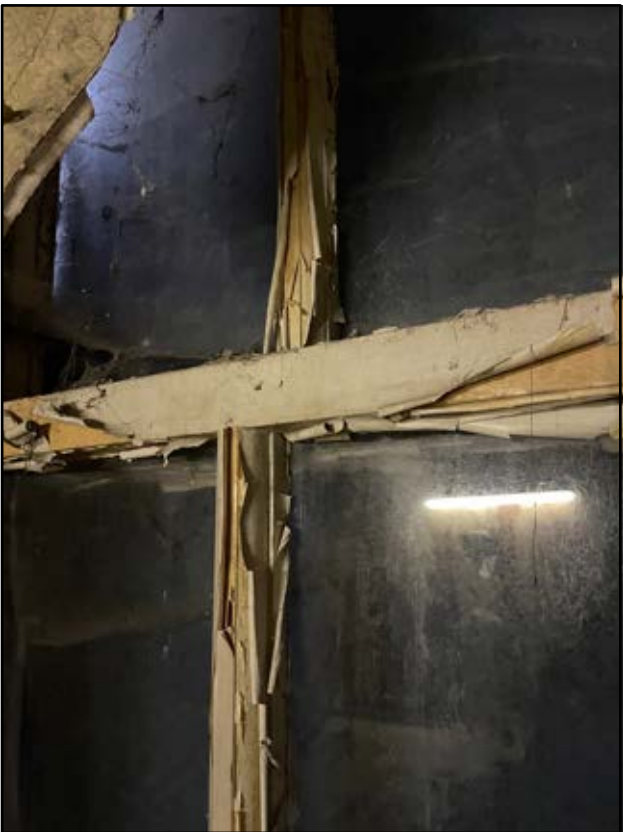
WINDOW **W1.05**

- Restricted access - Window is inaccessible due to collapsed ceiling and/or unsafe floor structure
- Photo taken from a distance
- Frame looks badly damaged

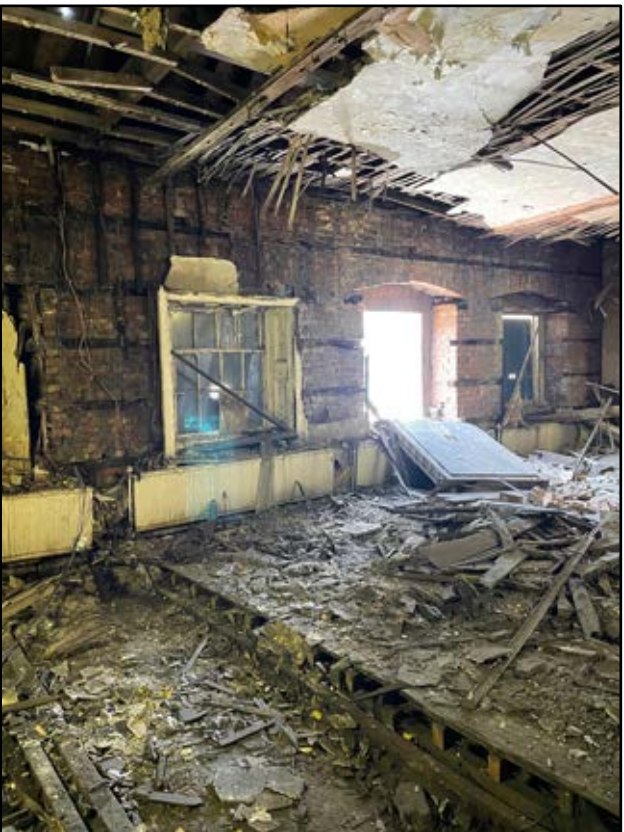
WINDOW **W1.07**

- Restricted access - Window is inaccessible due to collapsed ceiling and/or unsafe floor structure
- Photo taken from a distance
- Window is completely destroyed

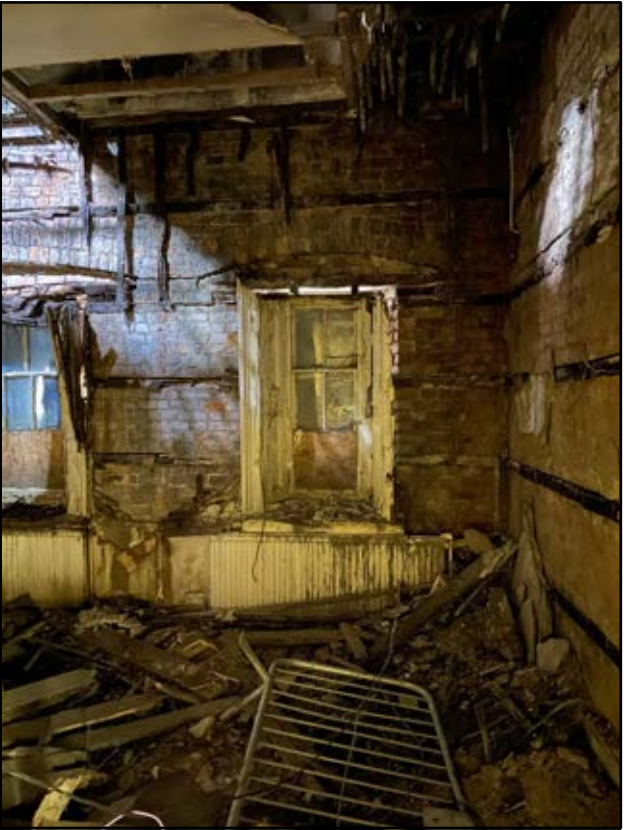
WINDOW **W1.18**

- Restricted access - Window is inaccessible due to collapsed ceiling and/or unsafe floor structure
- Photo taken from a distance
- Frame appears to be gone completely
- No glass remaining
- Window is boarded from the outside

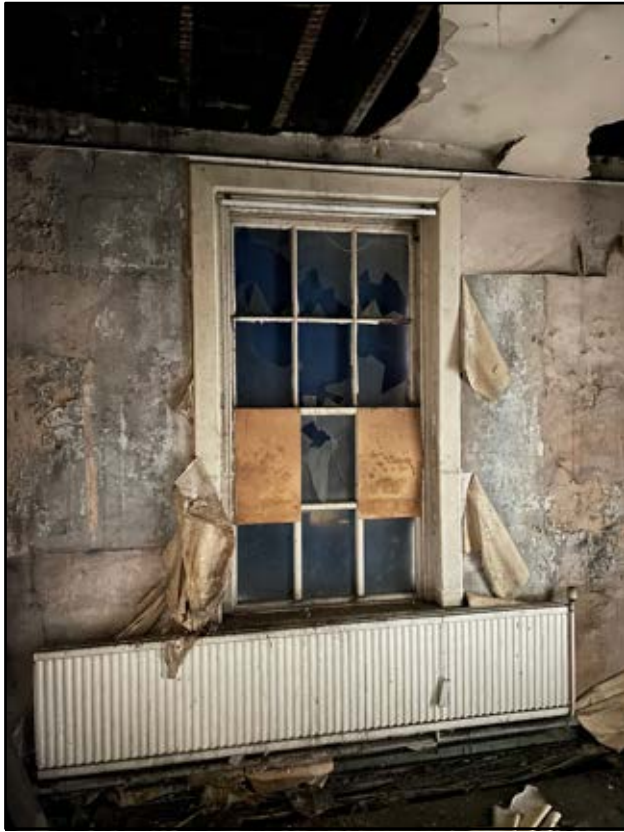
WINDOW **W1.20**

- Frame looks original
- Frame is rotten
- Glass is missing and/or broken

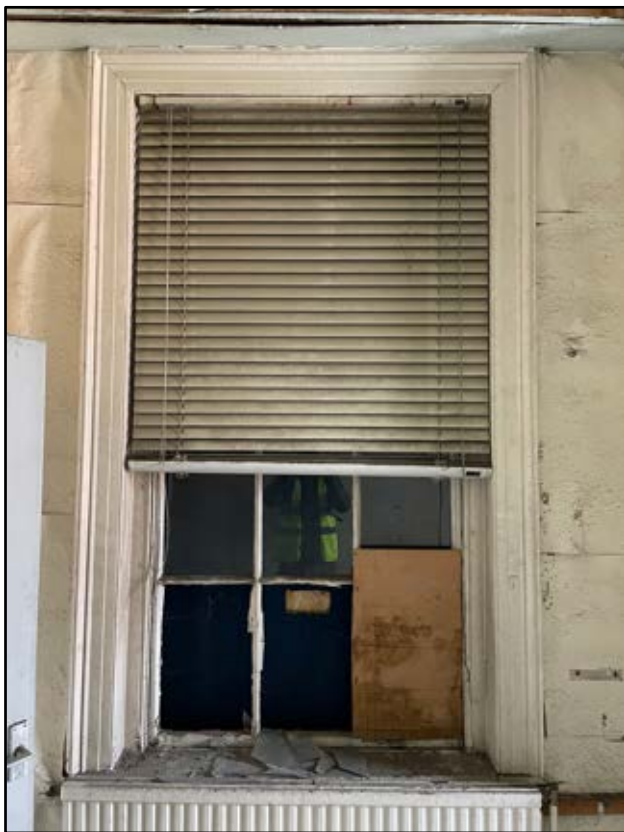
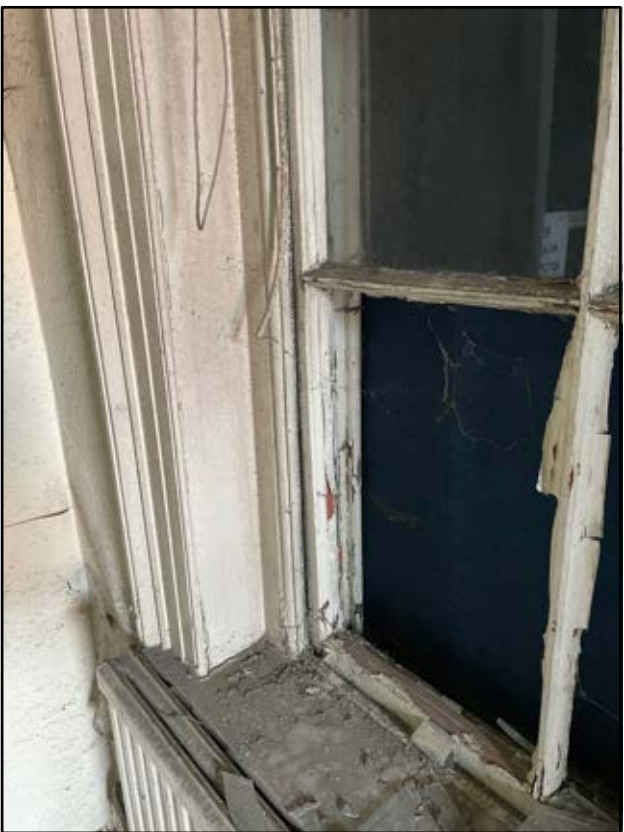
WINDOW **W1.22**

- Unable to open
- Original frame
- Frame is rotten
- Glass is missing and/or broken
- No chords

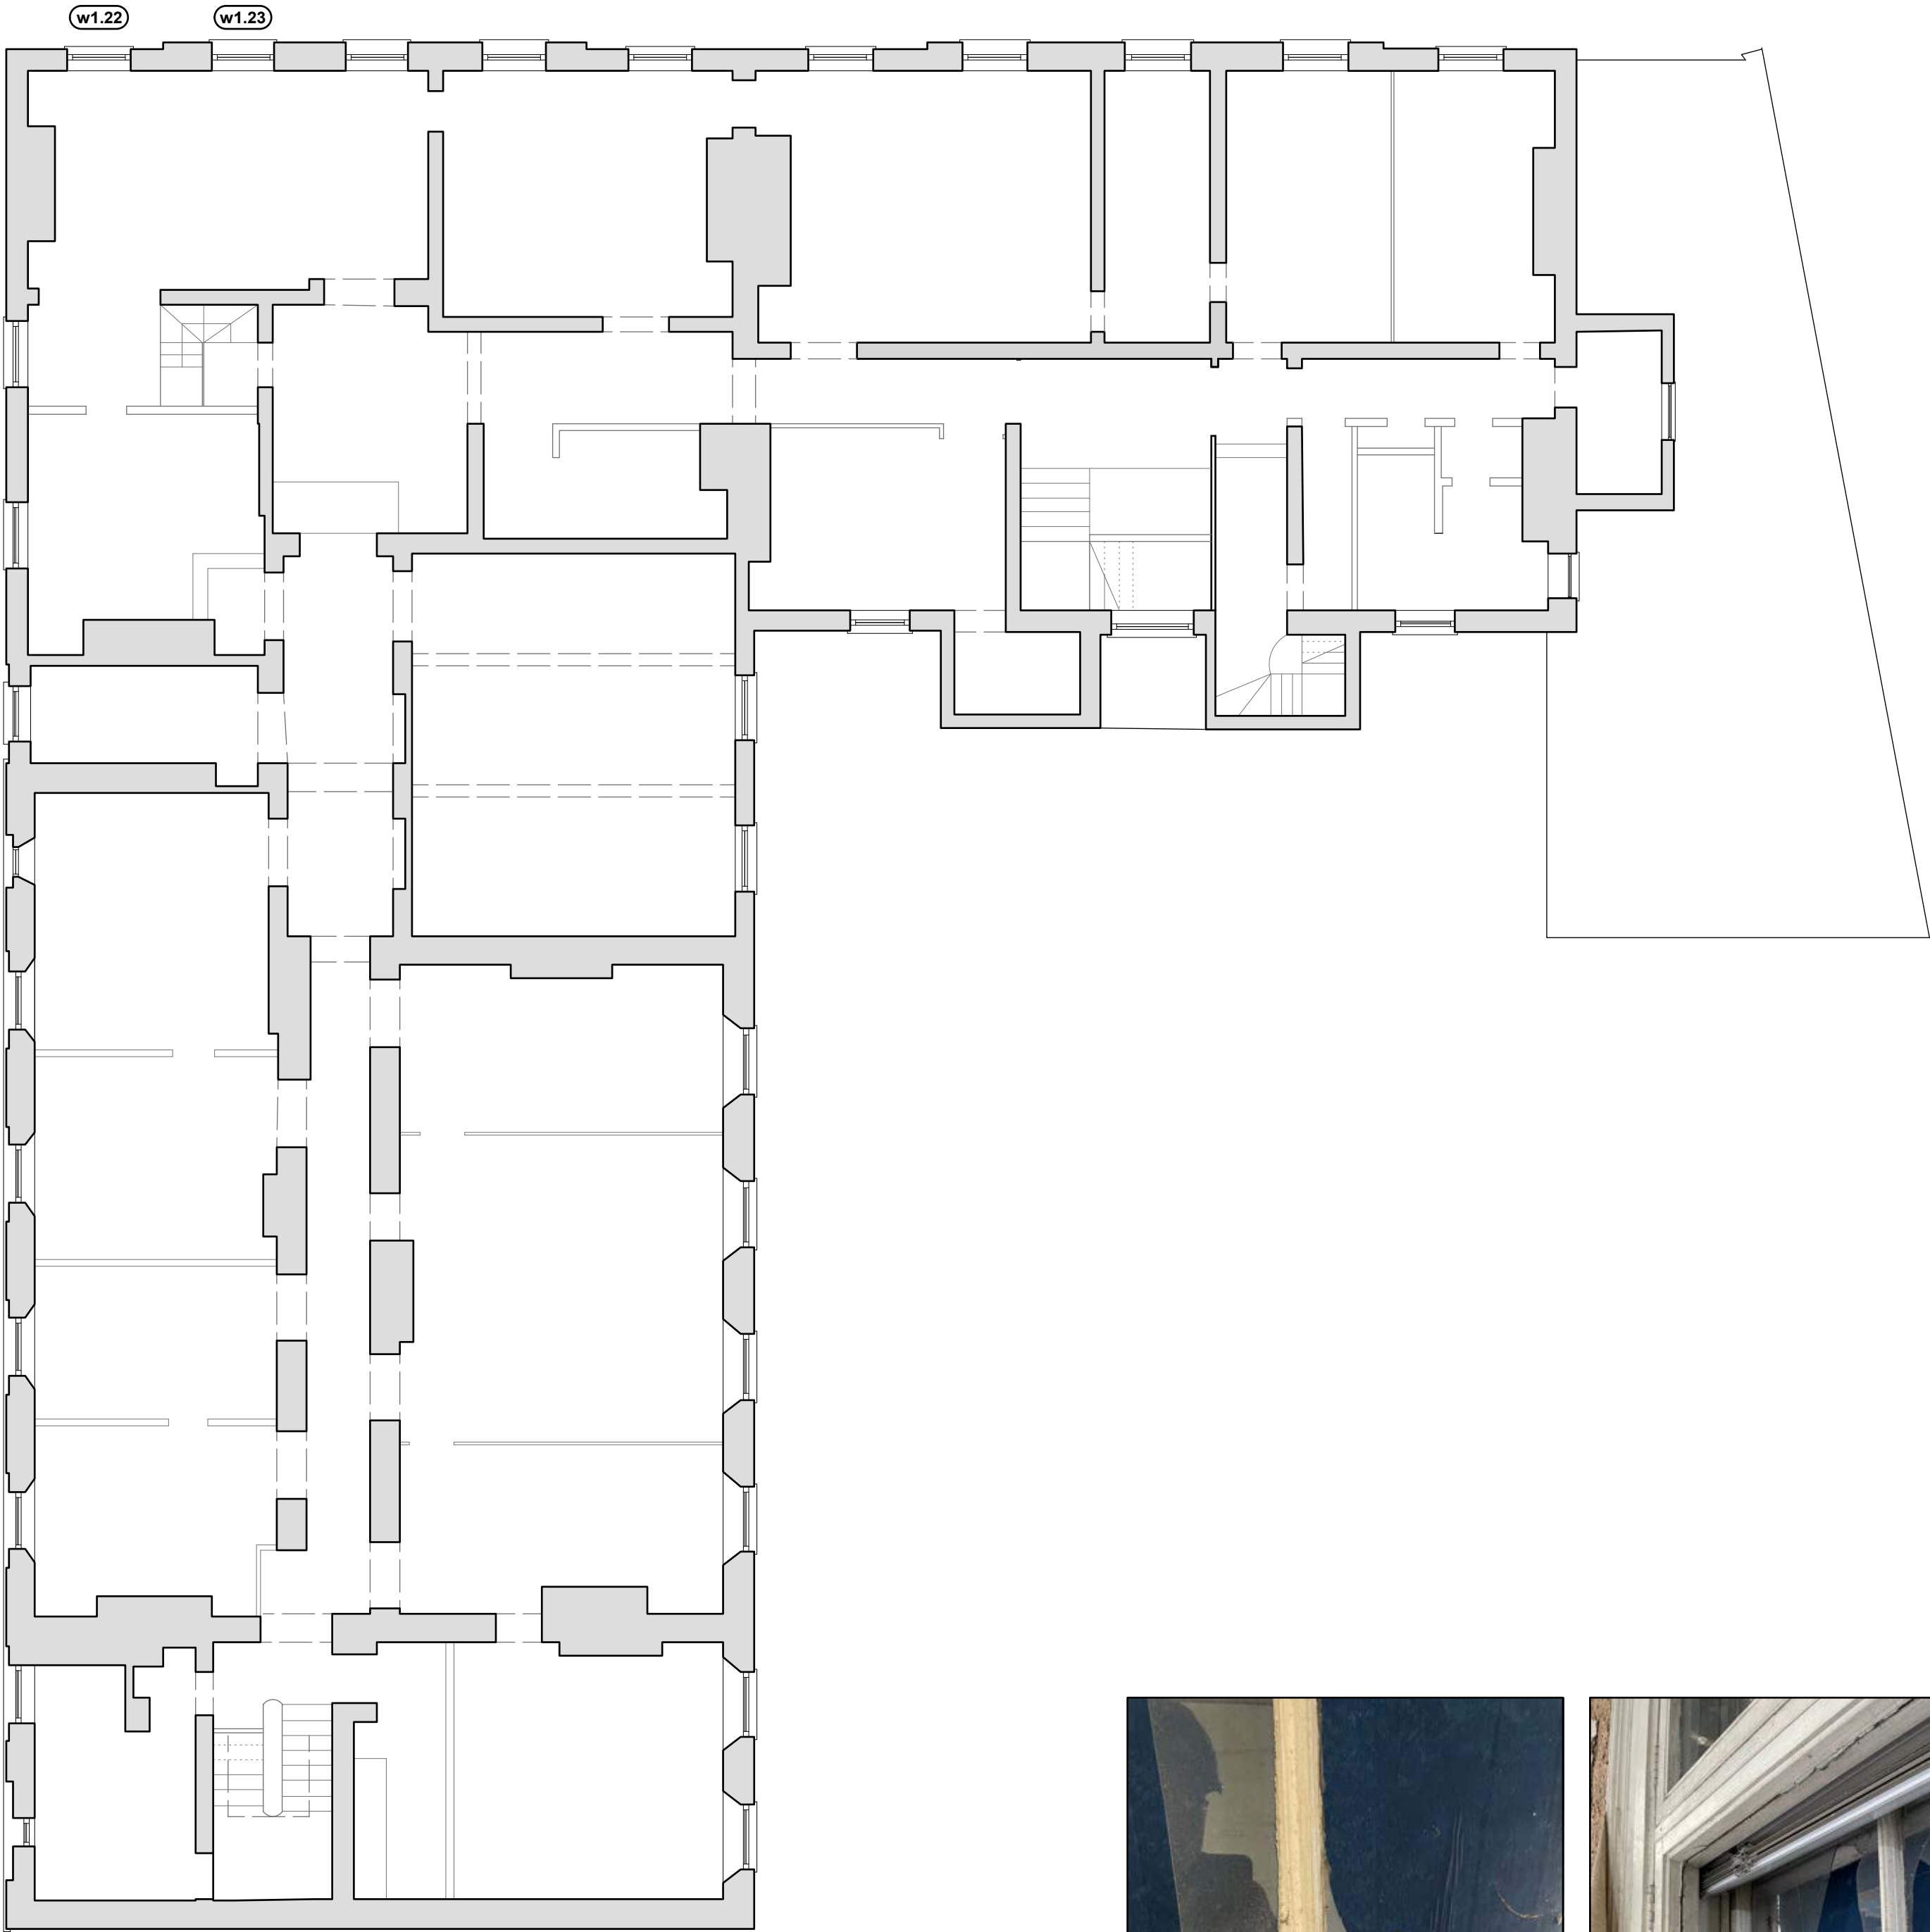
WINDOW **W1.23**

- Unable to open
- Original frame
- Frame is rotten
- Glass is missing and/or broken
- No chords

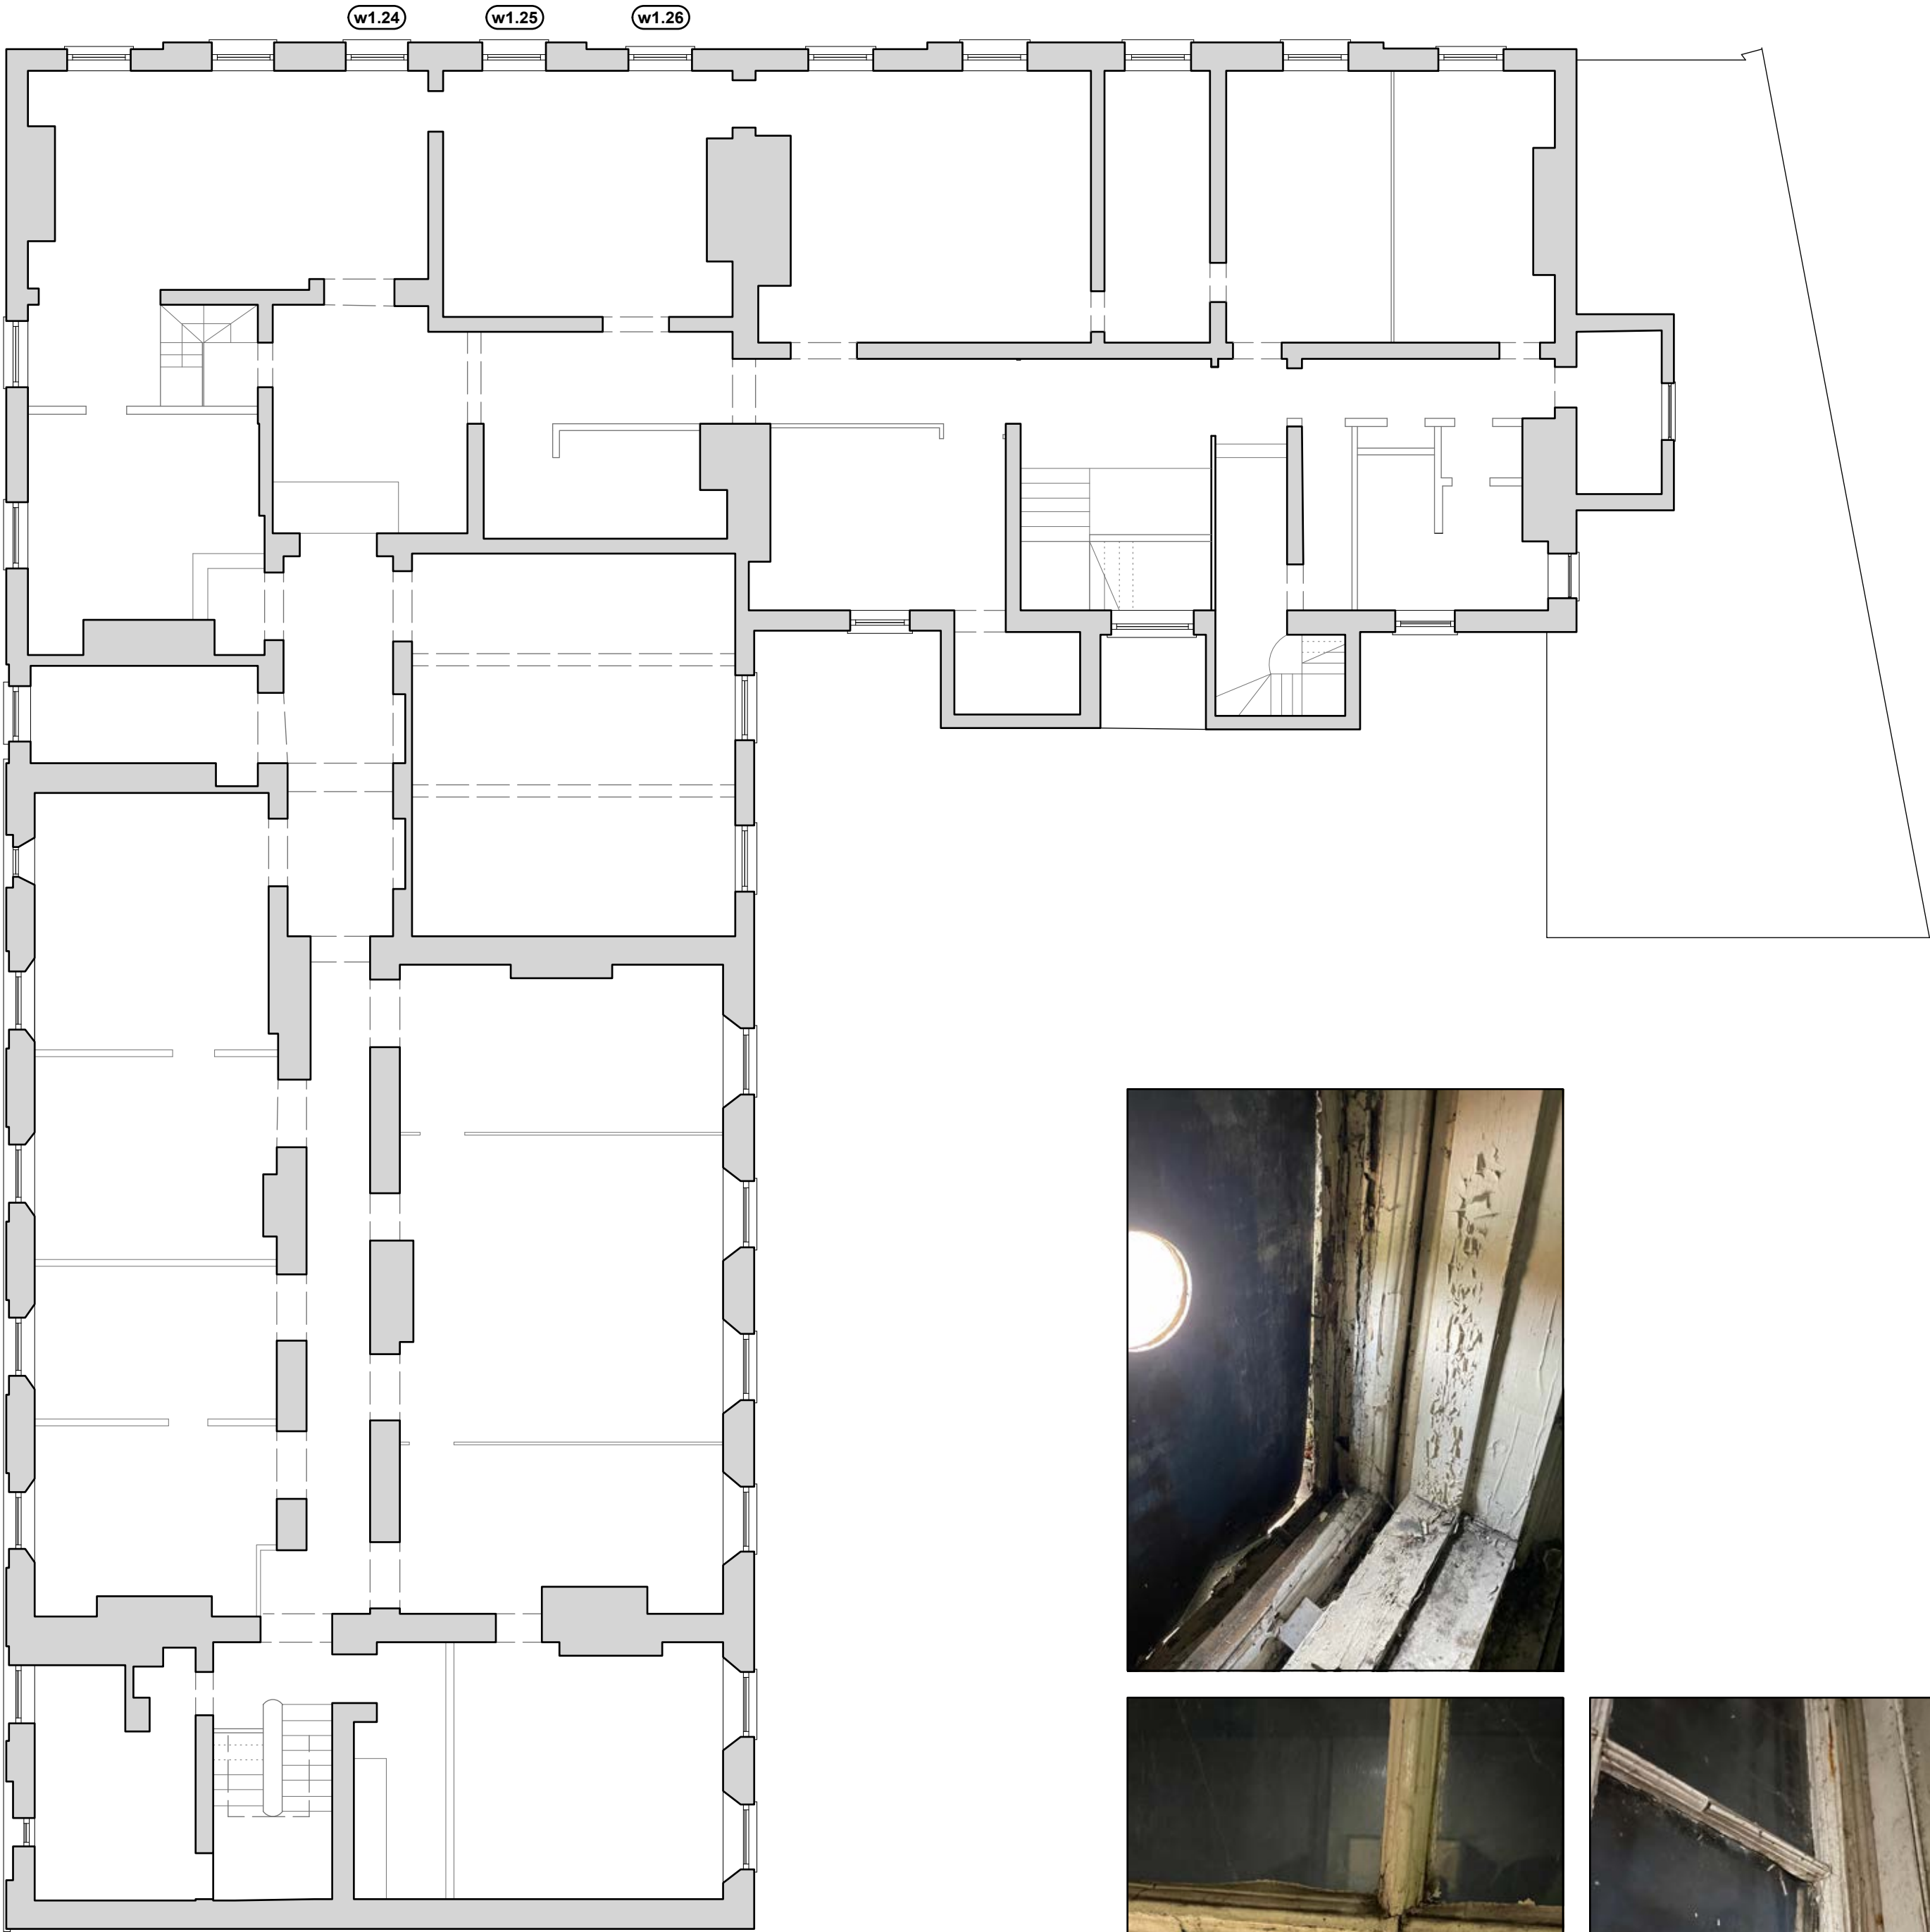
WINDOW W1.25

- Unable to open
- Original frame
- Frame is rotten and damaged
- Non original glass
- No chords
