GROUND FLOOR | WINDOWS

| snookarchitects | | project: | rev. | date | description |
|---|---|---|---|---|---|
| 89 Wood Street | Liverpool | bridgewater house | | | |
| t: 0151 707 0100 | | dwg title: | | window survey [1 of 16] | |

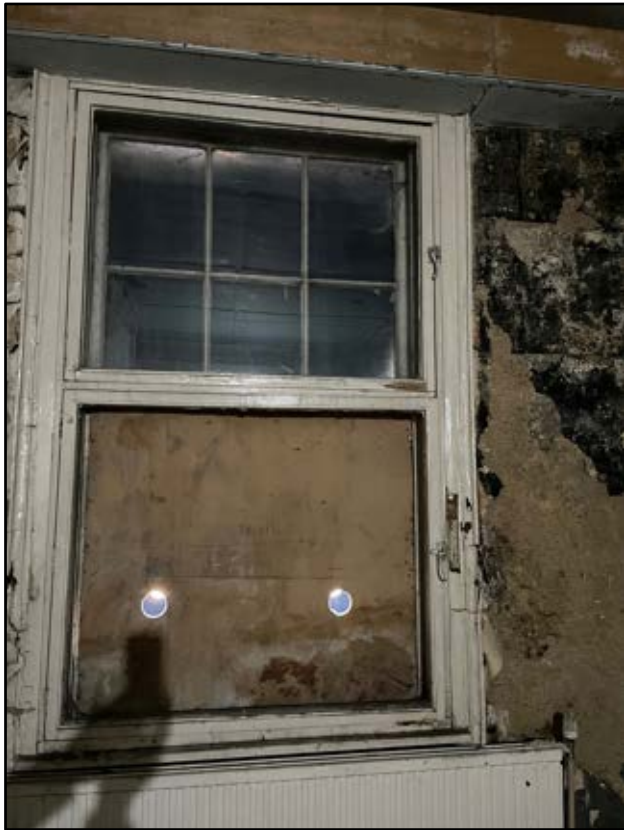
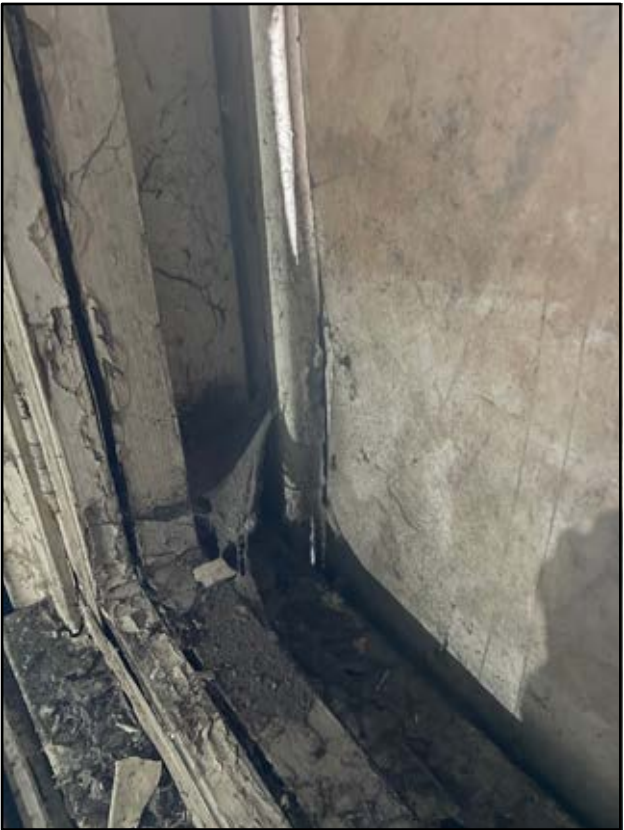
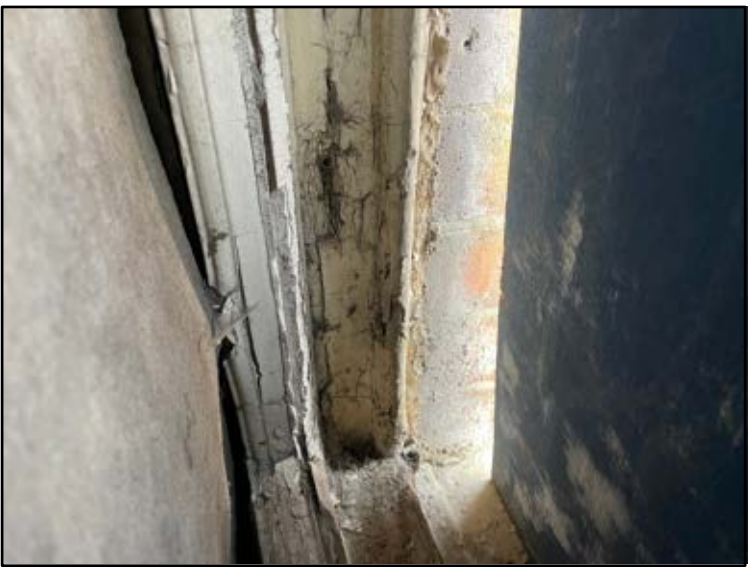
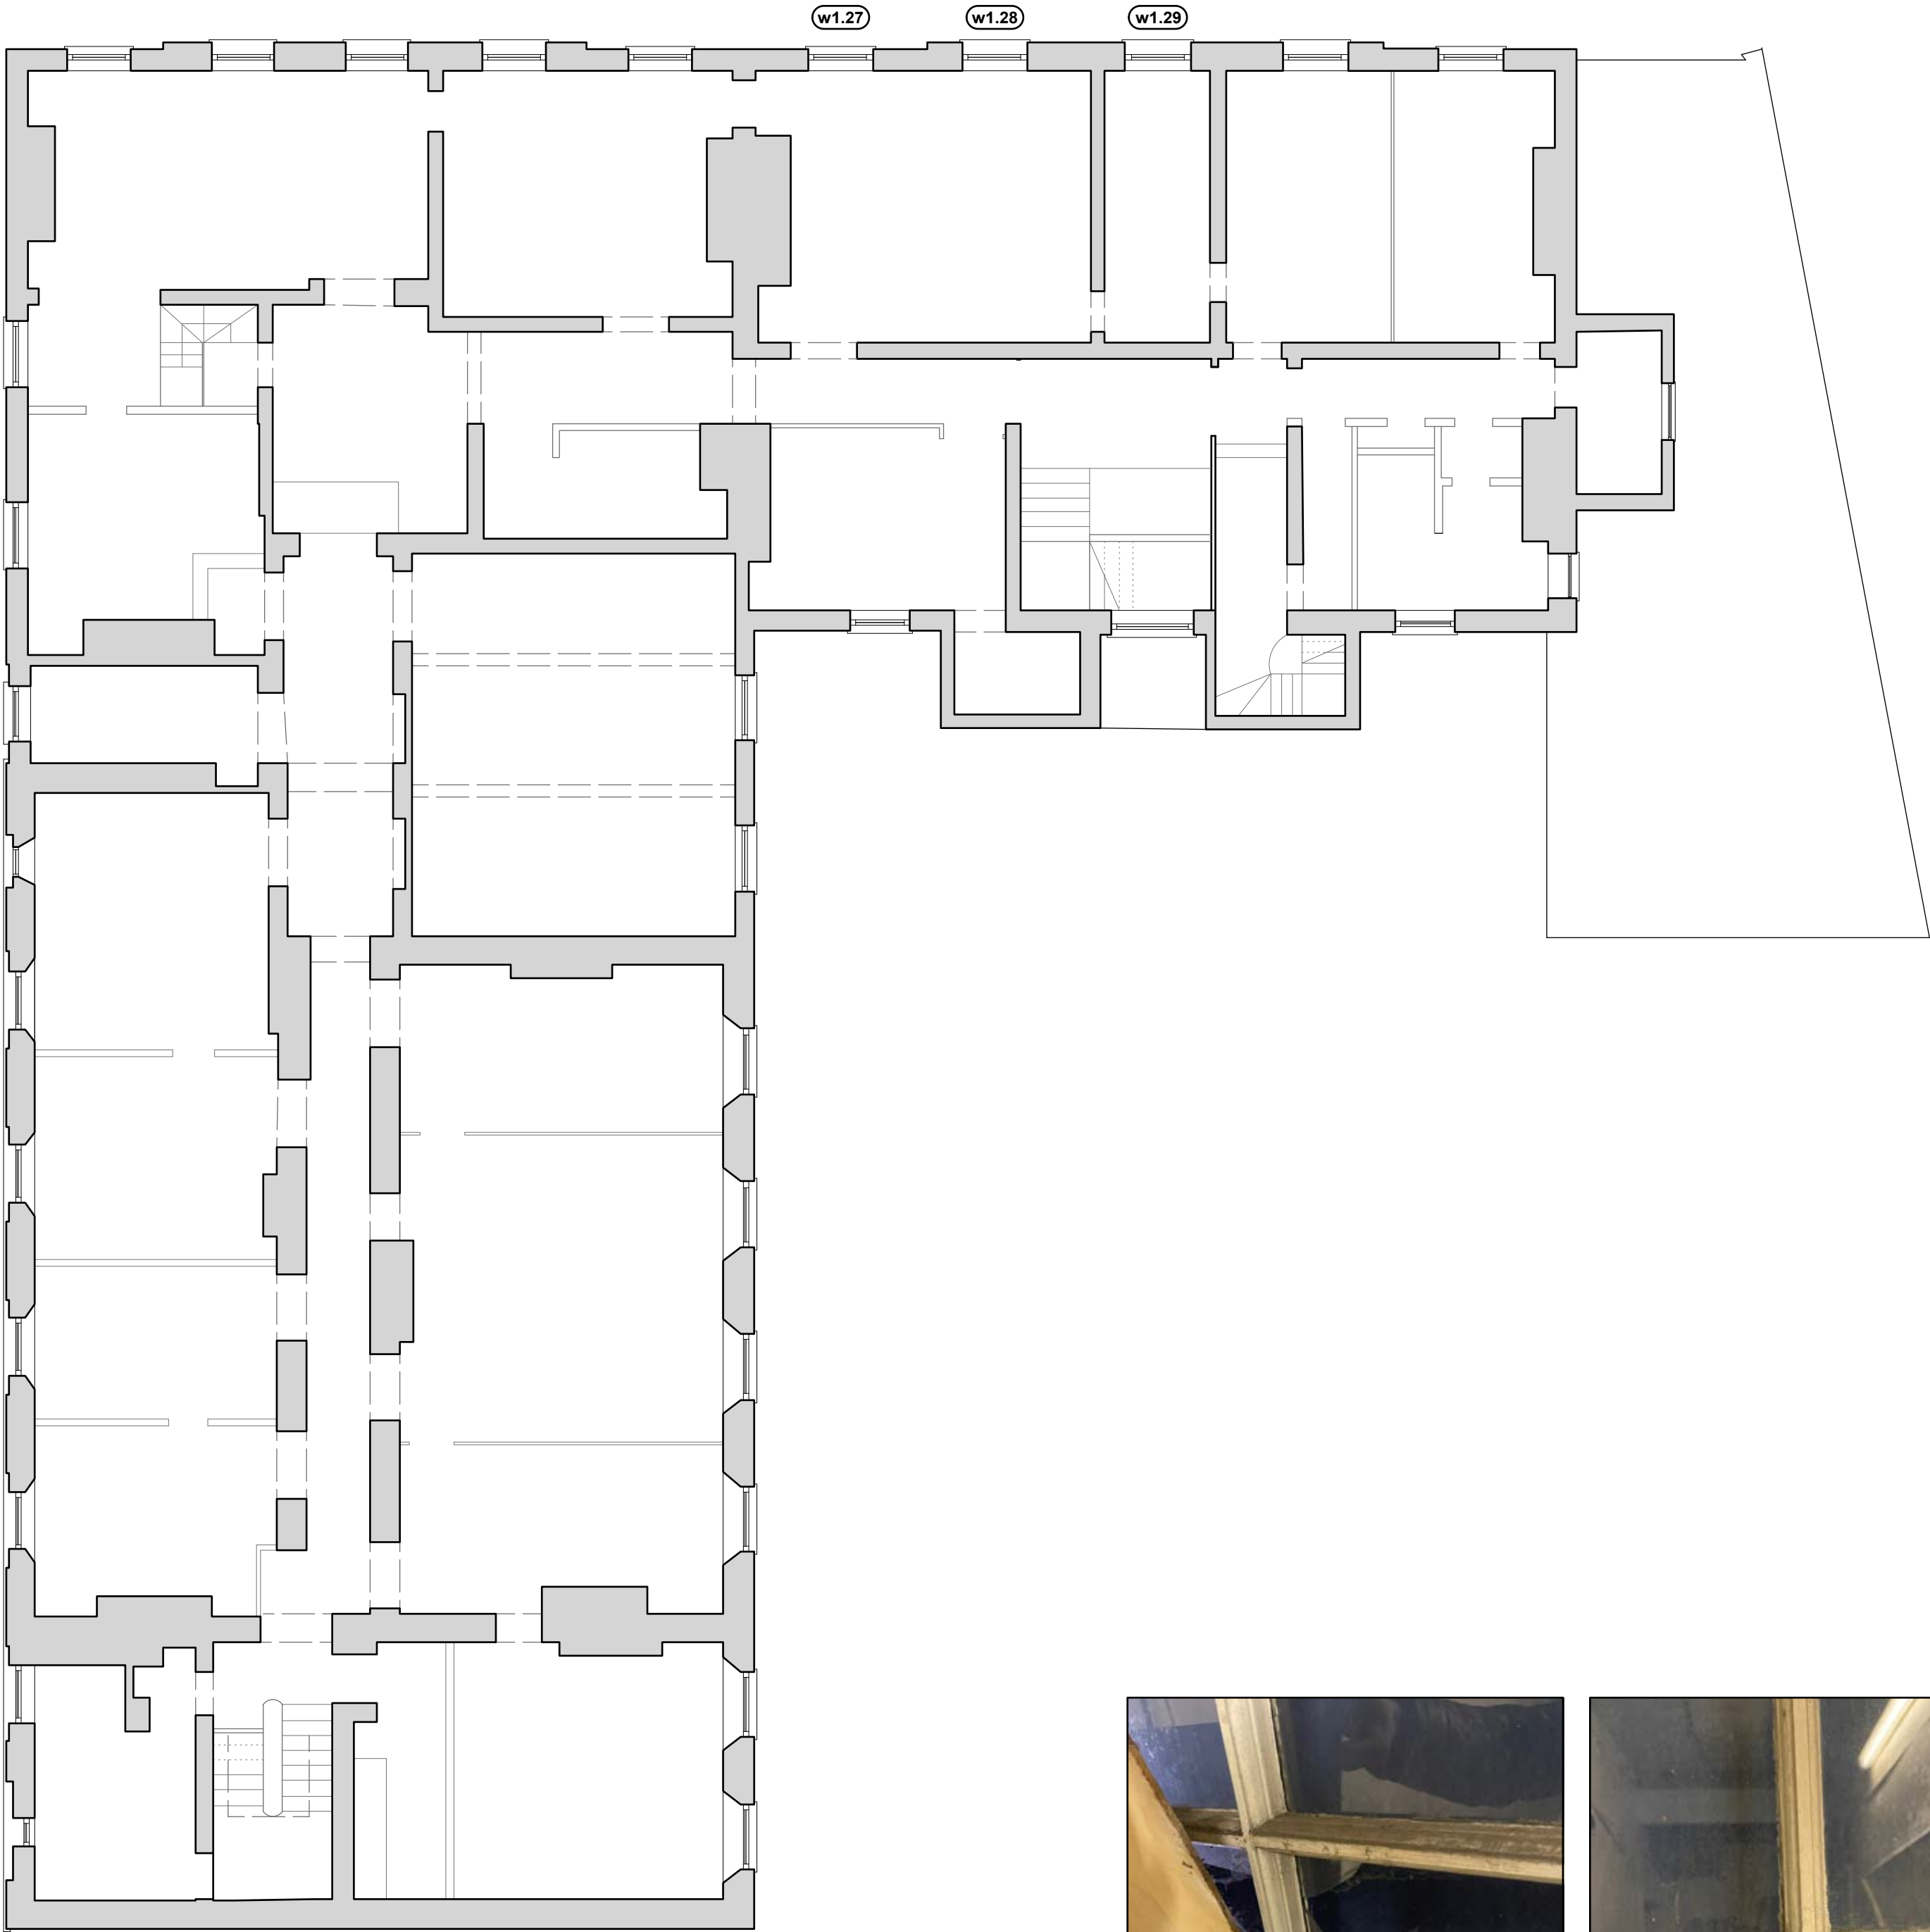
WINDOW W1.27

- Unable to open
- Unable to assess it properly - window is boarded up
- Frame looks original
- Frame is damaged
- Non original glass
- Glass missing and/or broken
- No chords

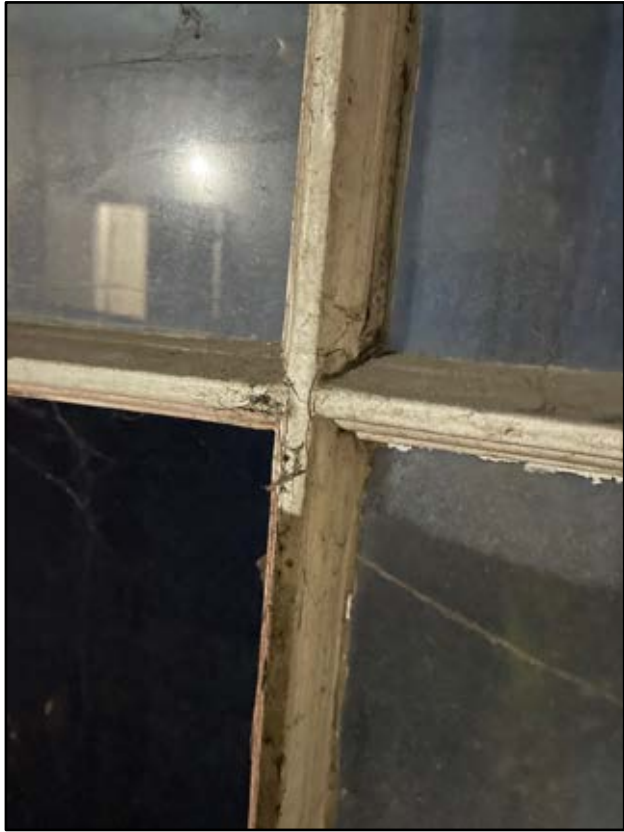
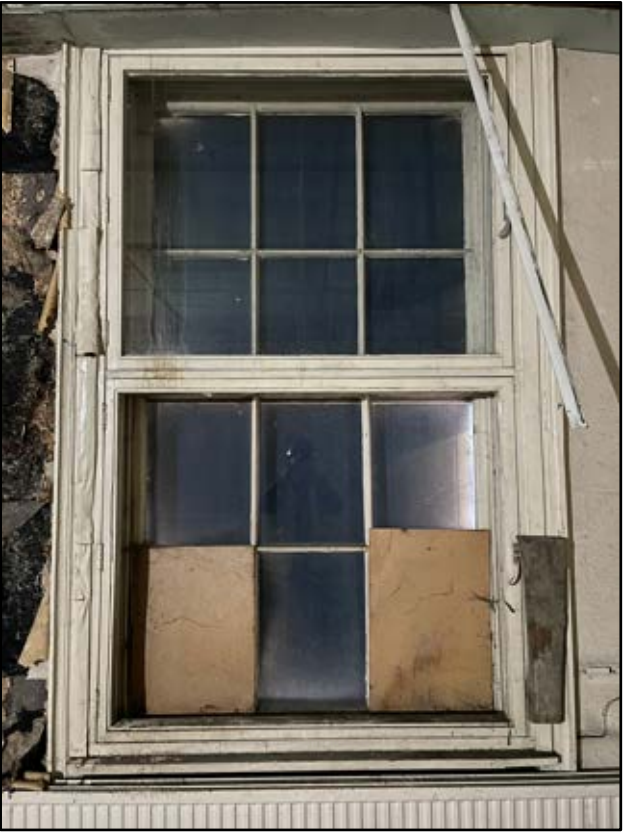
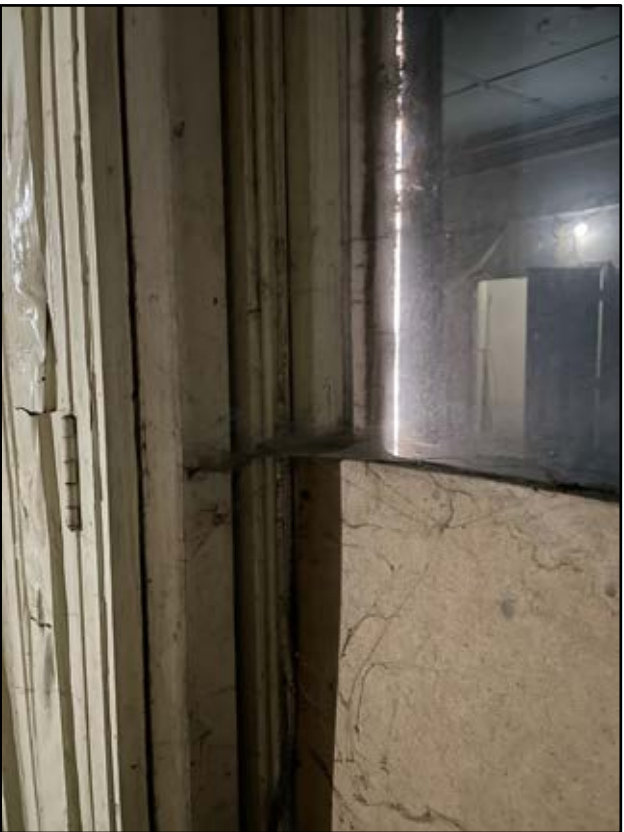
WINDOW W1.28

- Unable to open
- Original frame
- Non original glass
- Most of the glass is missing
- Chords snapped

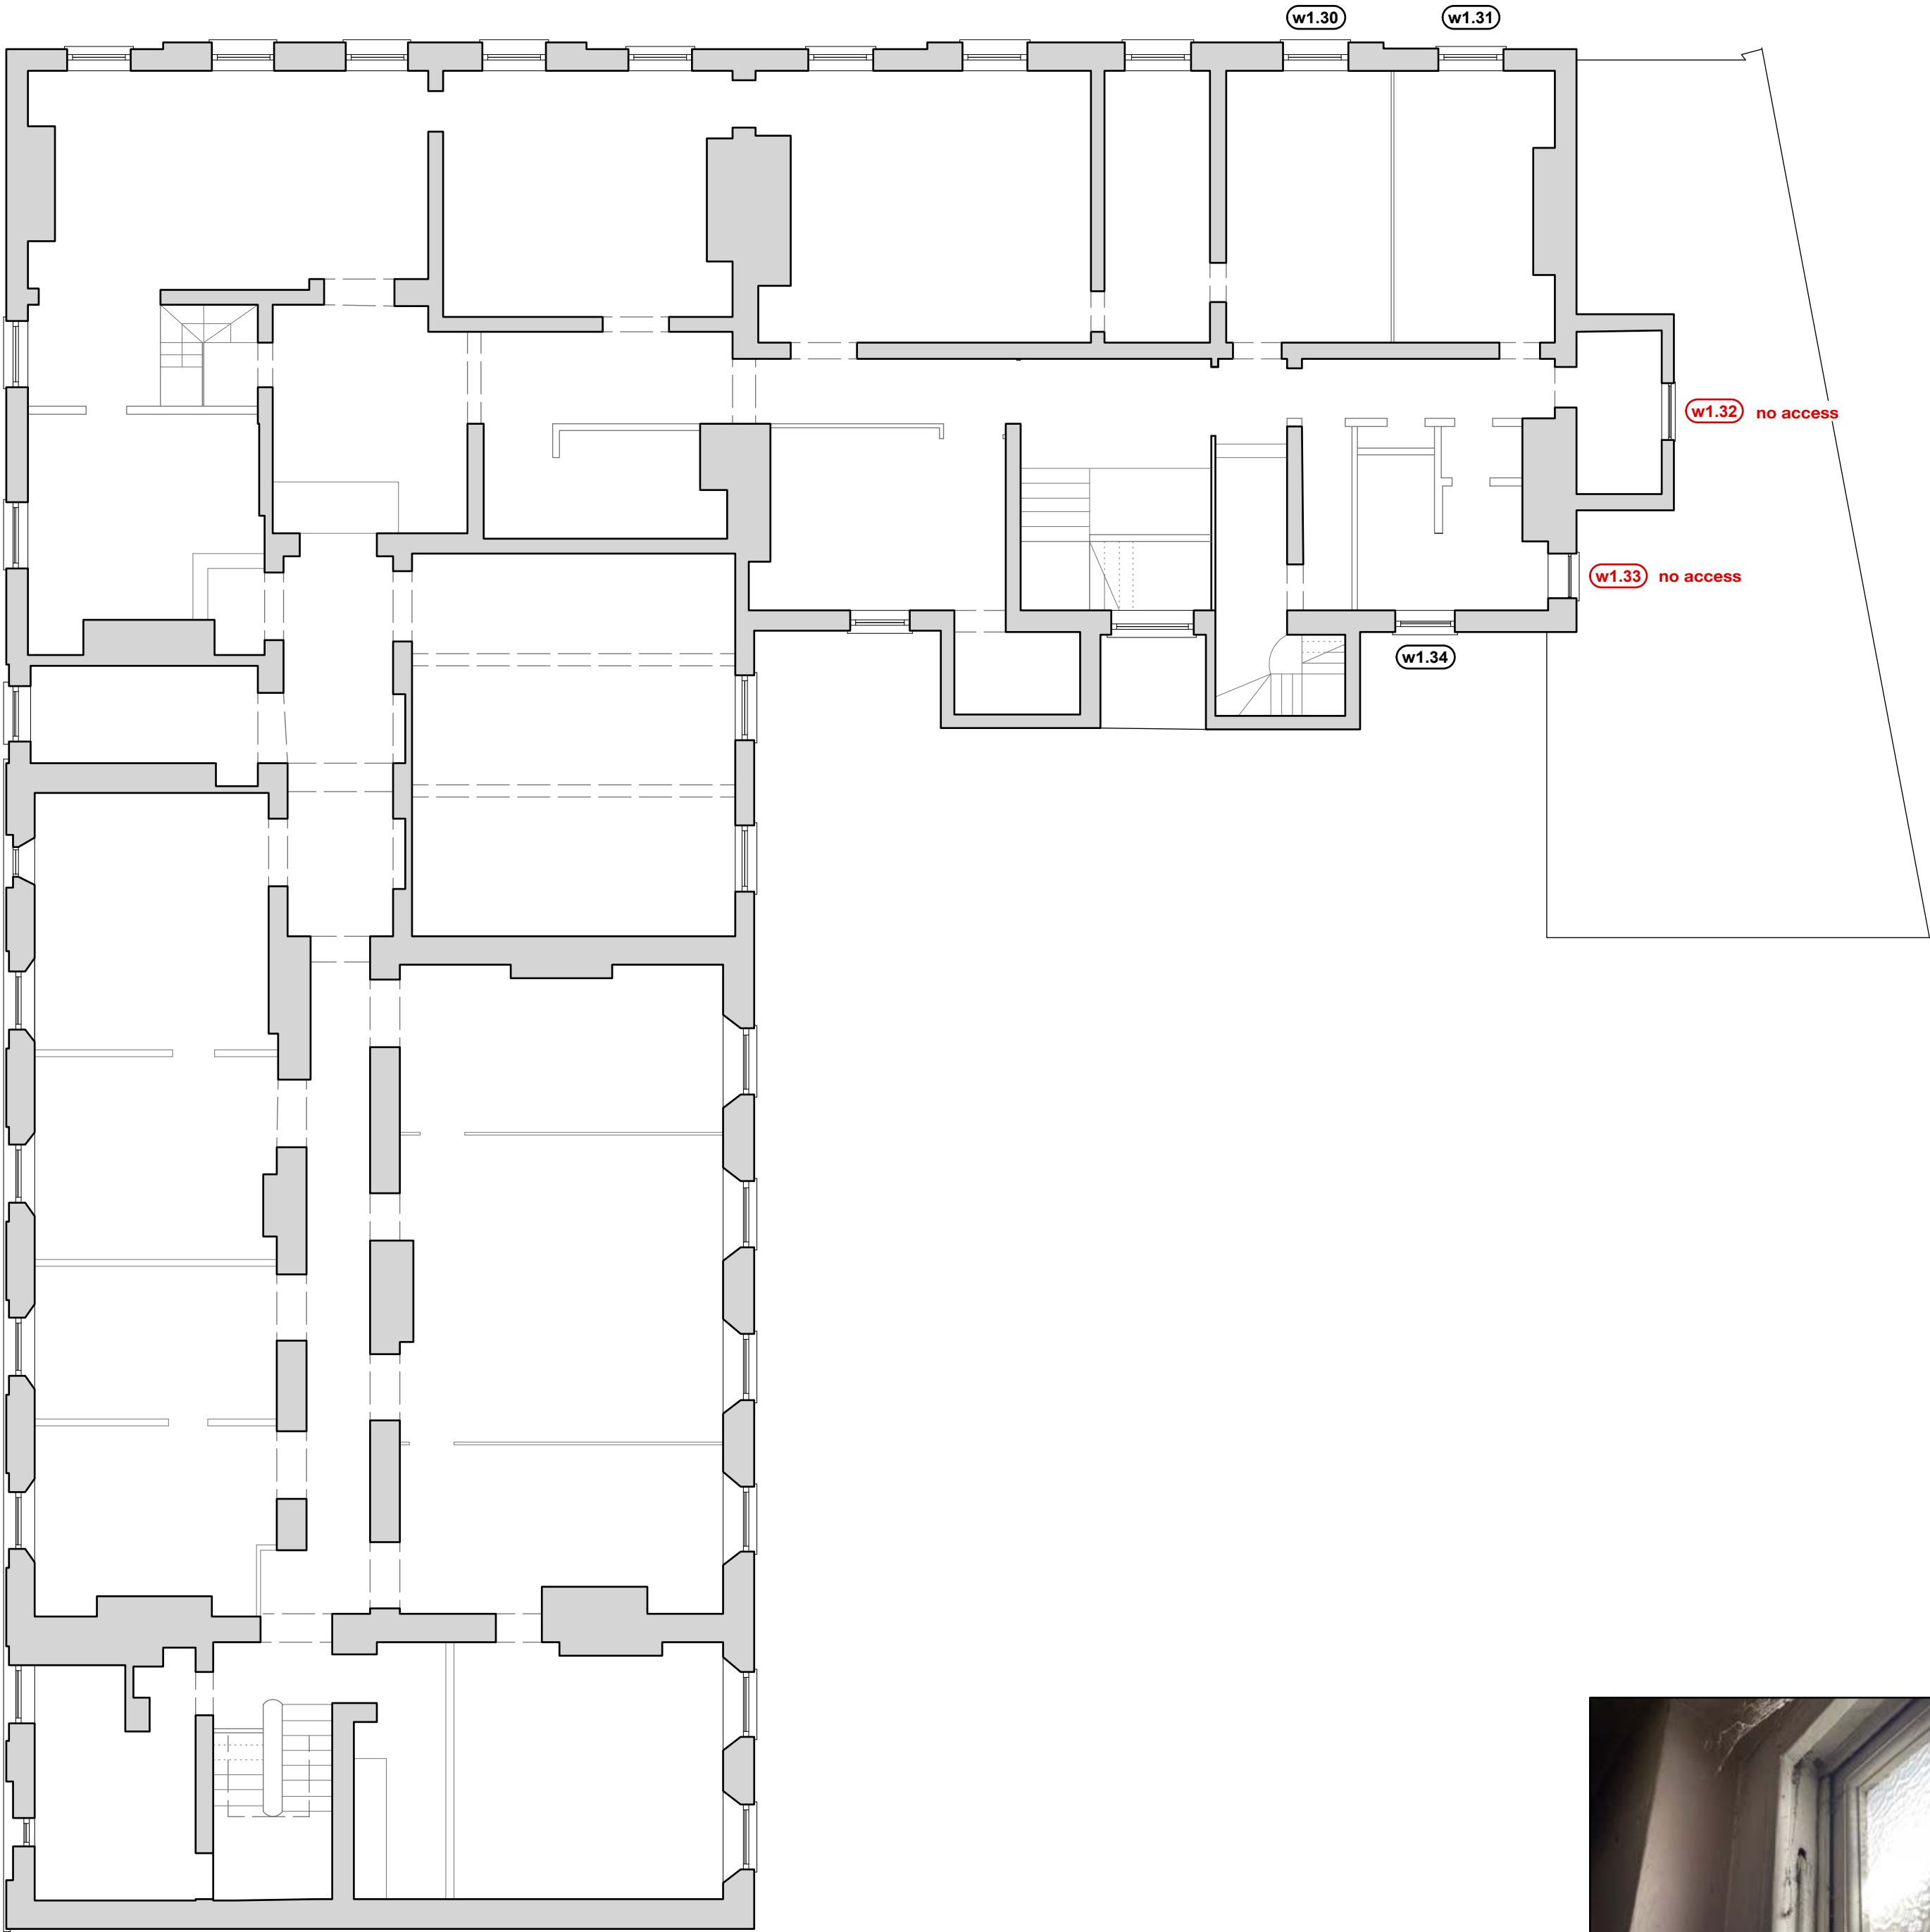
WINDOW W1.31

- Unable to open
- Original frame
- Non original glass
- Glass is smashed
- Chords are missing
