GROUND FLOOR | WINDOWS

| snookarchitects | | project: | rev. | date | description |
|---|---|---|---|---|---|
| 89 Wood Street | Liverpool | bridgewater house | | | |
| t: 0151 707 0100 | | dwg title: | | window survey [1 of 16] | |

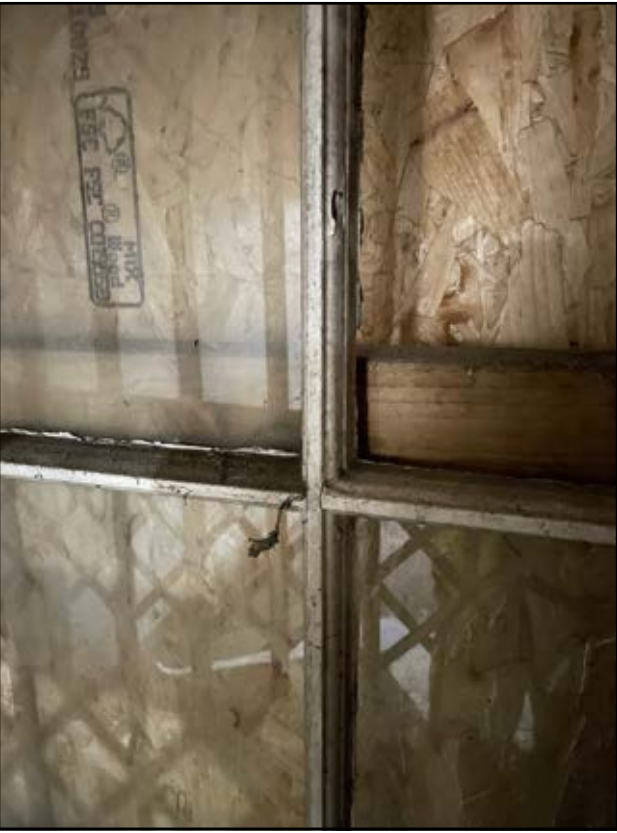
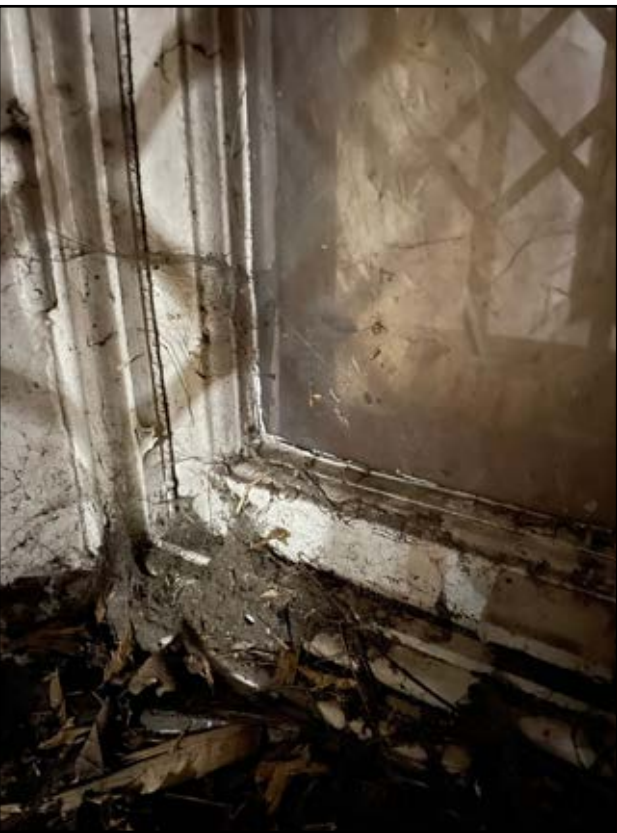
WINDOW **WG.22**

- Unable to open
- Original frame
- Damaged frame
- Glass mostly broken

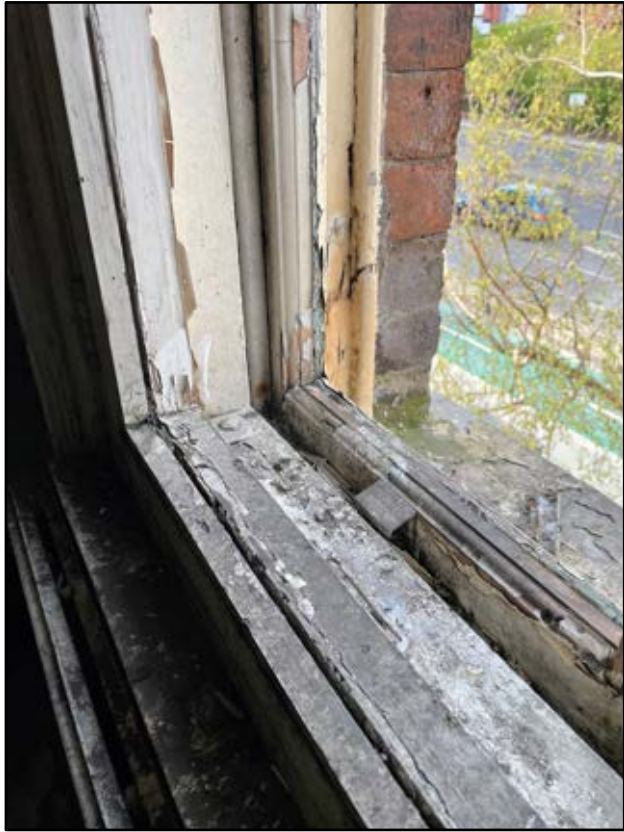
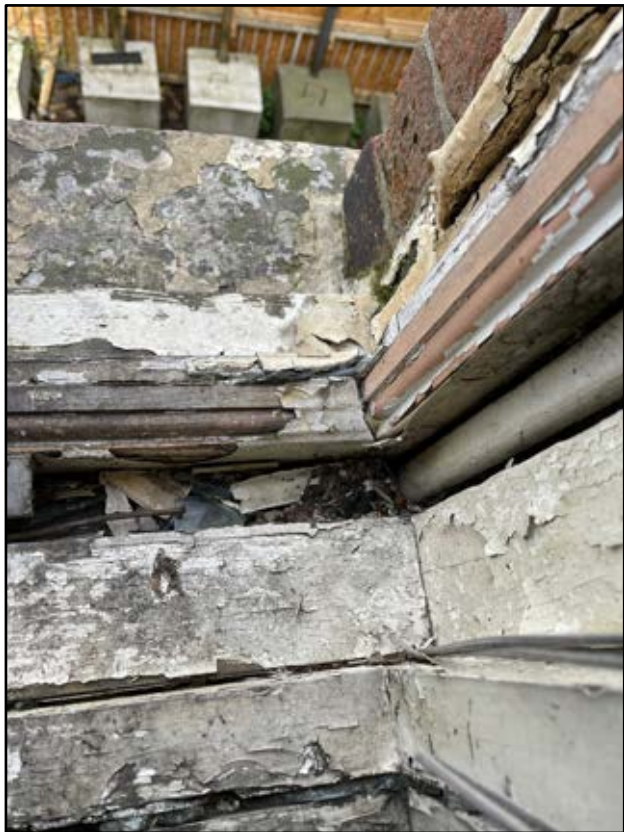
WINDOW **W1.22**

- Unable to open
- Original frame
- Frame is rotten
- Glass is missing and/or broken
- No chords
