## Schedule of Condition For

Wellington House,  
39 — 41 Piccadilly,  
Manchester  
M1 4AJ

Dated: 22<sup>nd</sup> March 2022

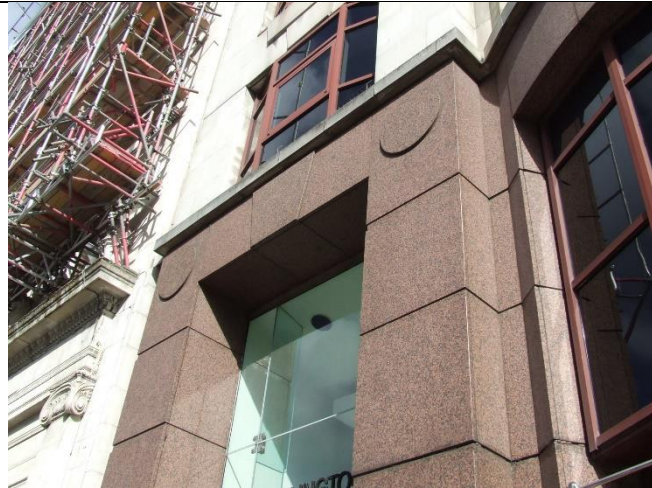
| <i>comments</i> | <i>photograph</i> | <i>comments</i> | <i>photograph</i> |
|---|---|---|---|
| <b>PICCADILLY PLAZA<br/>FRONT ELEVATION</b><br><br>Front elevation corner.<br><br>Steel frame building with stone or concrete block façade infills to curtain wall and rainscreen aluminium cladding systems. | | Marble block feature facades.<br><br>Washed out and aged pointing between blocks. | |

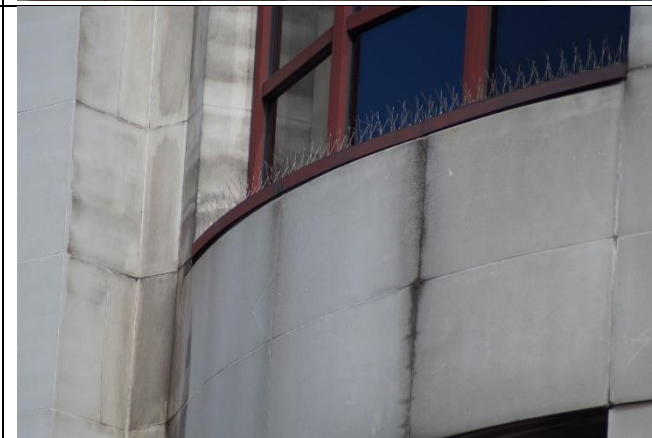
Concrete stone block infills soiled with washed out and eroded jointing.

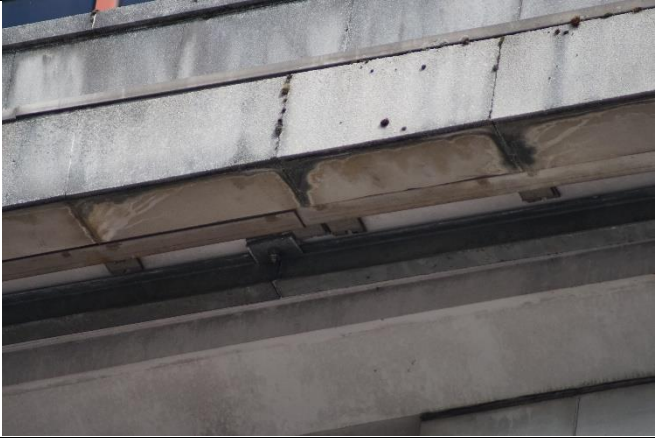
| Generally. | | Generally. | |

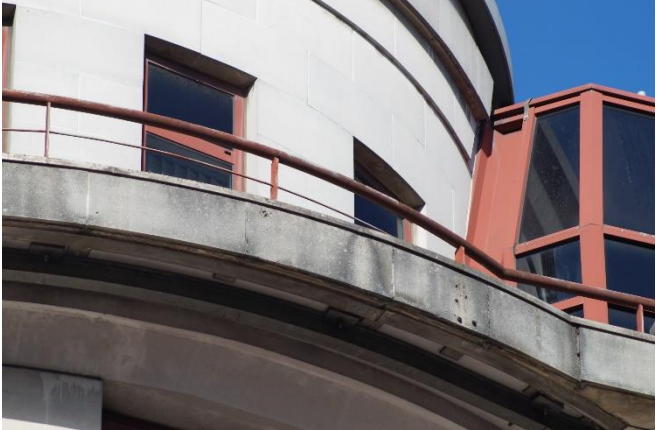
| Generally. | | Generally. | |

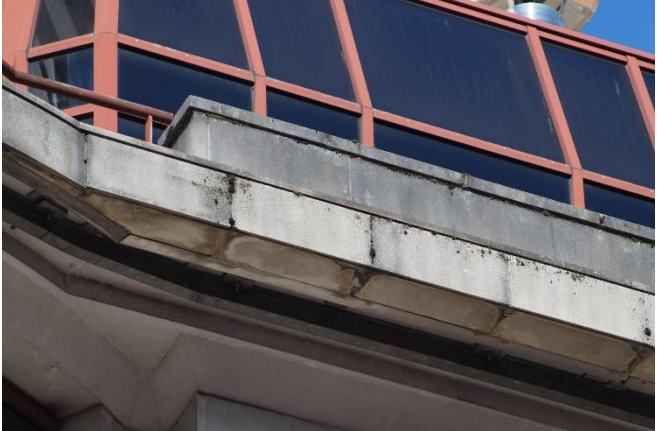
| Generally. | | Concrete stone block infills soiled with washed out and eroded jointing. | |

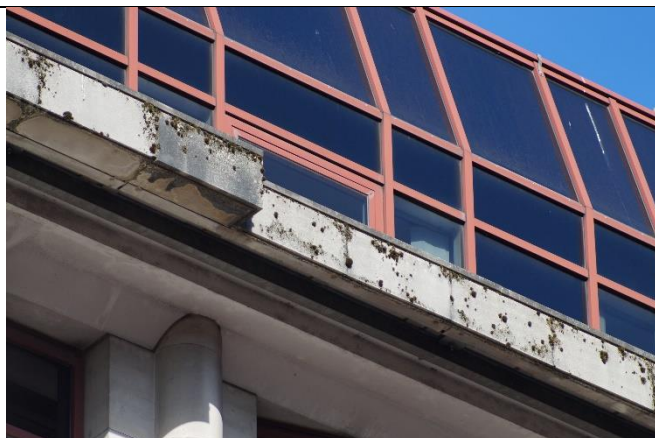
Concrete stone block infills soiled with washed out and eroded jointing.

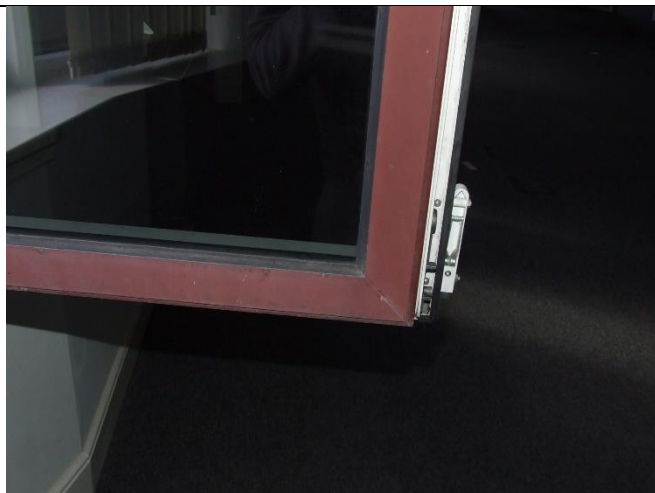
Generally.

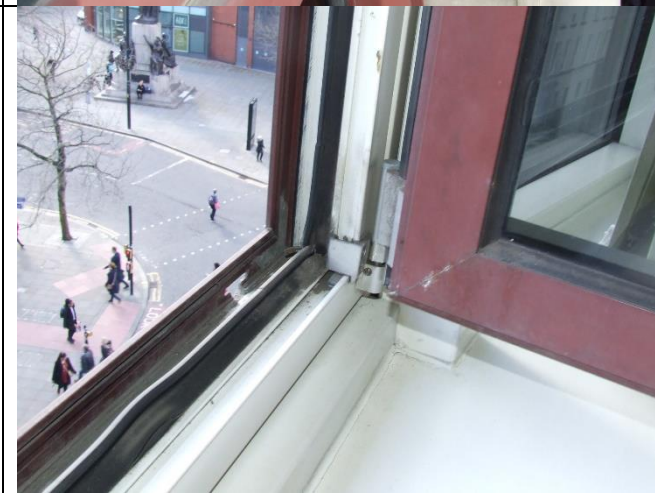
Generally.

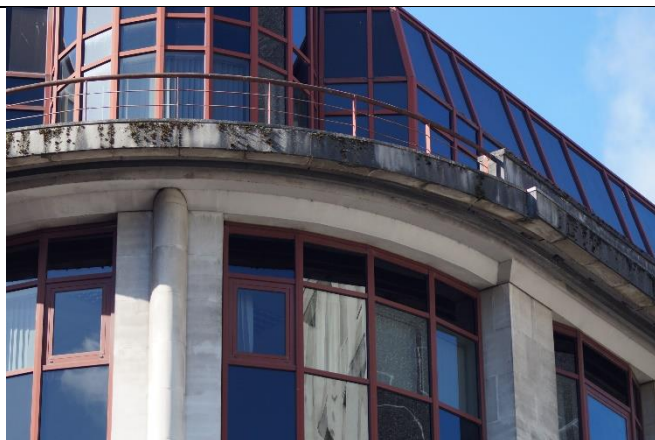
Concrete stone block  
infills soiled with  
washed out and  
eroded jointing.

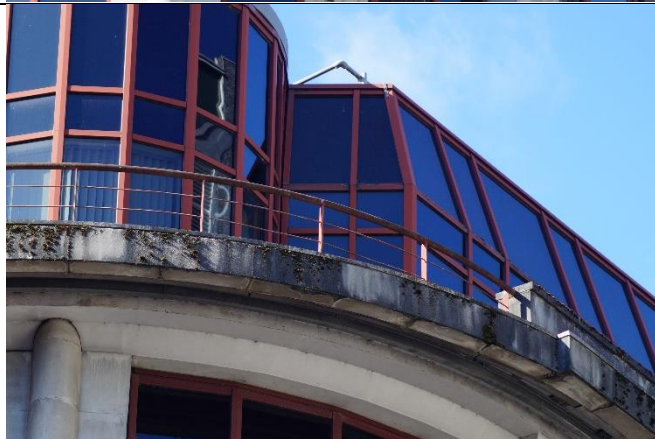
Concrete stone block  
infills soiled with  
washed out and  
eroded jointing.

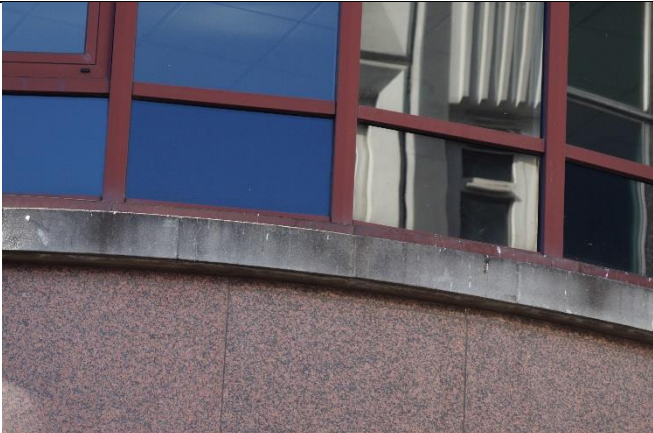
| <p>Generally.</p> | | <p>Concrete stone block infills soiled with washed out and eroded jointing.</p> | |

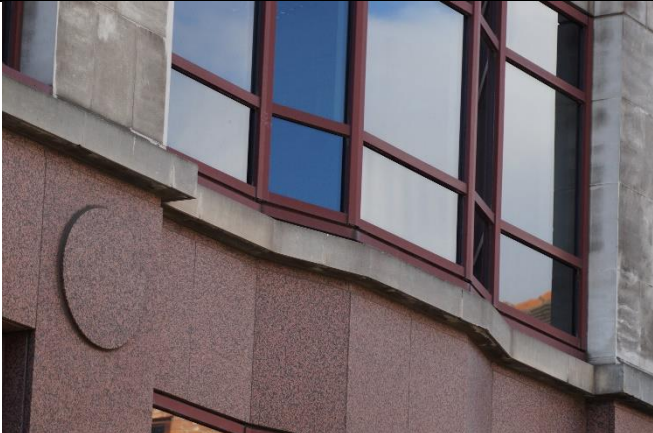
| <p>Generally.</p> | | <p>Concrete stone block infills soiled with washed out and eroded jointing.</p> | |

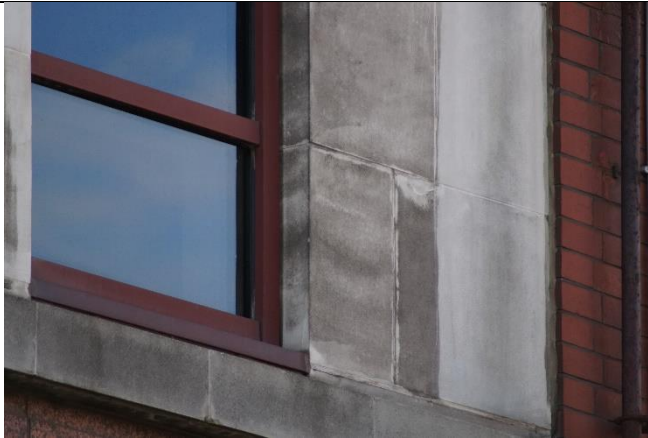
Concrete stone block  
infills soiled with  
washed out and  
eroded jointing.

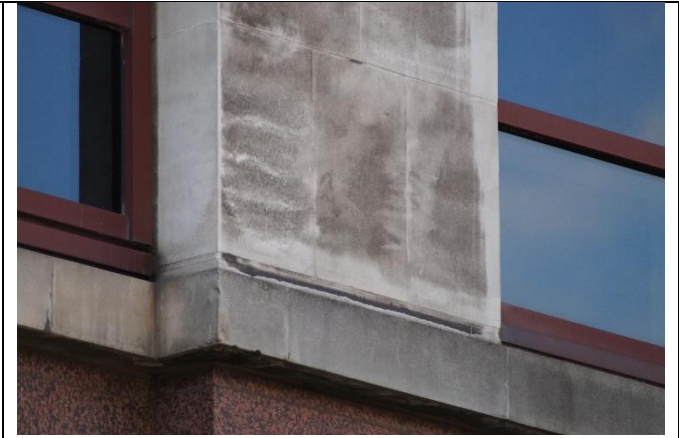
Concrete stone block  
infills soiled with washed  
out and eroded jointing.

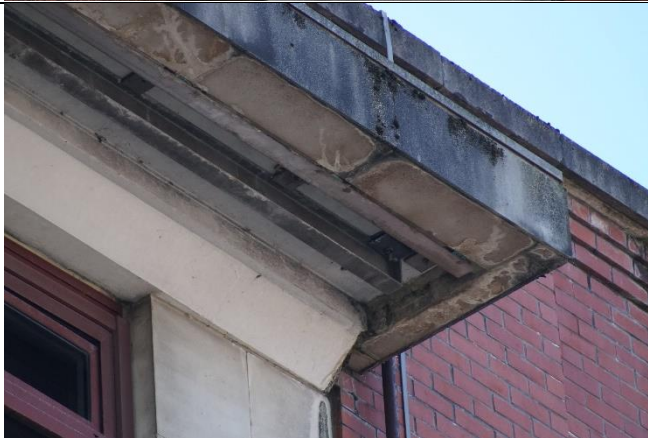
Concrete stone block  
infills soiled with  
washed out and  
eroded jointing.

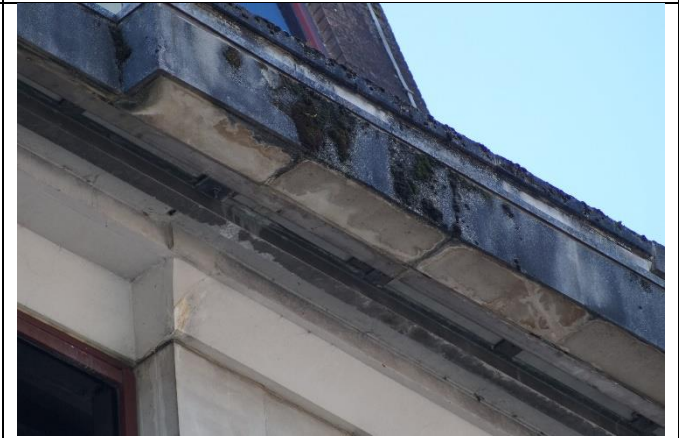
Concrete stone block  
infills soiled with washed  
out and eroded jointing.

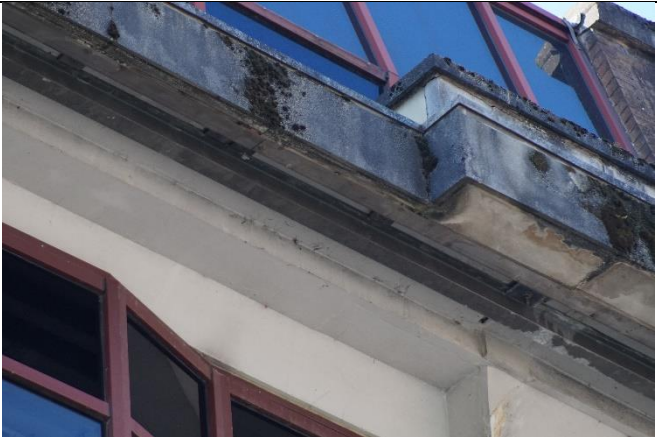
| <p>Generally.</p> | | <p>Concrete stone block infills soiled with washed out and eroded jointing.</p> | |

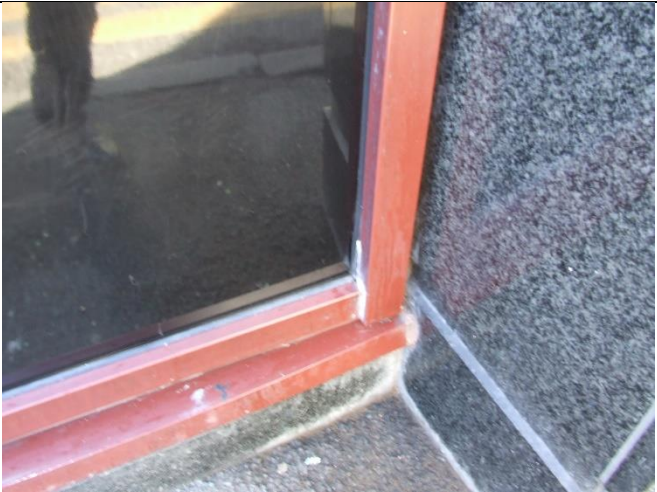
| Generally. | | Generally. | |

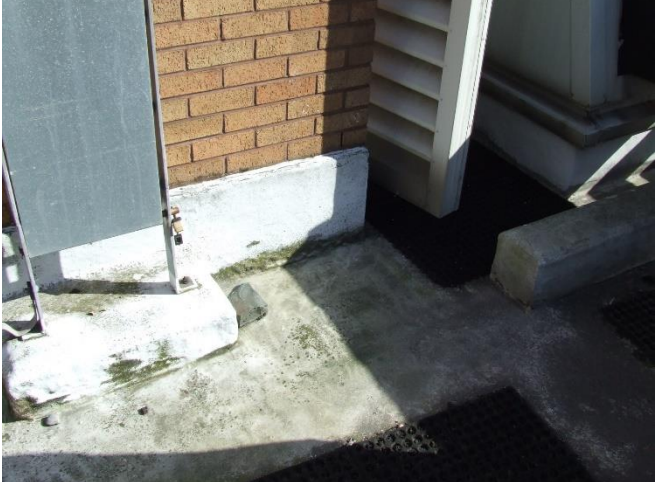
| <p>Generally.</p> | | <p>Generally.</p> | |

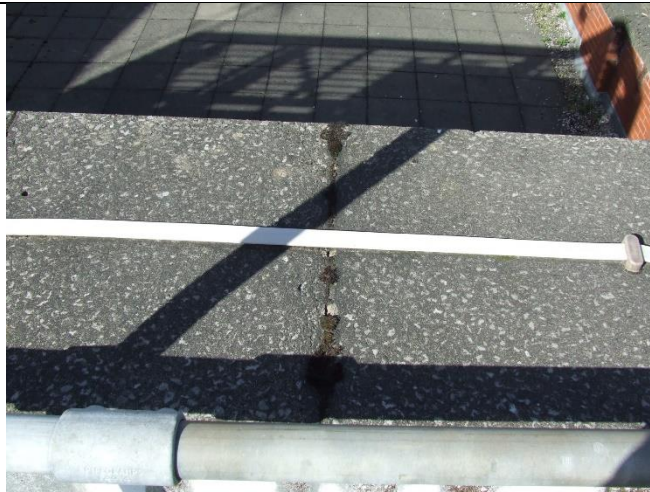
Eroded and washed out pointing to the concrete coping joints.
