### STRUCTURAL REPORT

#### CLAYTON HALL MANCHESTER

**Date:** February 2022

**Reference:** RGR/BBR/16076~srep rev 2

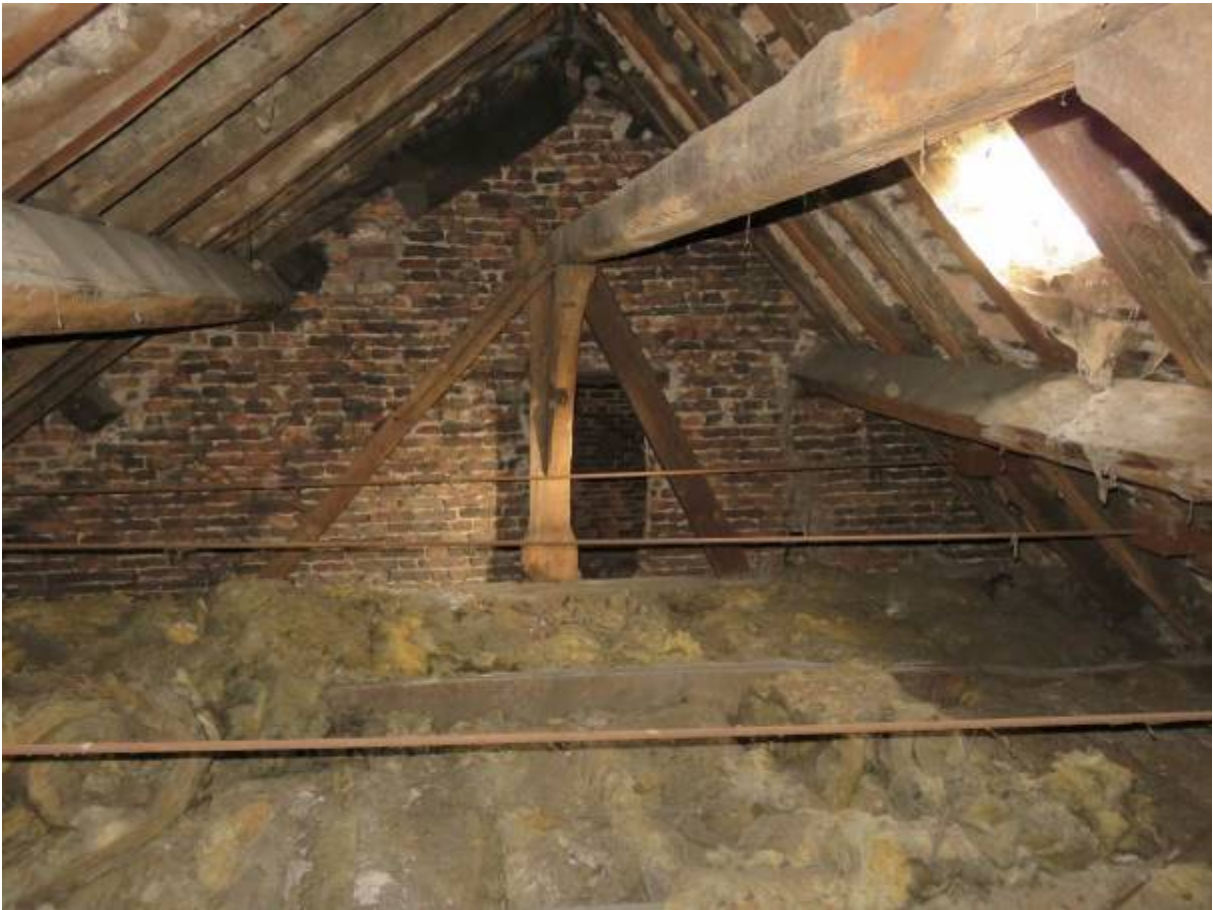
Photograph 6: North part crown post

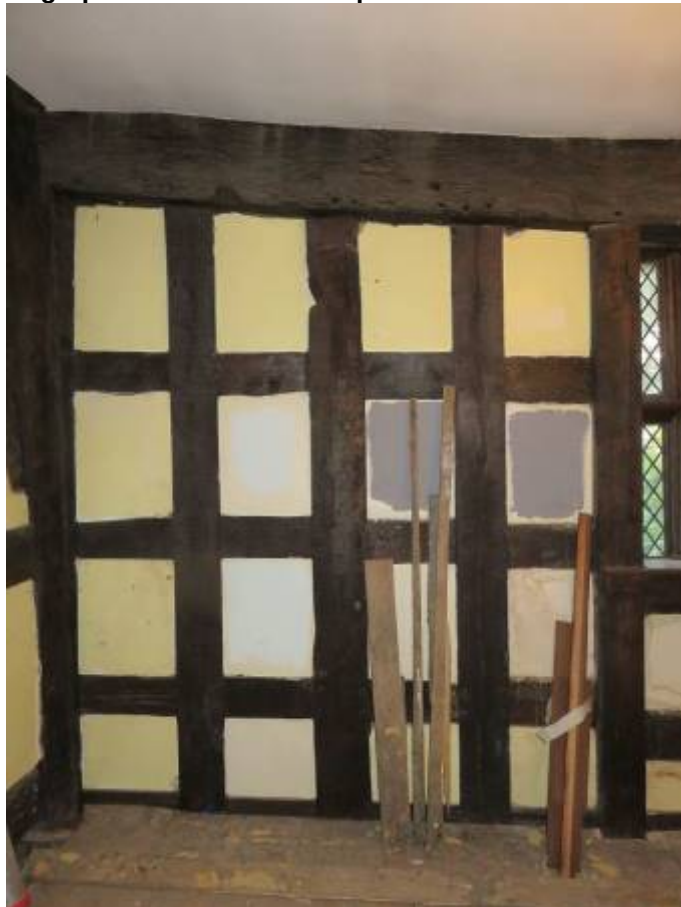
Photograph 15: North wall panel to north bay to east side with clear later introduced timbers

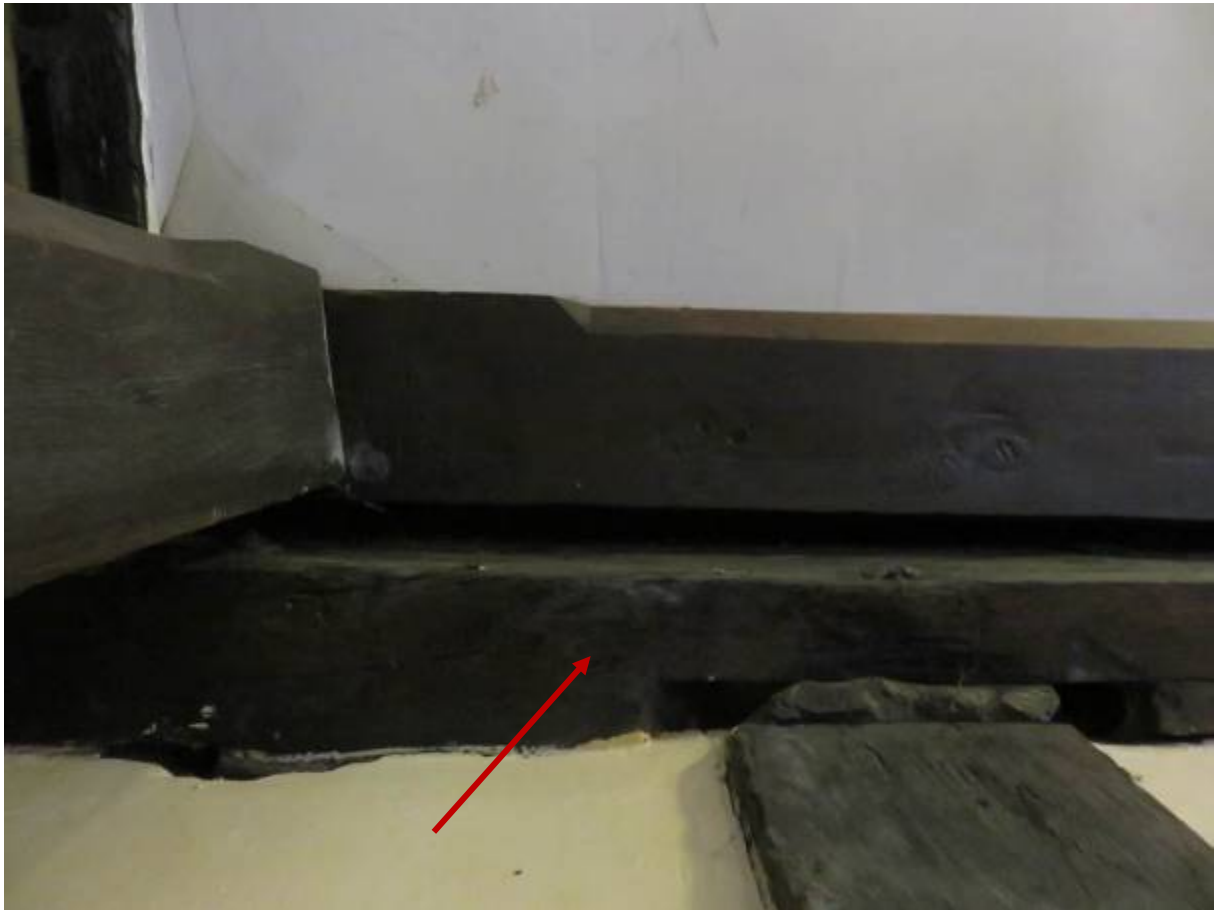
Photograph 21: Added secondary frame to internal face of east wall to south bat

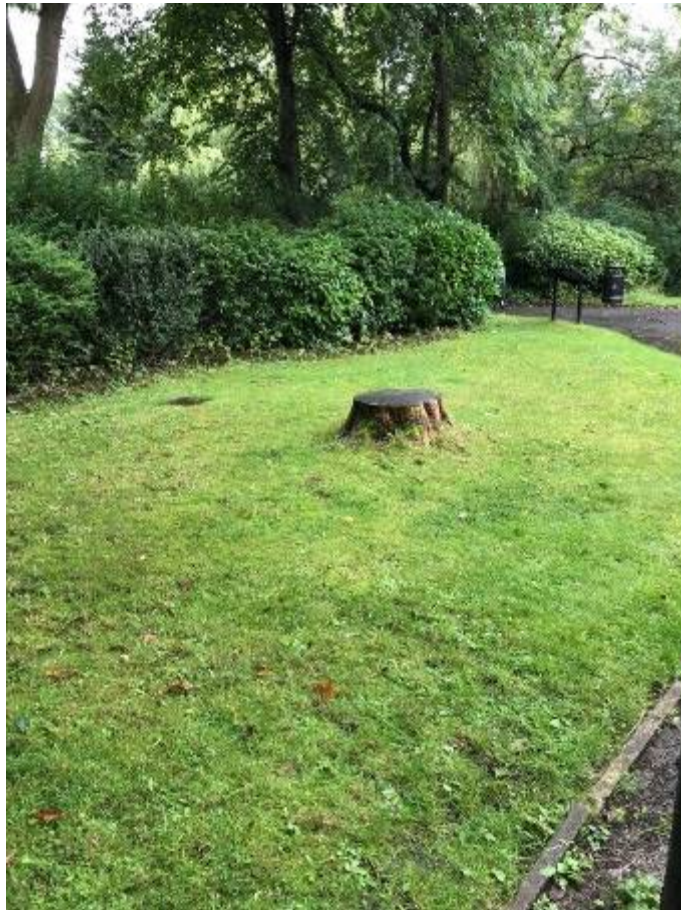
**Photograph 42C: Cut tree in close proximity to mall and south west corner**

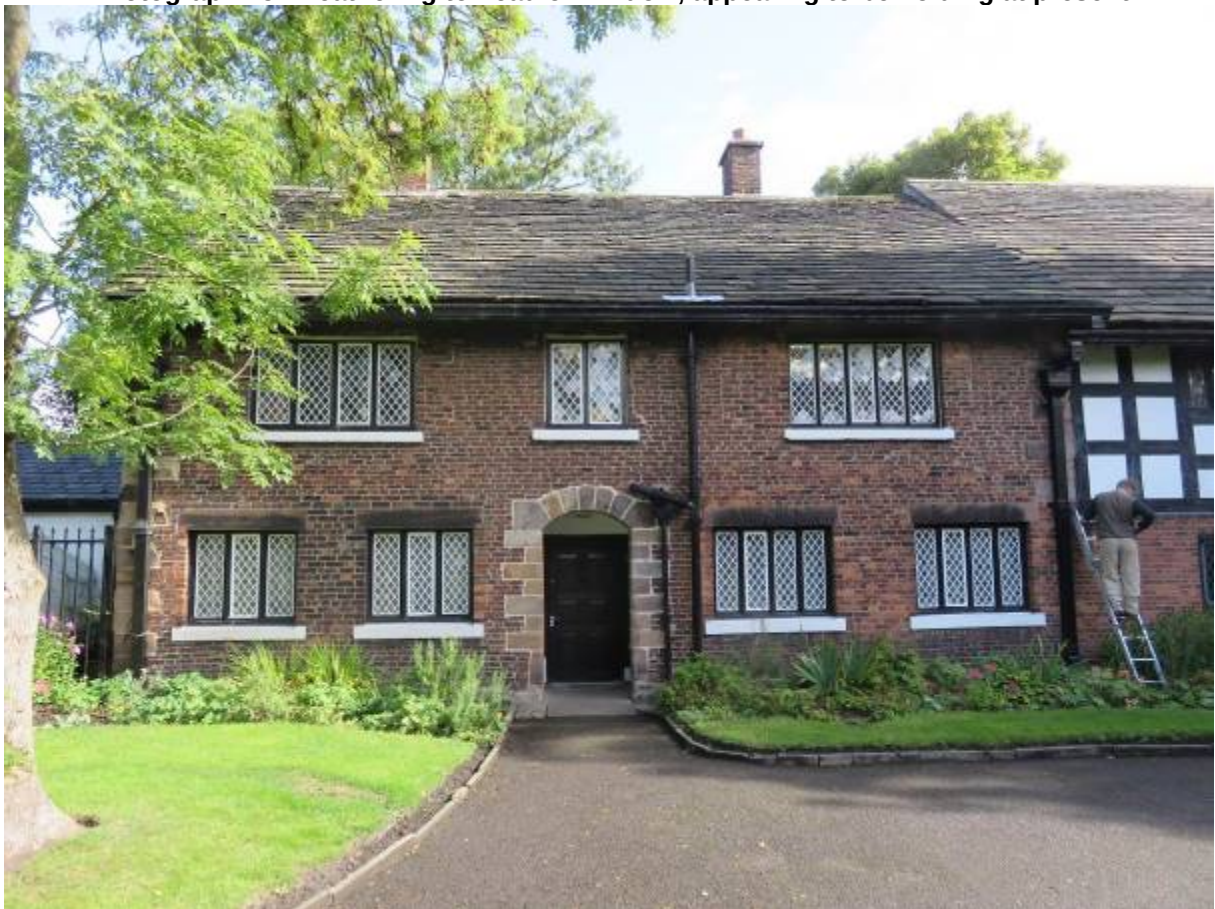
| <p>3.1.57 The head of the windows are protected with a weathering which seems to be working reasonably well (see photograph 45) at this time.</p> | <p>Appears to still be working appropriately.</p> |

**Photograph 45: Weathering to head of window, appearing to be holding at present**

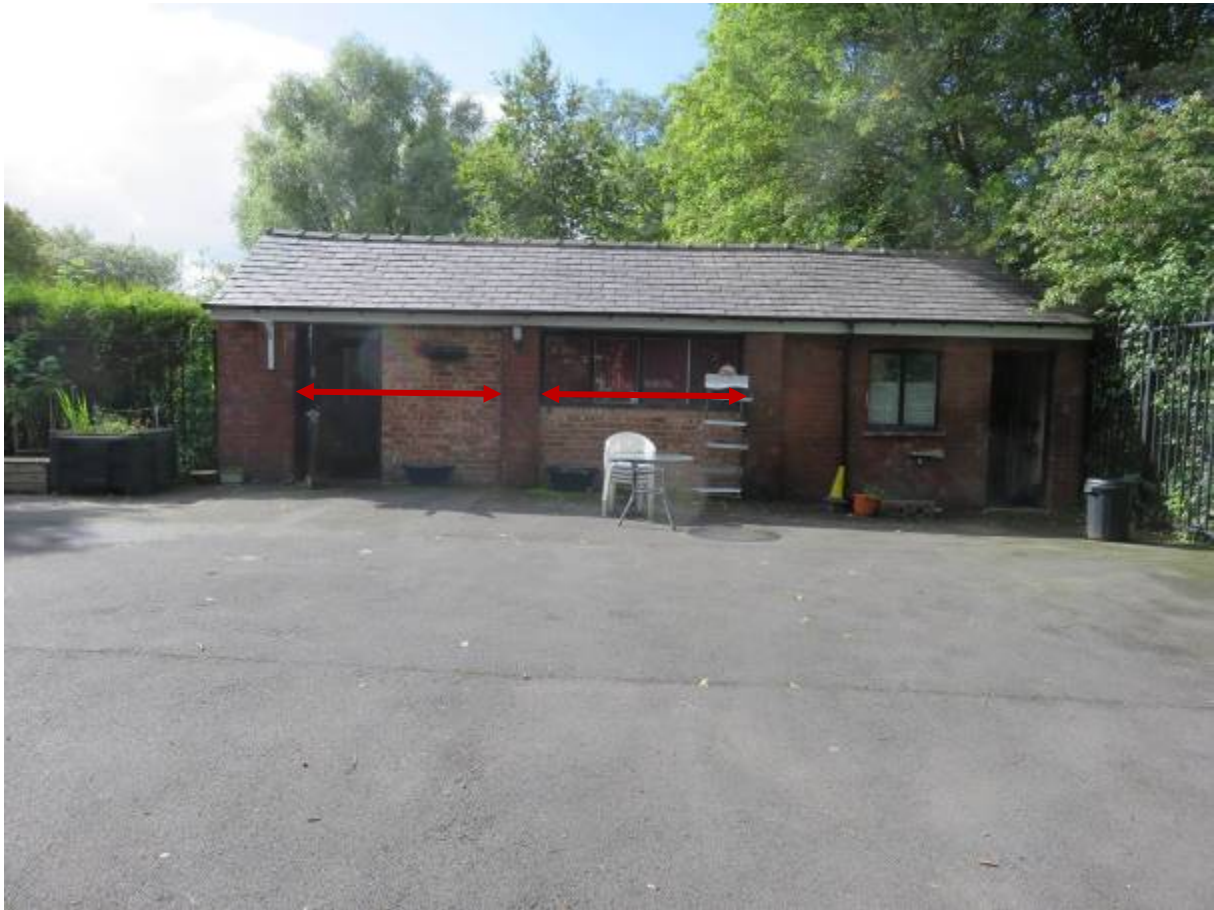
| 3.3.1 | The café and store is set a little to the north of the main building and adjoining the moat (see photograph 4). To the east elevation there appears to have been two open bays originally, then with a solid wall to the north (see photograph 64). It is constructed of 9 inch brick with a slate covered pitched roof over and a ceiling running through a short way above eaves. To the west side there is a flat roofed element felt covered roof (see photograph 65).<br>This area no longer serves as a café, with this now relocated into Clayton Hall at its southern wing. No changes have taken place to the building other than this since the previous report, with it largely being used as a storage space (see photograph 65A). |

**Photograph 64: Apparent open bays highlighted**

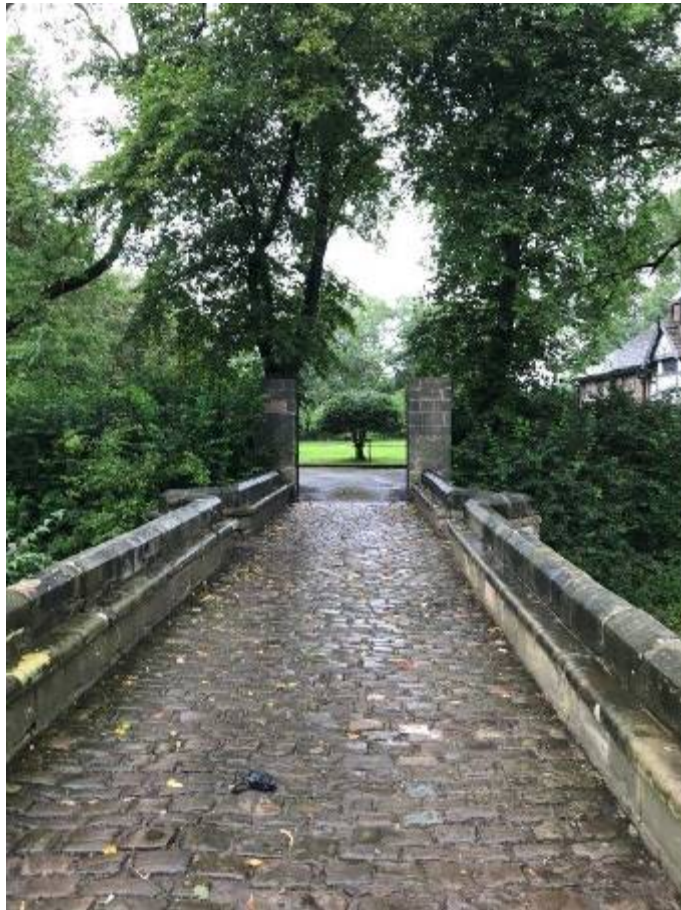
Photograph 70D: Stone set surfacing with depressions relating to vehicle track route
