**Asbestos Survey Report**  
**Public Car Park**  
**below Renaissance Hotel, Manchester**

**Report No. IC20126**

**Date of Issue: 3<sup>rd</sup> February 2021**

| <b>Survey Type:</b> | <b>Refurbishment &amp; Demolition</b> |

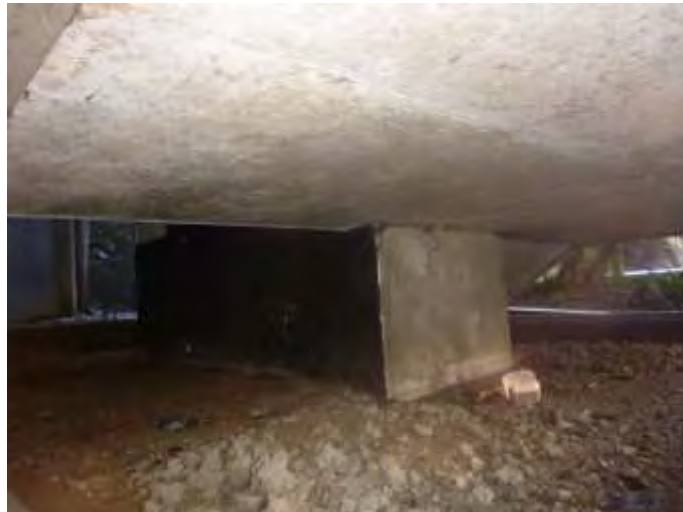
**Concrete Pedestrian Stairs**

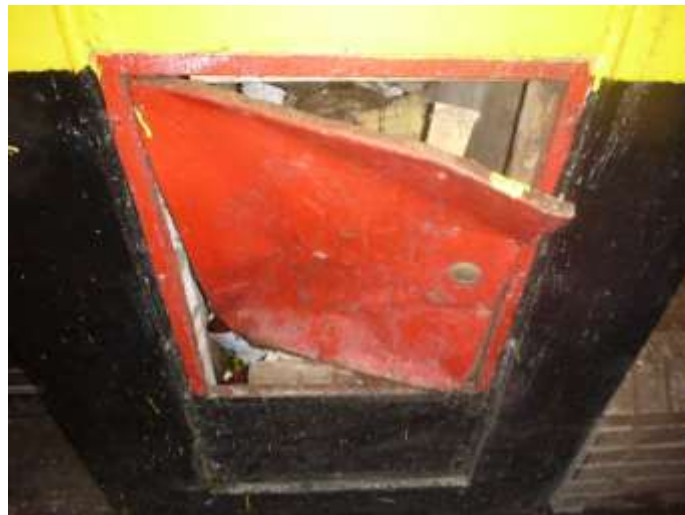
**Tin / Timber Doors to Stairs Risers**

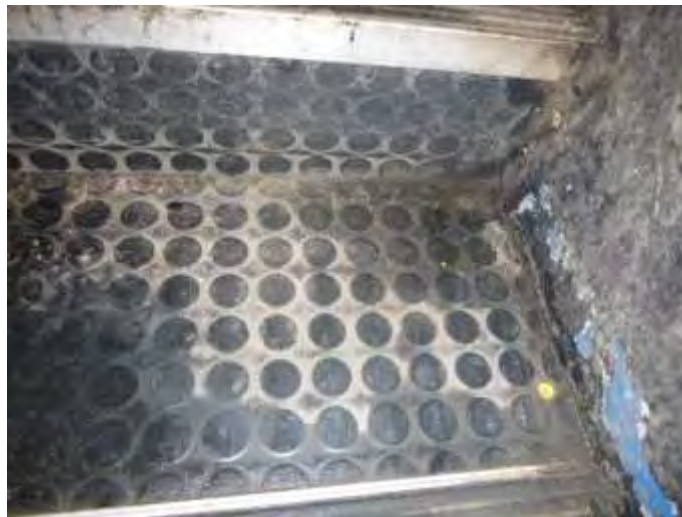
**Rubber Coating to Steps**

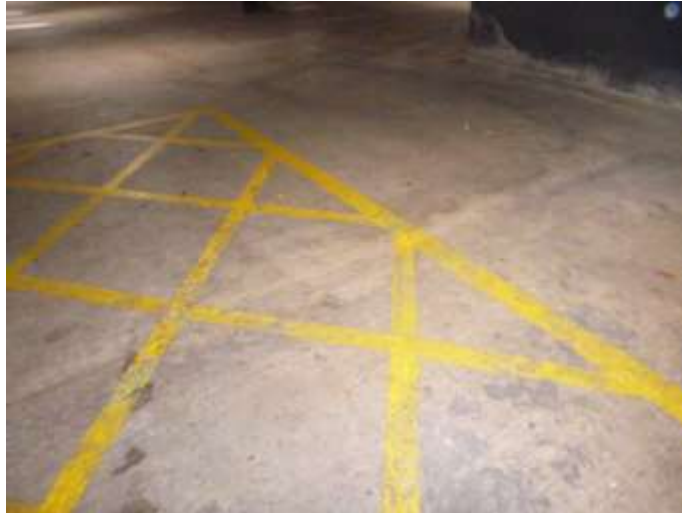
**Concrete Floors**

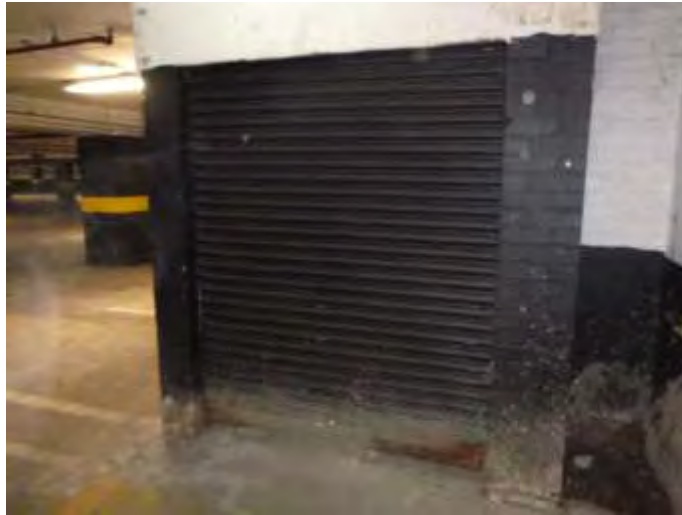
**Steel Roller Shutter Doors**

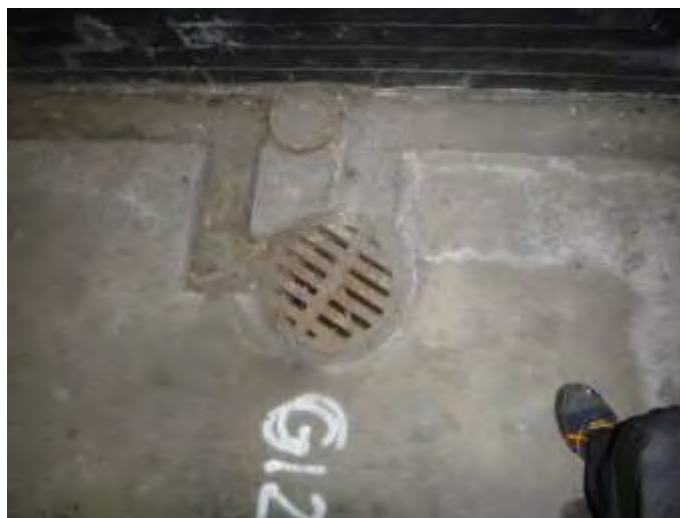
**Cast Grates to Floors**

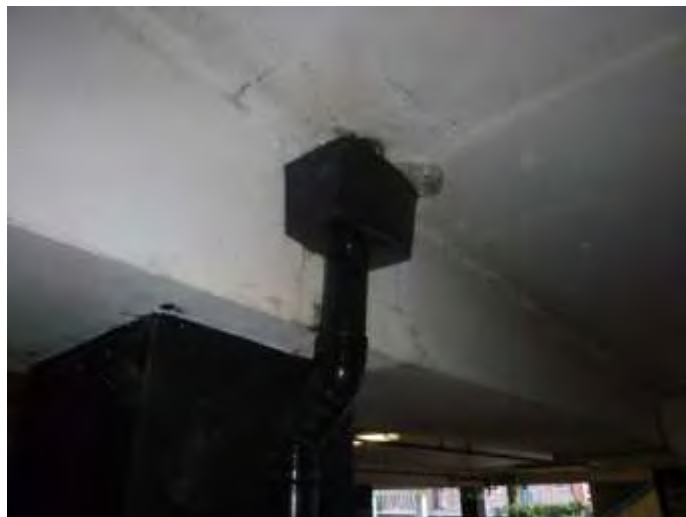
**Part Plastic Rainwater Goods**

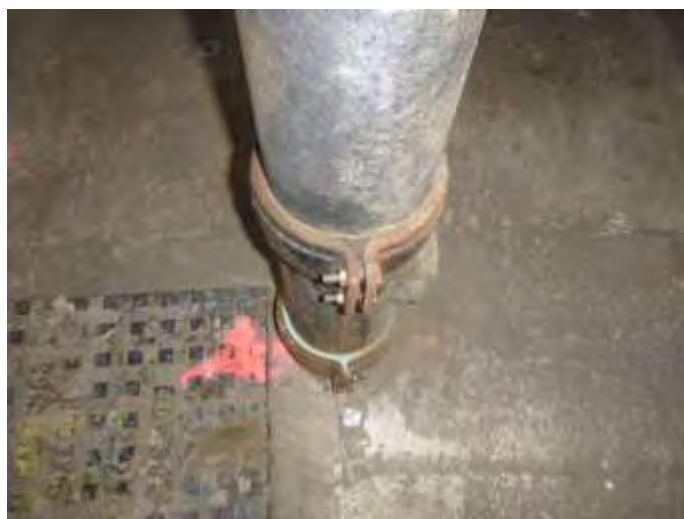
**Rubber Seals to Vertical Cast Pipes**

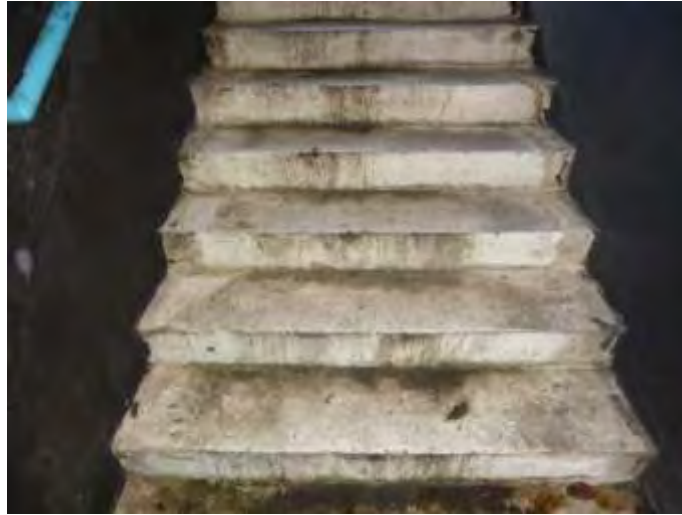
**Concrete Steps**

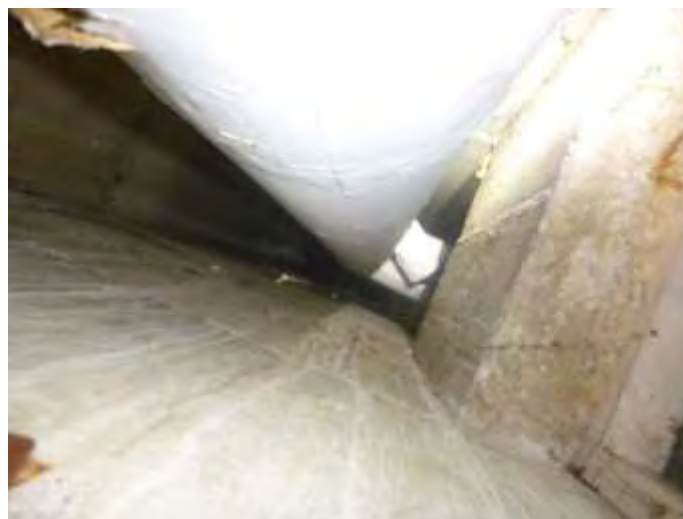
**Concrete Risers**

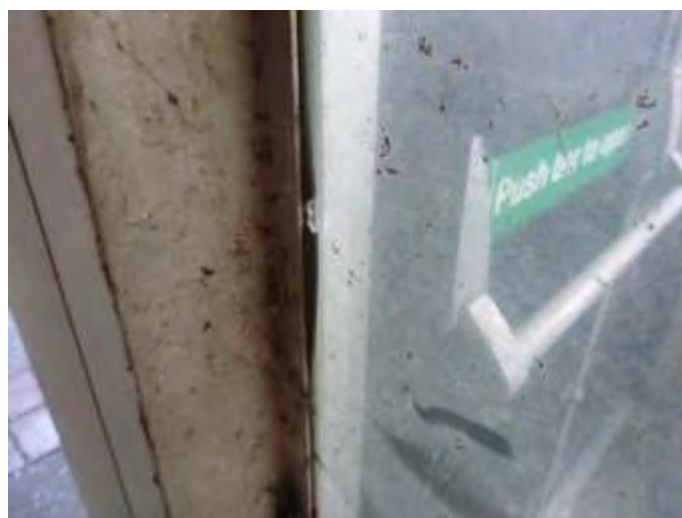
**Rubber Seals to Glazed Stairs Panels**

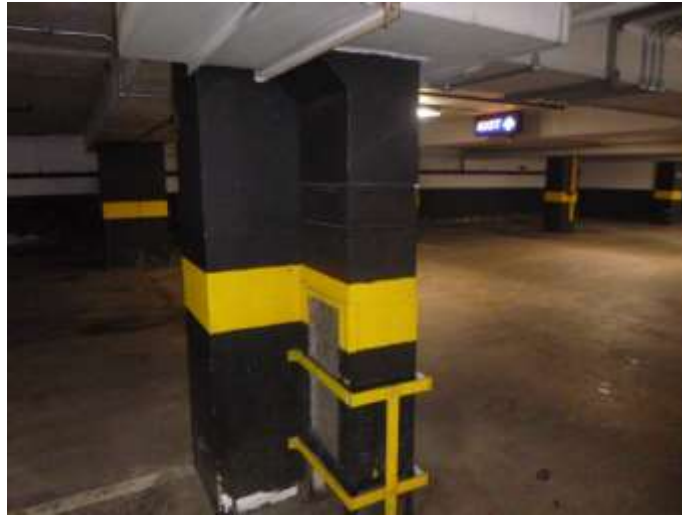
**Metal Vertical Vents**

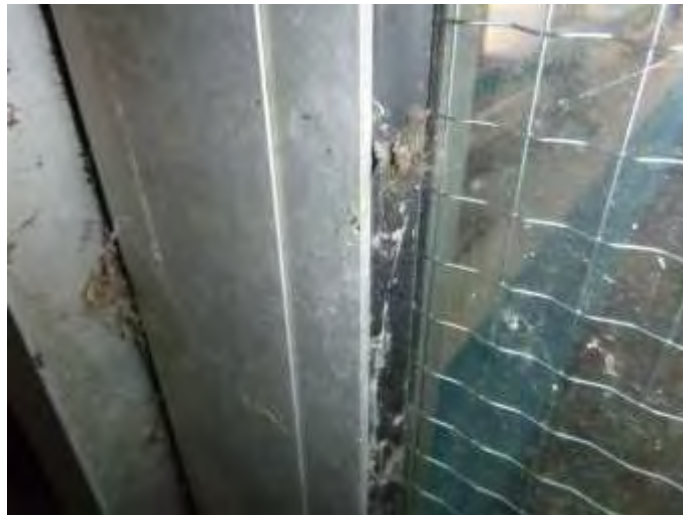
**Rubber Seals to Glazed Panels**

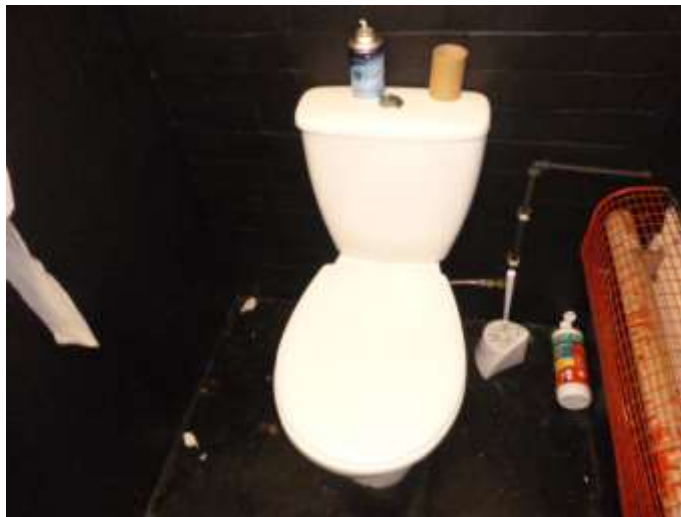
**Ceramic Cistern in Staff WC**

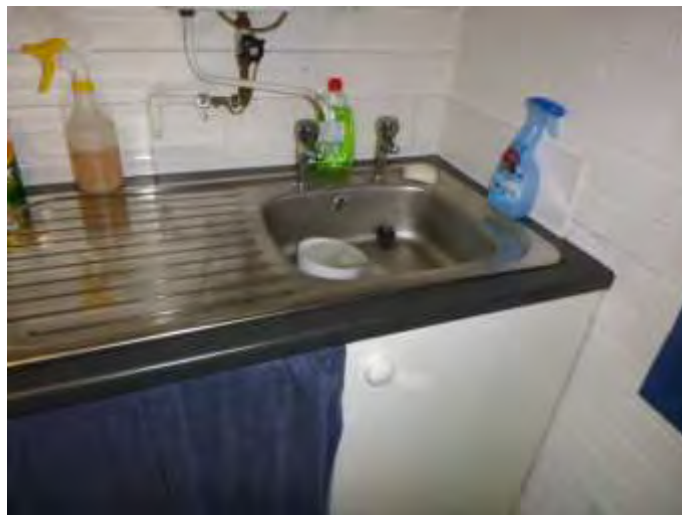
**Modern Sink in Security Office**
