Gas Membrane Installation  
Validation Report  
Kier  
Nelson Street  
Miles Platting  
Manchester  
M40 8BB

## Appendix 1 – Site Survey Sheets

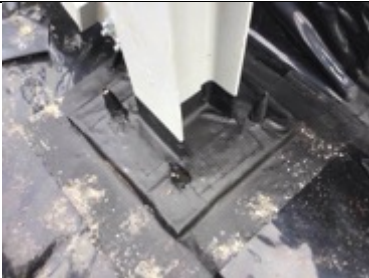
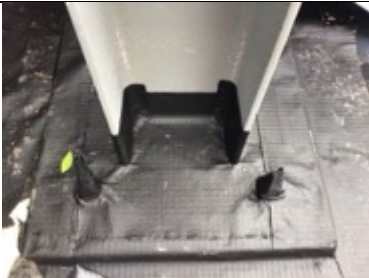
Stanchion detailing sealed using Juta GP1 SAM and heat applied

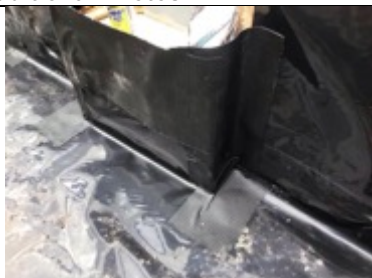
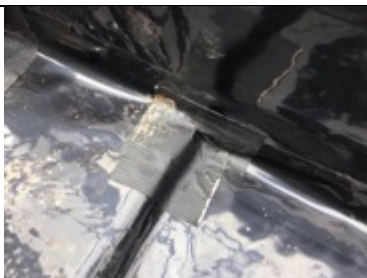
Corner detailing sealed using Juta  
GP1 SAM and heat applied

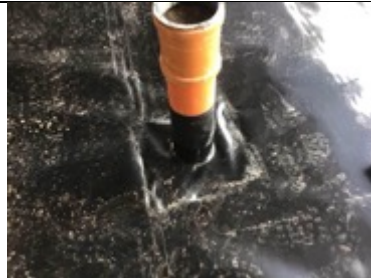
Pipe penetration sealed using hand welded preformed top hat and Juta GP1 SAM

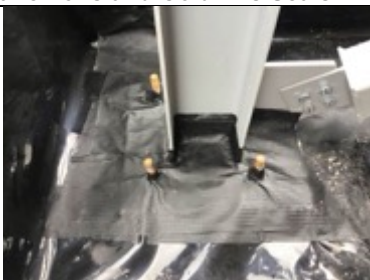
Stanchions sealed using Juta GP1 SAM

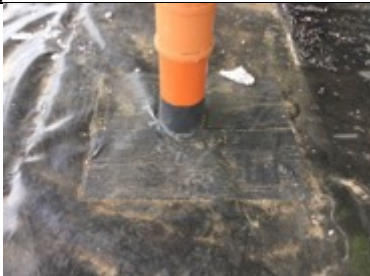
Sealed pipe penetration detail within pour area 3.

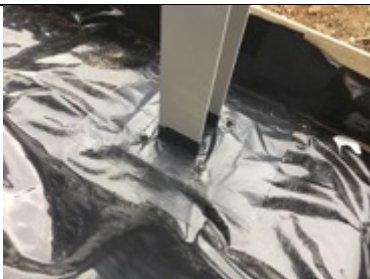
Sealed stanchion detailing

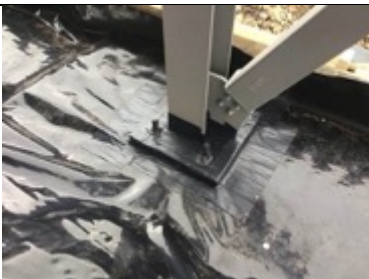
Sealed stanchion detailing
