Gas Membrane Installation  
Validation Report  
Kier  
Nelson Street  
Miles Platting  
Manchester  
M40 8BB

## Appendix 1 – Site Survey Sheets

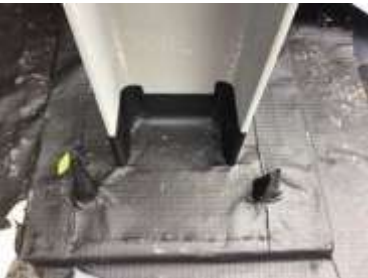
Stanchion detailing sealed using Juta GP1 SAM and heat applied

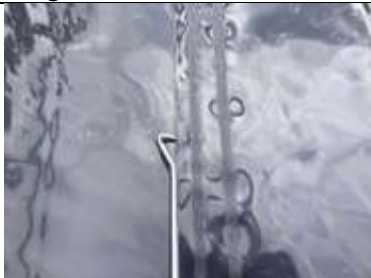
Testing sealed auto welded membrane lap joint

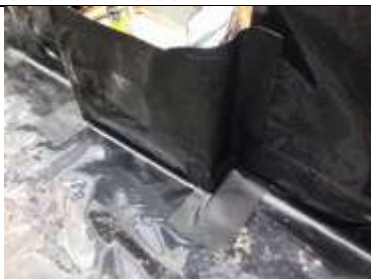
Corner detailing sealed using Juta  
GP1 SAM and heat applied

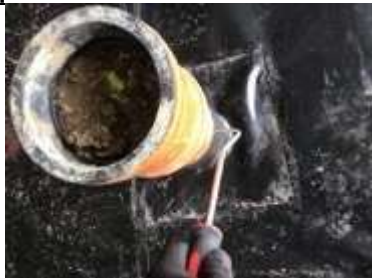
Testing Juta GP1 SAM sealing the top hat to the pipe sleeve

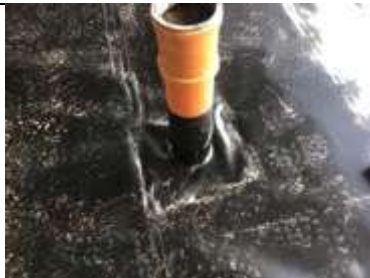
Pipe penetration sealed using hand welded preformed top hat and Juta GP1 SAM

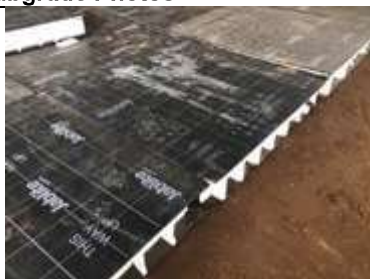
Heave board installed prior to the membrane installed above

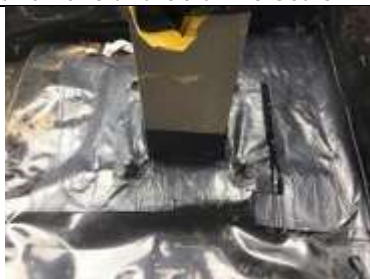
Sealed stanchion detailing

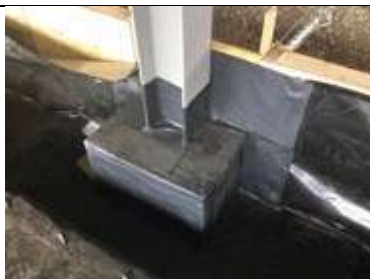
Sealed internal stanchion and  
concrete surround detailing

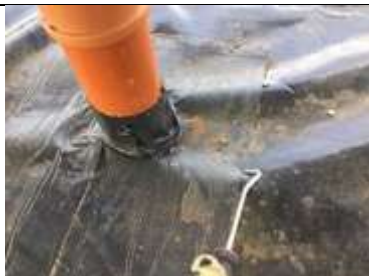
Pick testing to the pipe detail to Pour area 3.

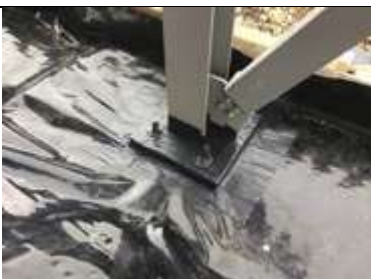
Sealed stanchion detailing

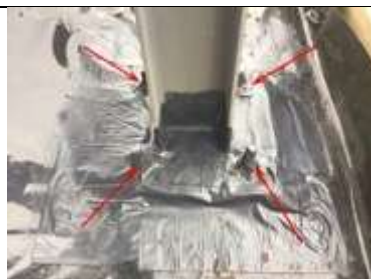
Double sided butyl tape used on the stanchion bolts
