| KELIOS AMEY METROLINK INSPECTIONS |
| A53 - WILLIAM STREET ARCHES |

## Appendix B: Photographs

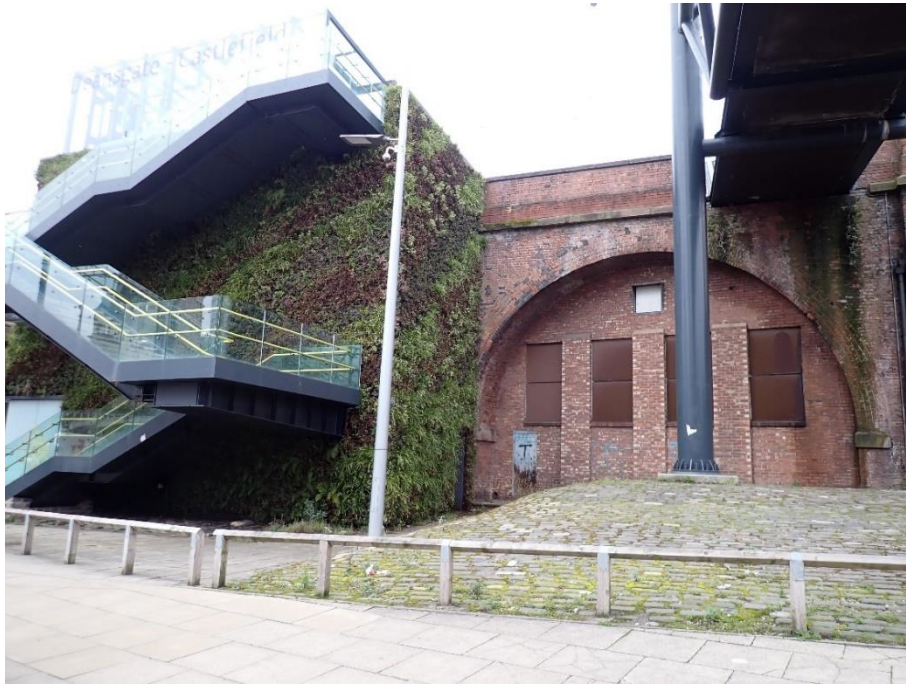
Photo 1: General view south elevation (picture from previous GI report – 2021).

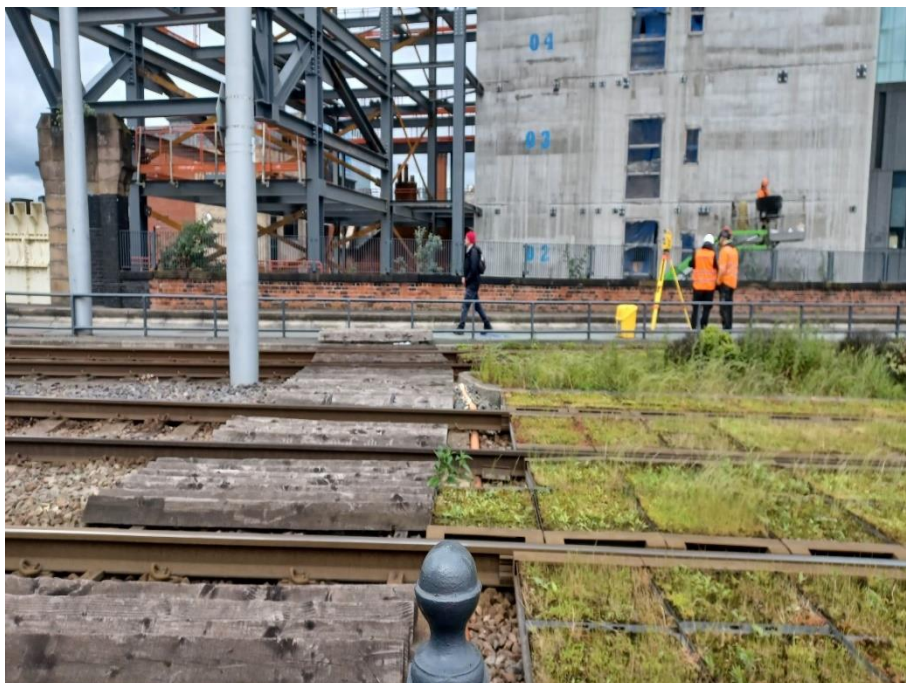
Photo 2: General view across topside looking south to north.

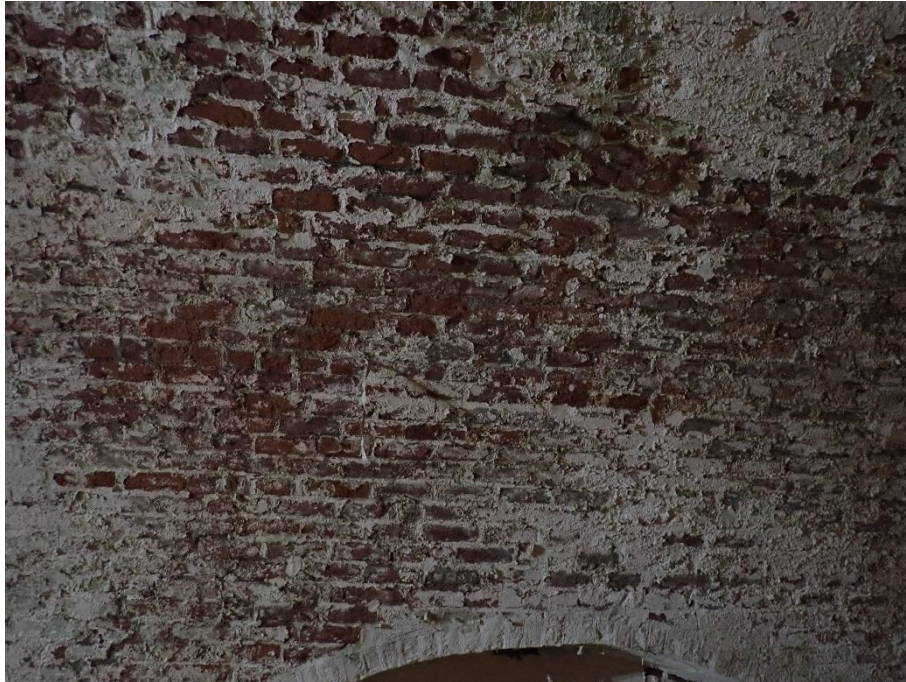
Photo 39: Area of sodden and hollow sounding brickwork 15x1.2m to east face of arch barrel starting from south infill wall and approx. 2m up from east springing of span 2.
