# CIS Tower- Manchester

## Condition Survey of the William Mitchell Mural

September 2019

## Condition Survey of the Barry Daniels Mural

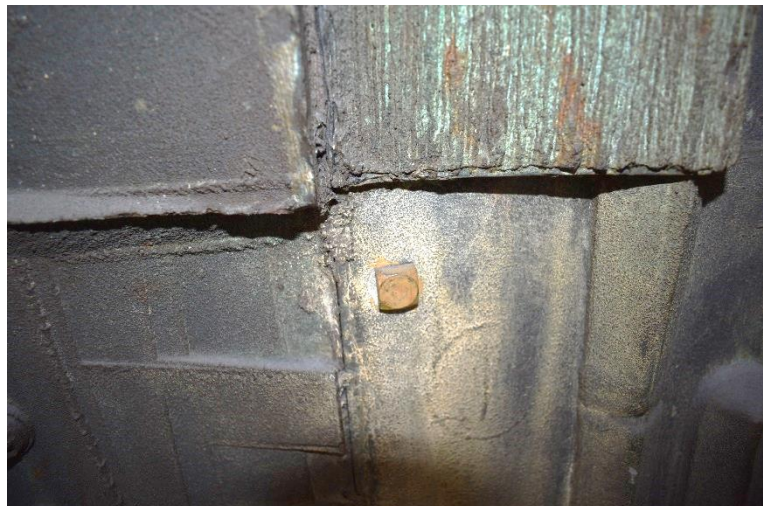
Coach bolt – securing the mural panels to the rear wall.

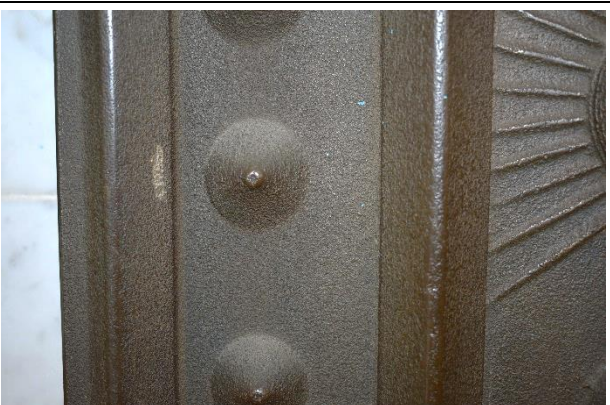
| Description | Photograph |
|---|---|
| <p>Minor marking to panel together with additional spots of blue paint.</p> | |

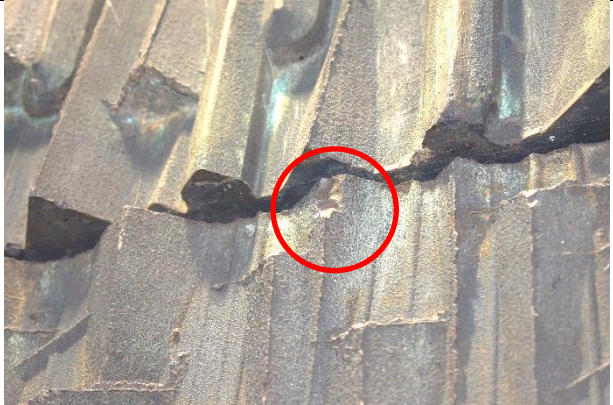
| Description | Photograph |
|---|---|
| Minor impact to exposed edges of GRP. | |

| Ditto. | |

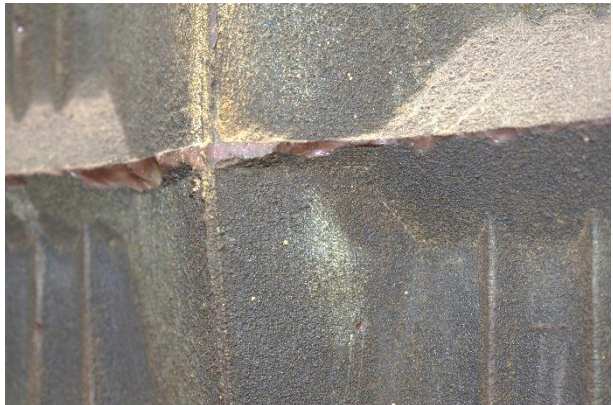
| Ditto. | |

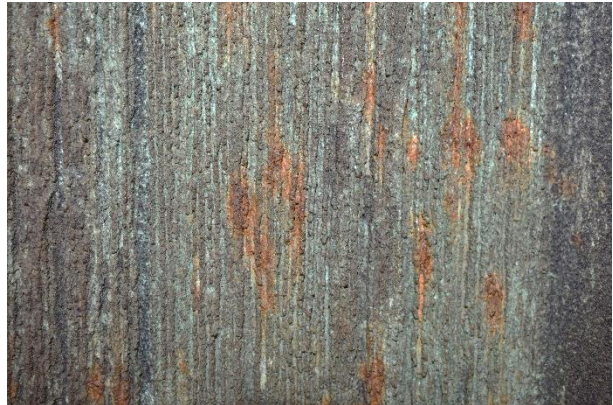
Brown staining formed by use of iron filings – used extensively over the mural panel.

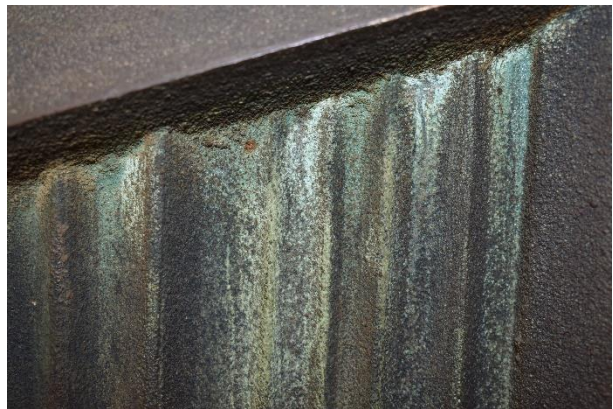
Variances in copper sulphate staining – from light to dark green colours are present.

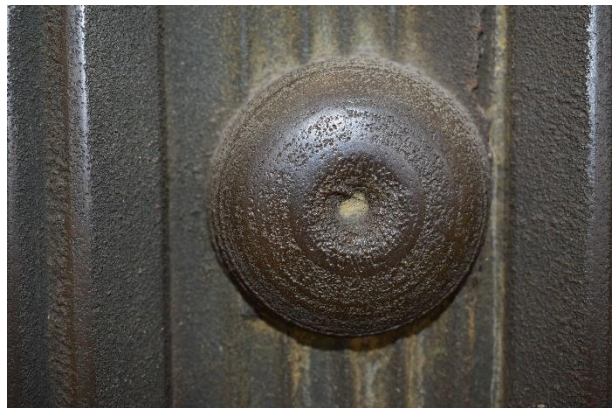
Little or no surface applied finishes and base bronze impregnated resin on show.

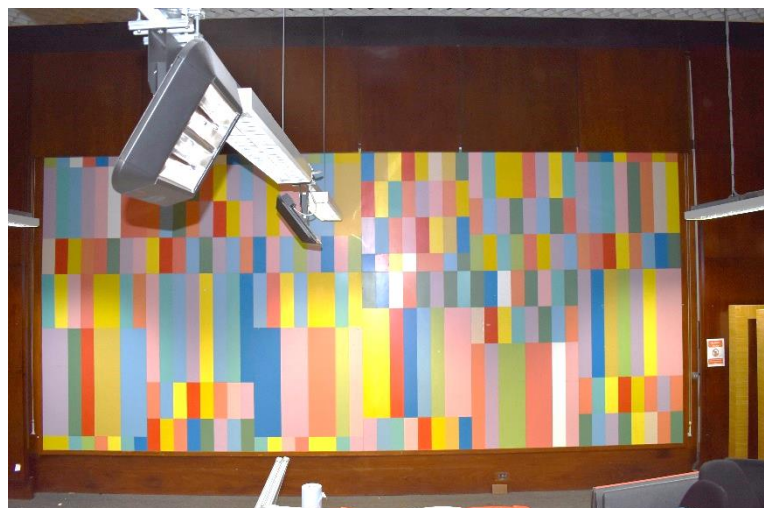
Mural panel as currently presented – the panel is surrounded by a series of dark coloured panels. The upper panels reduce the size of the mural significantly from its original installation.

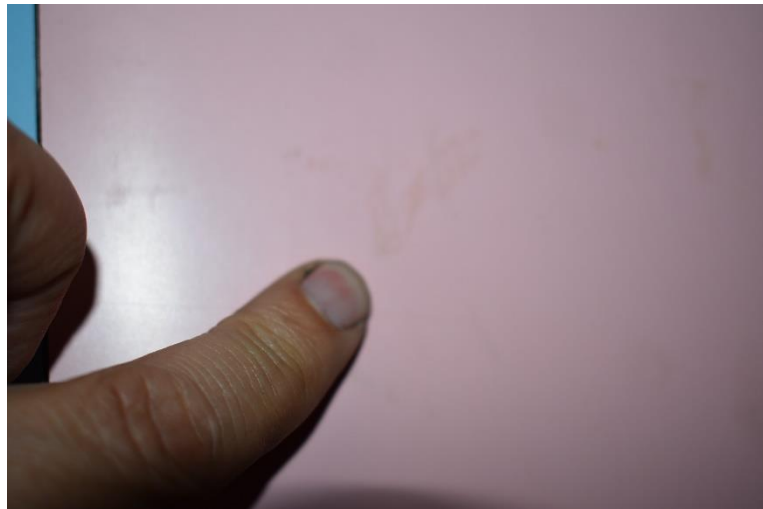
Dirt and surface marks to laminate panels. Each of the panels needs to be carefully cleaned.

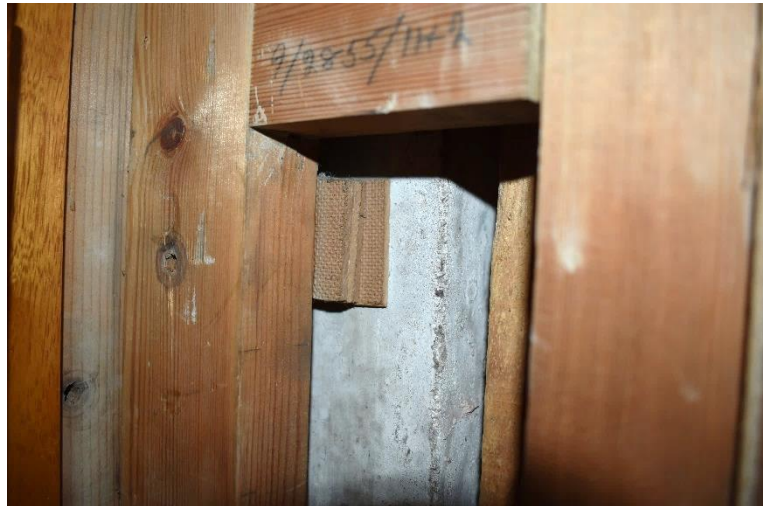
Timber 70 x 34mm framework to rear of the panels – assumed to be the same as for the mural panels.

Although the framework behind the mural panels may be similar to that of the main timber panels the number of gravity battens and their positions may differ as the bowing of the panels at the joint positions notes that the panels are unrestrained at this point. Careful removal of the later upper panels will be required to allow a full inspection of the mural panel and determine the exact fixing method.
