## CONDITION SURVEY

Premier Inn Manchester Airport (Heald Green)  
Hotel, Finney Lane, Heald Green, Cheadle  
SK8 3QH

31 March 2026

BSC03722

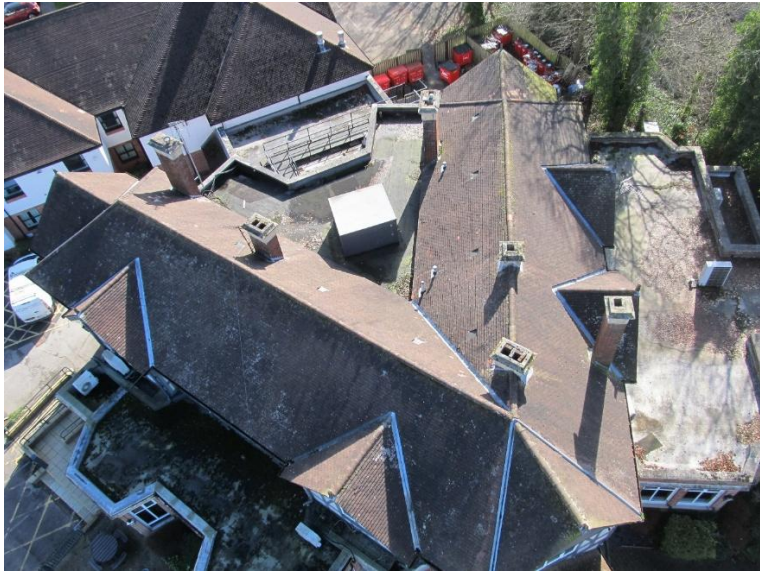
1. Aerial view of roofs from cherry picker basket – interconnected pitched roofs covered with clay tile and single storey flat roofed extensions.

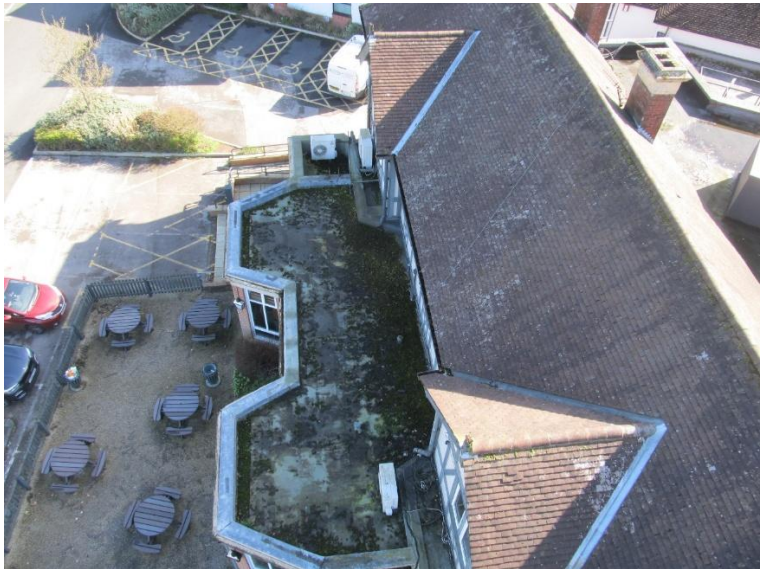
2. Main Pitched Roofs – front slope with dormer gable ends. Sheet lead used to weather the valleys.

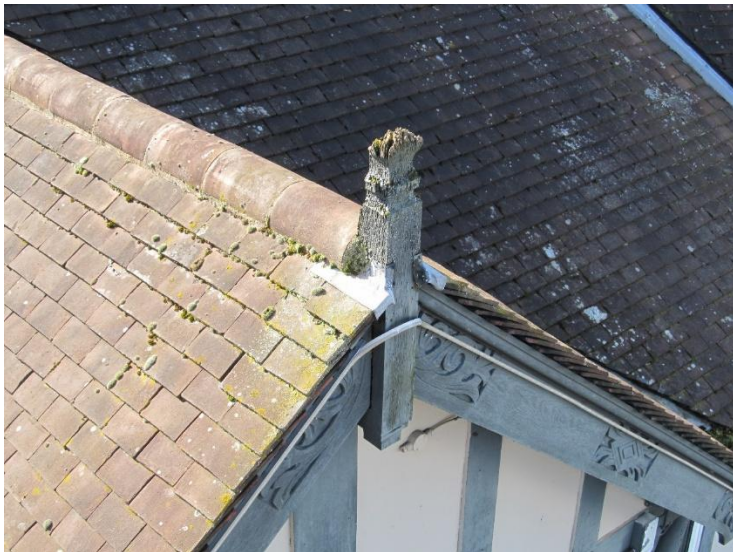
3. Main Pitched Roofs – projecting gable end, carved barge boards and oak finial; open tile verge detail, no mortar.

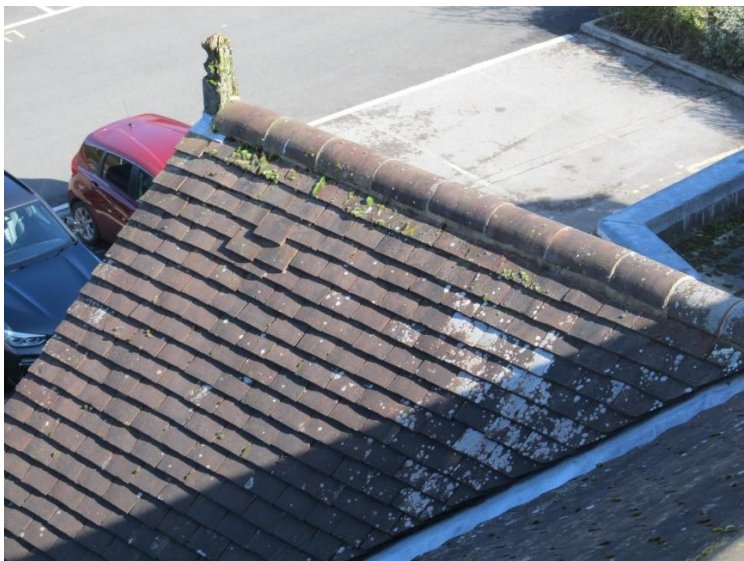
6. Main Pitched Roofs – typical example of slipped tiles to the entrance dormer and decay to the finial.

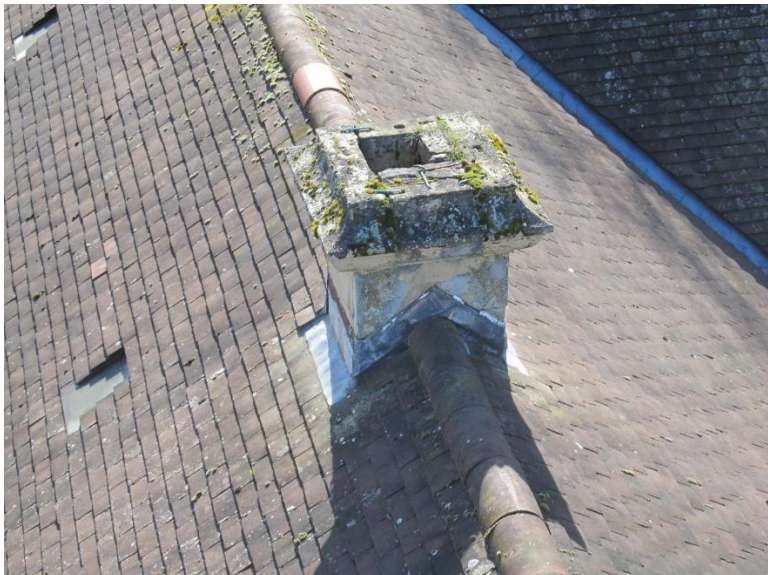
| 8. | Main Pitched Roofs – ridge and chimney stacks general arrangement. | |

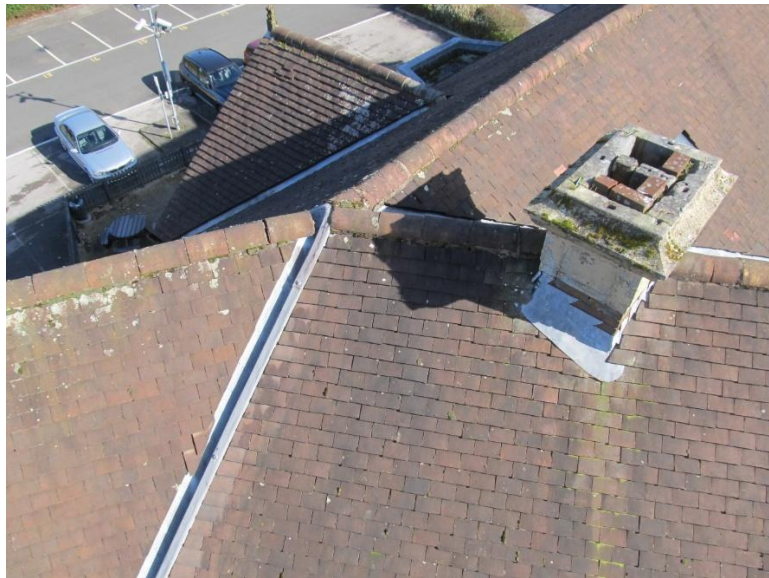
9. Main Pitched Roofs – intersection of ridge lines and example of valley gutter. Lead has been used to weather the valleys and base of the chimney stacks.

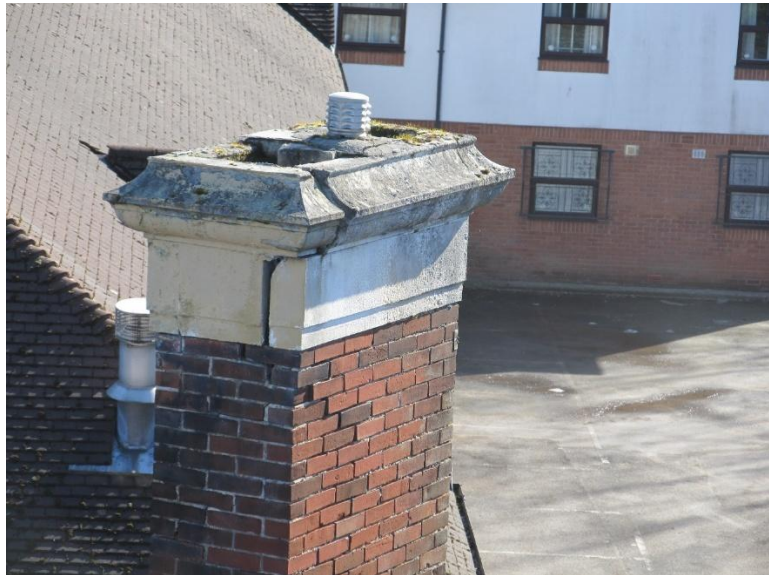
10. Main Pitched Roofs – structural movement to one of the tall stacks; the top course of ornate wet cast stone and the brickwork has moved significantly.

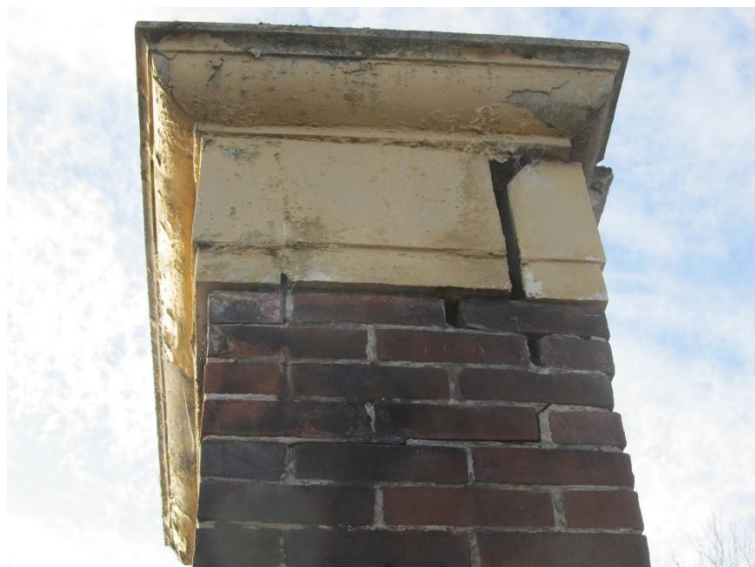
11. Main Pitched Roofs – this stack will need to be rebuilt.

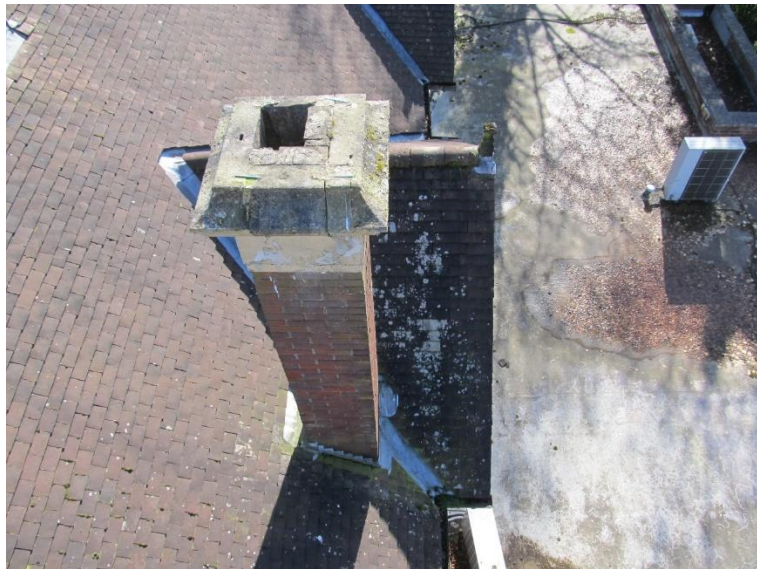
12. Main Pitched Roofs – cracking and open joints to the chimney stack heads which are open; there is no cowl or pot.

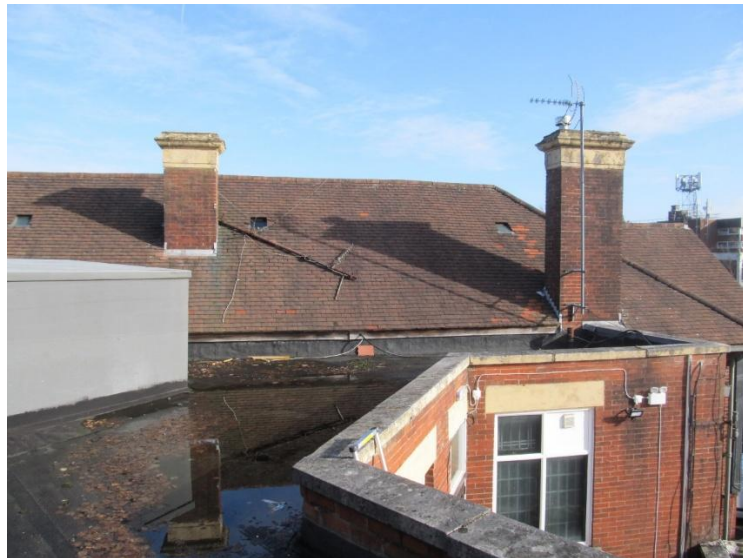
15. Main Pitched Roofs – general arrangement of slopes, stacks and rainwater disposal.

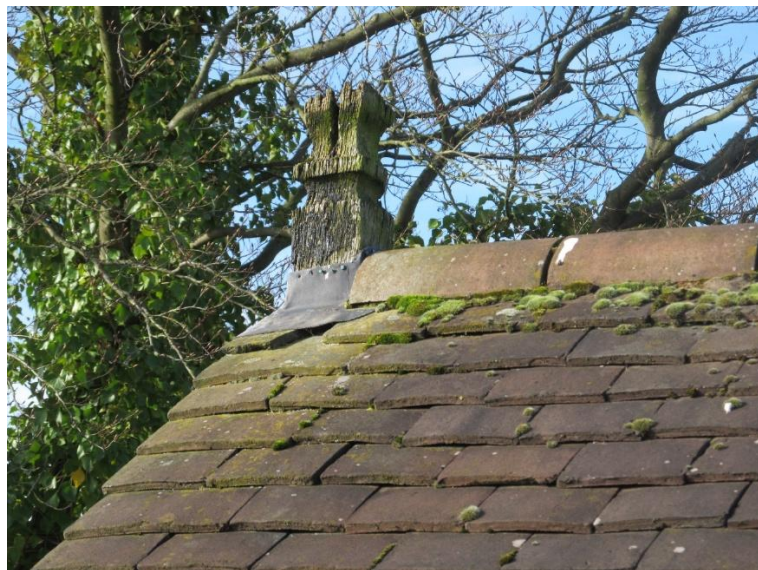
16. Main Pitched Roofs – reconstruction works required to the finial and re-bedding of half round clay ridge tiles.

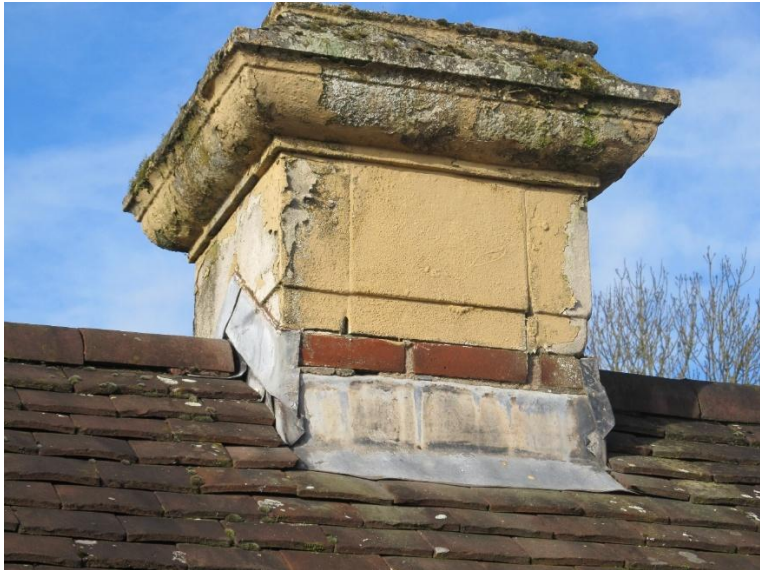
17. Main Pitched Roofs – short stacks to repoint, plus new coats of masonry paint

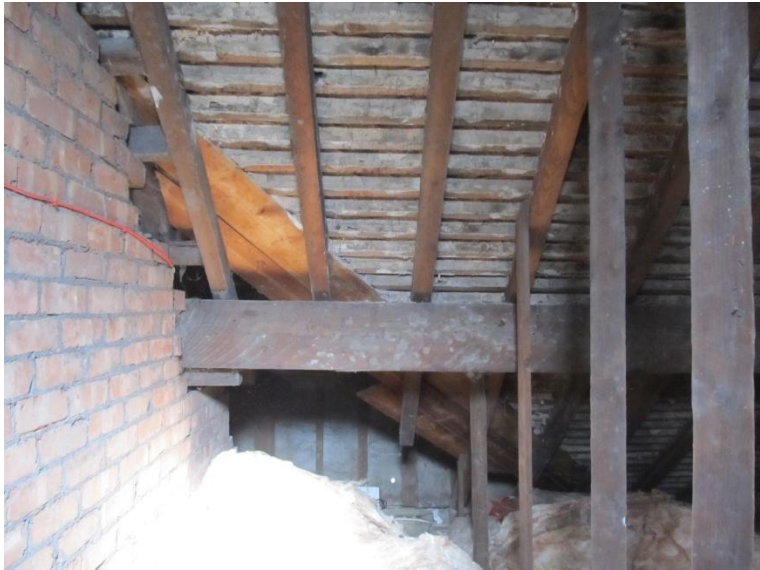
20. Main Pitched Roofs – attic space partially accessible from the First Floor Flat. Note original backpointing (lime mortar torching) to the tile and battens, and no underfelt.

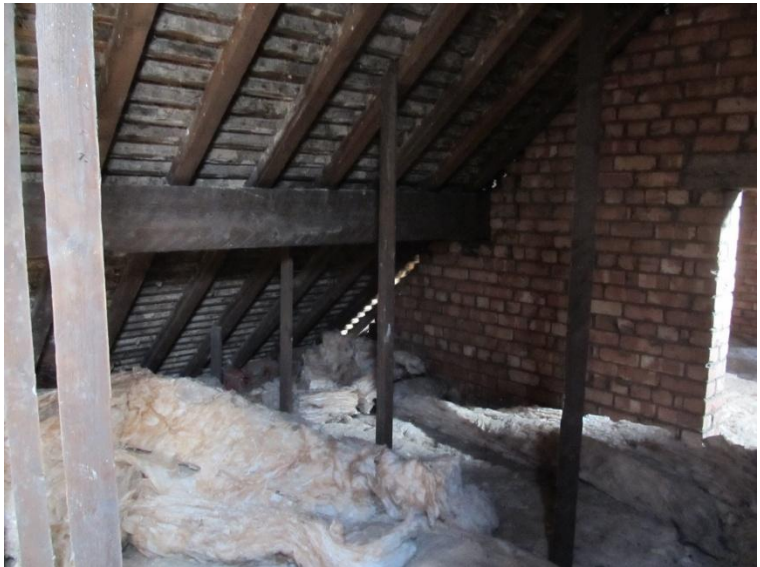
21. Main Pitched Roofs – timber structure comprising rafters and purlins.

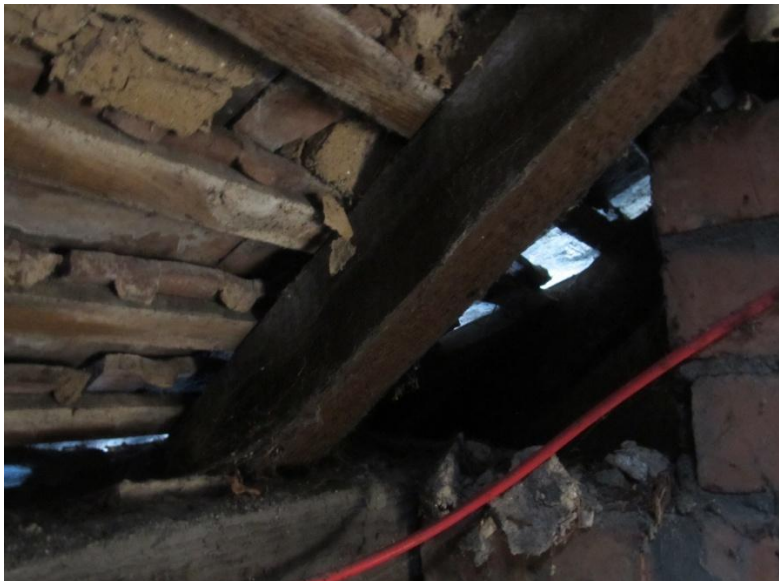
22. Main Pitched Roofs – close up photographs of back of tile and mortar torching to battens. Daylight visible in one of two locations.

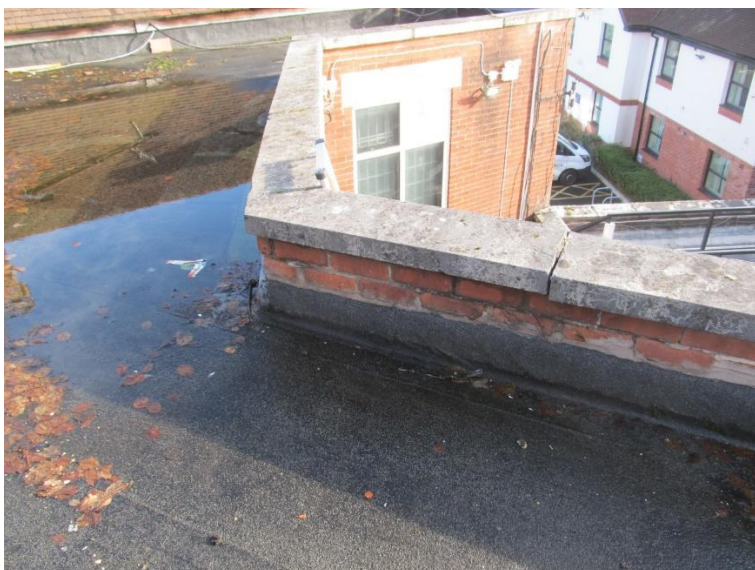
25. Rear (South-Eastern Corner) Flat Roof – bitumen felt covering with mineral cap sheet and upstand skirting to perimeter parapet wall.

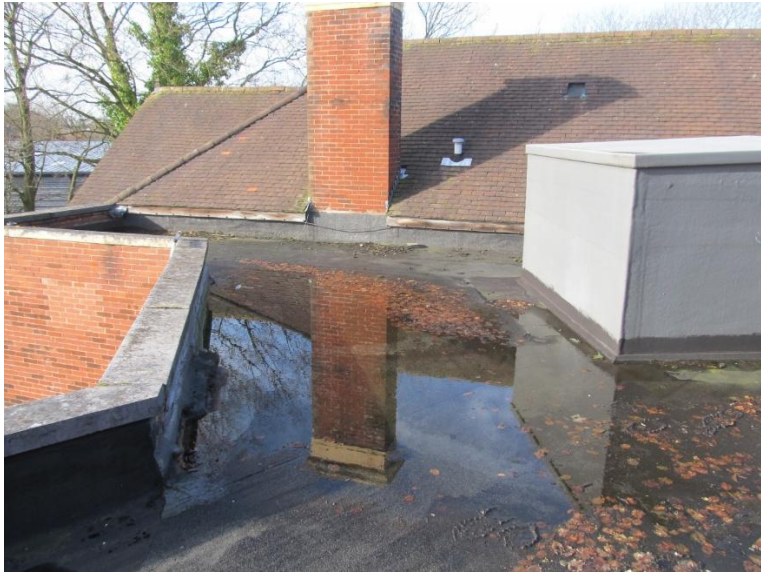
26. Rear (South-Eastern Corner)  
Flat Roof – ponding of  
rainwater where flat roof  
deck has dipped to the  
centre of the roof.

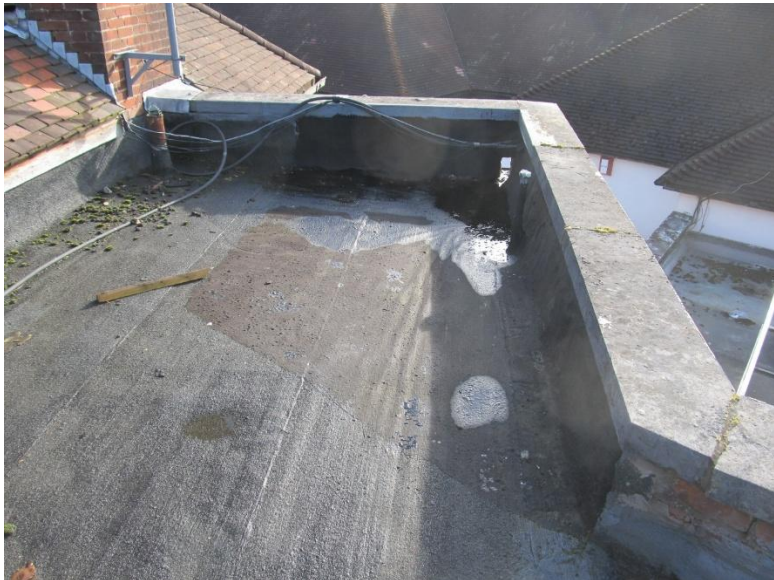
27. Rear (South-Eastern Corner)  
Flat Roof – drainage to either  
end where hoppers have  
been provided to an external  
rainwater pipe.

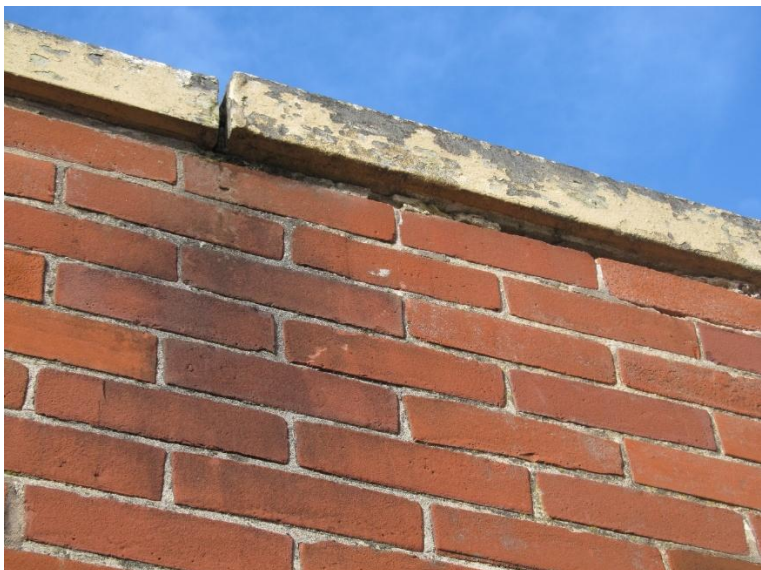
28. Rear (South-Eastern Corner)  
Flat Roof – example of  
movement to the precast  
concrete / wet cast stone  
coping.

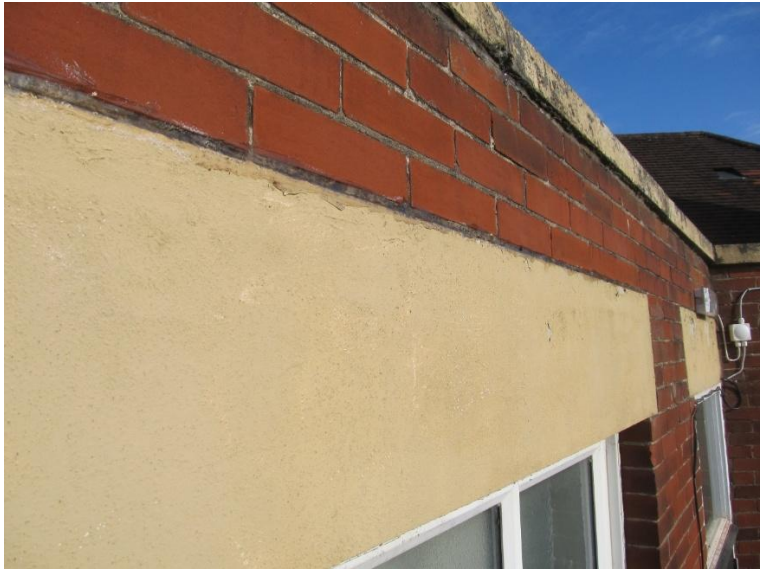
29. Rear (South-Eastern Corner)  
Flat Roof – outer face of  
parapet wall. Silicone has  
been gunned into the joint  
above the lintel, suggesting  
an ongoing issue with  
rainwater ingress.

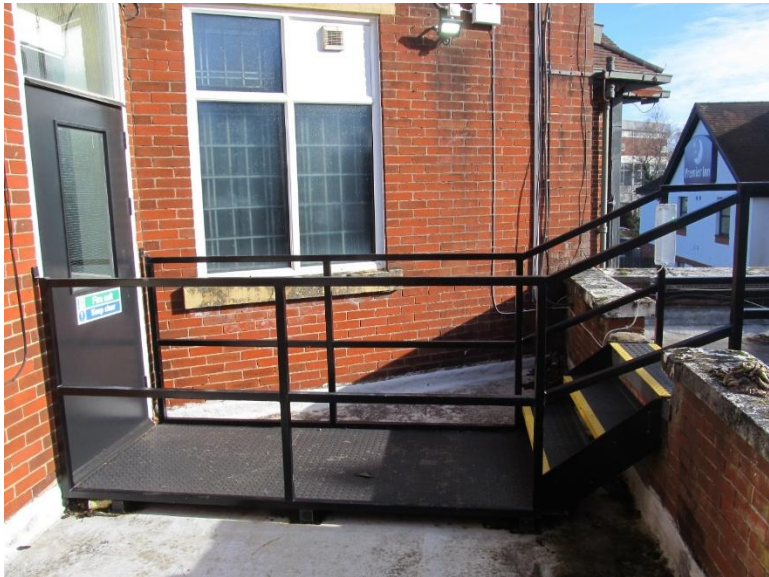
30. Flat Roof and Secondary  
Means of Escape from First  
Floor Bedrooms – general  
arrangement.

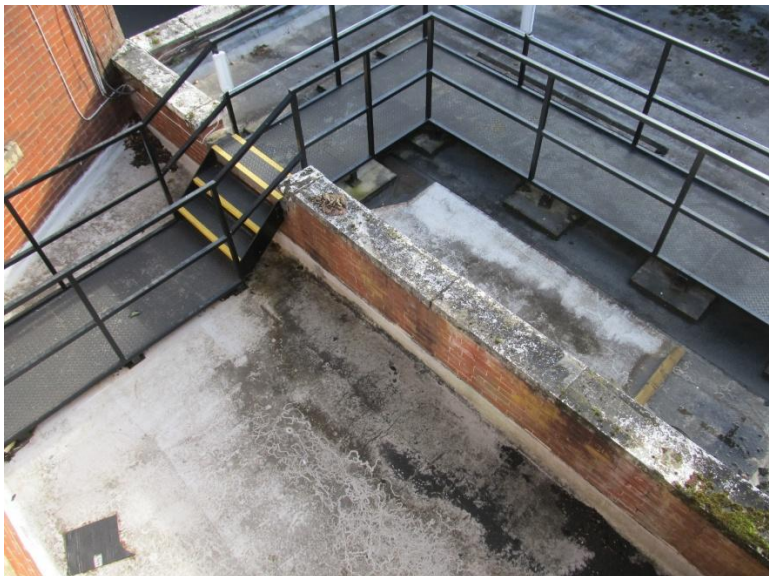
31. Flat Roof and Secondary  
Means of Escape from First  
Floor Bedrooms – the lower  
level flat roof covering has  
been overpainted.

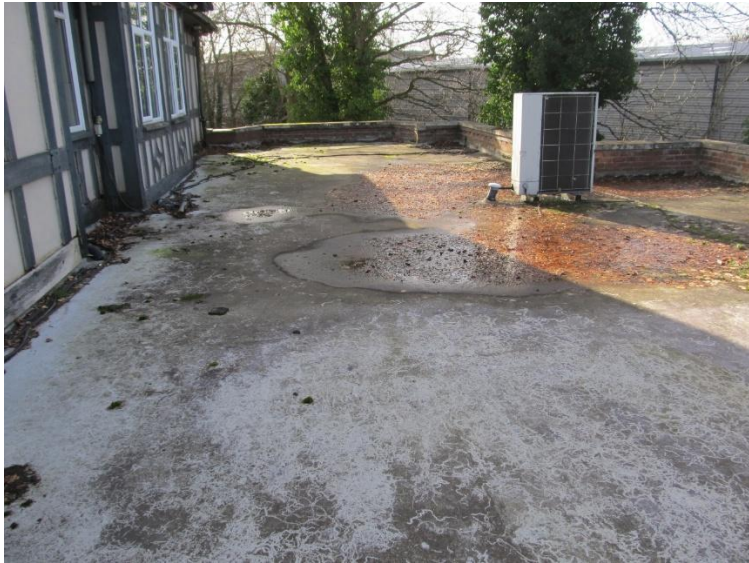
35. Rear (Western) Large Flat roof over Dining Room – general arrangement. Note ponding of rainwater to the centre of the roof where this has dipped.

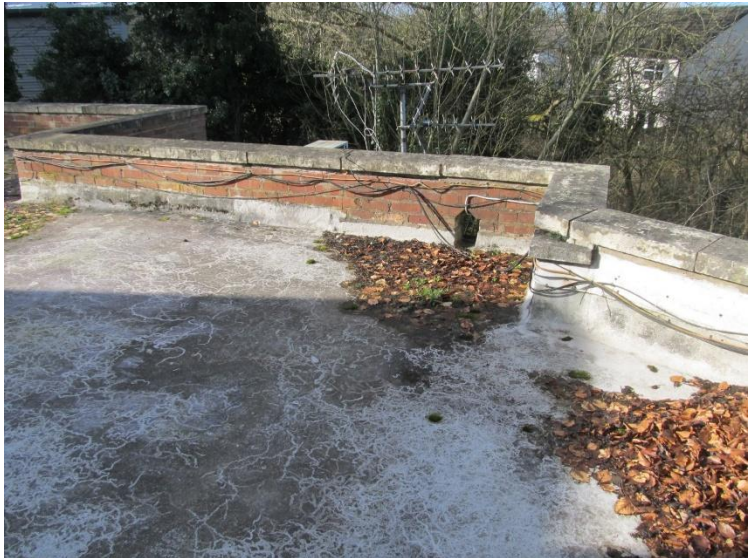
36. Rear (Western) Large Flat roof over Dining Room – arrangement of perimeter parapet

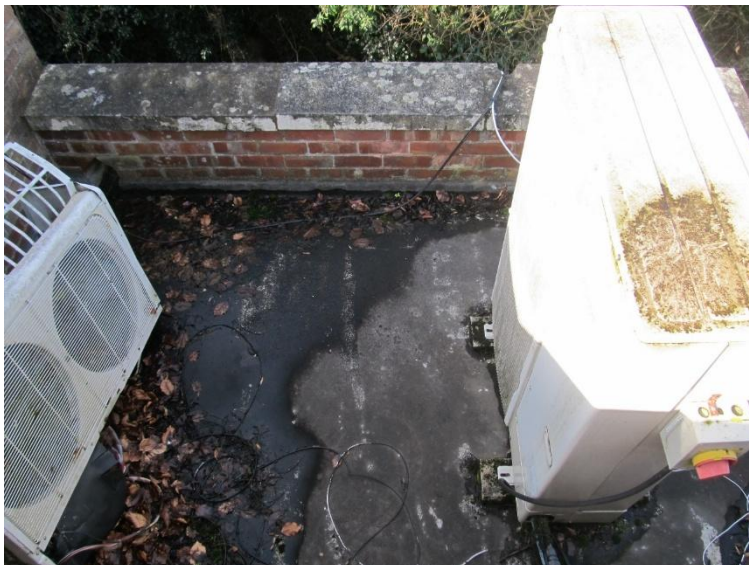
37. Rear (Western) Large Flat roof over Dining Room – split DX condensers to lower level roofs.

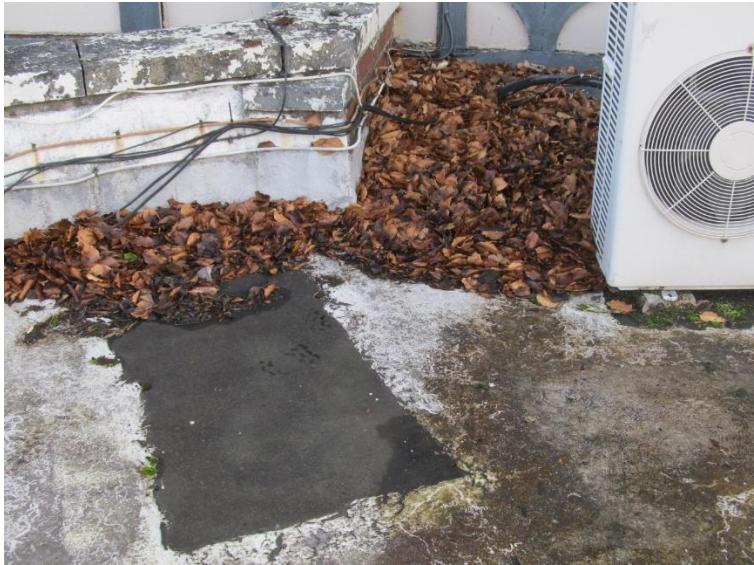
38. Rear (Western) Large Flat roof over Dining Room – build up of tree litter and leaves. Obvious patch repairs to the membrane.

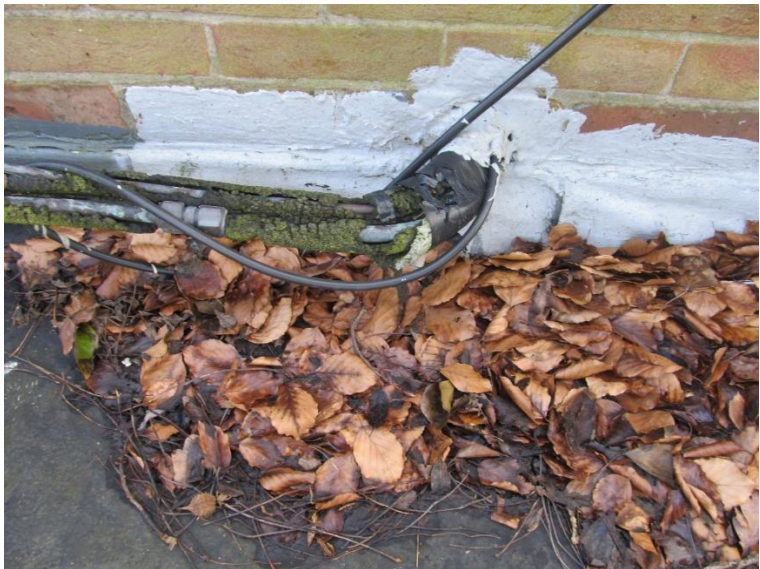
39. Rear (Western) Large Flat roof over Dining Room – poorly weathered fridge pipe penetration.

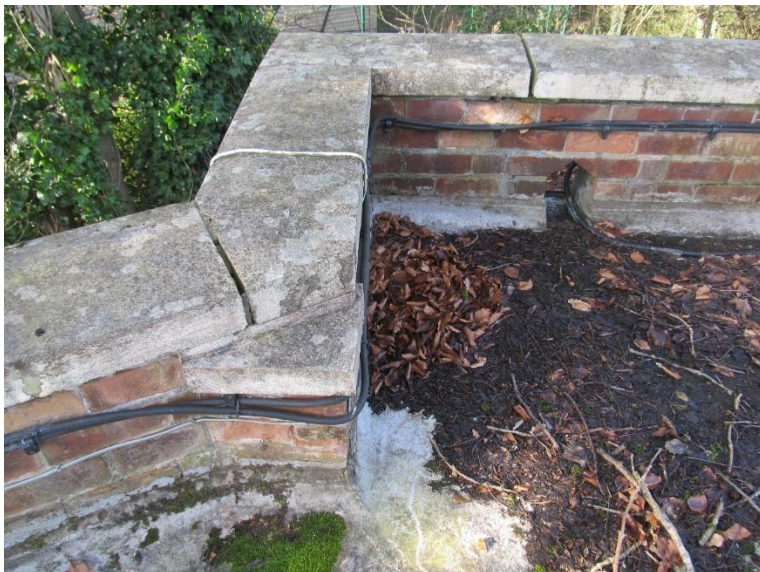
40. Rear (Western) Large Flat roof over Dining Room – gapping to coping stones.

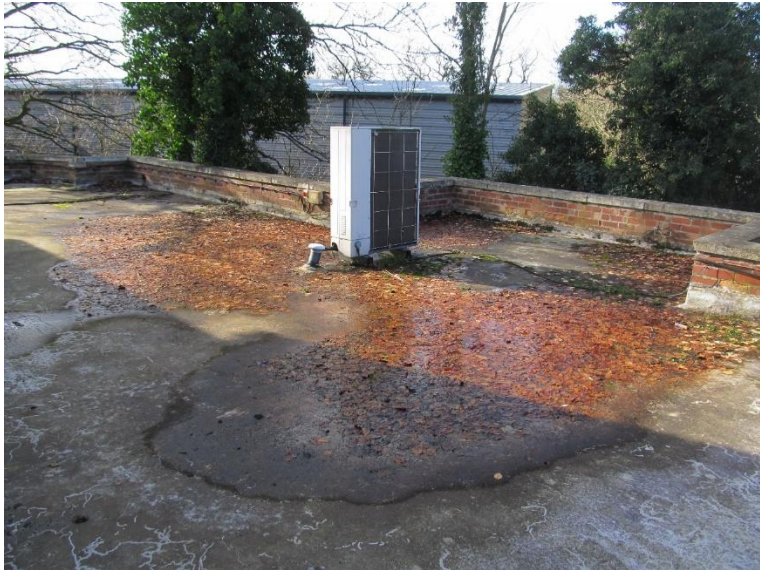
41. Rear (Western) Large Flat roof over Dining Room – ponding of rainwater where the flat roof has dipped.

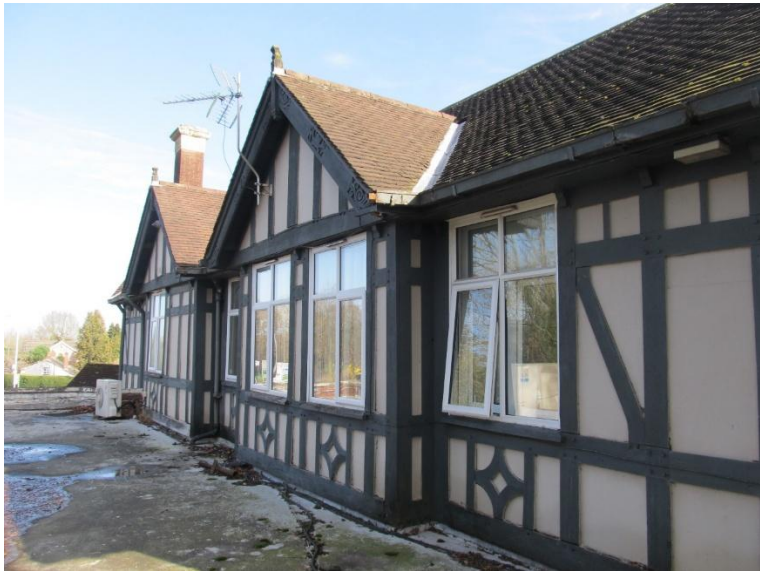
48. Rear (Western) Large Flat roof over Dining Room and Elevation to First Floor Bedrooms – faux Tudor black and white elevation.

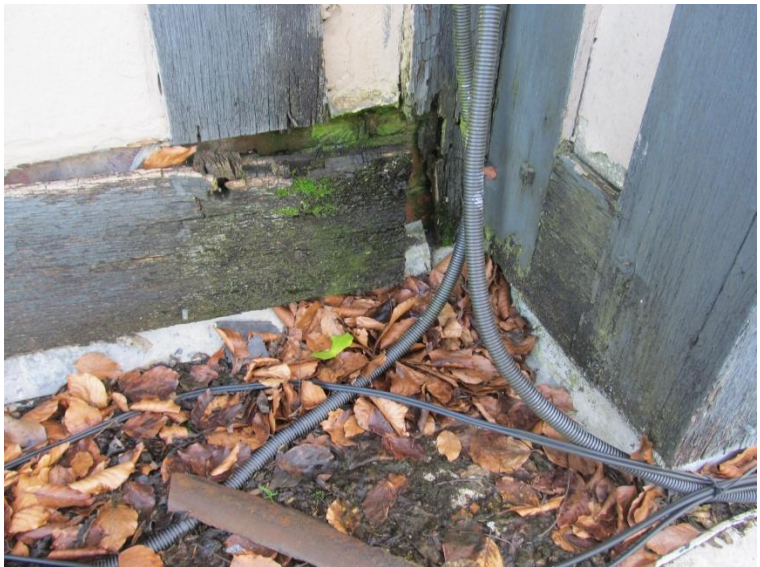
49. Rear (Western) Large Flat roof over Dining Room and Elevation to First Floor Bedrooms – example of decay and deterioration to planted on timber boards.

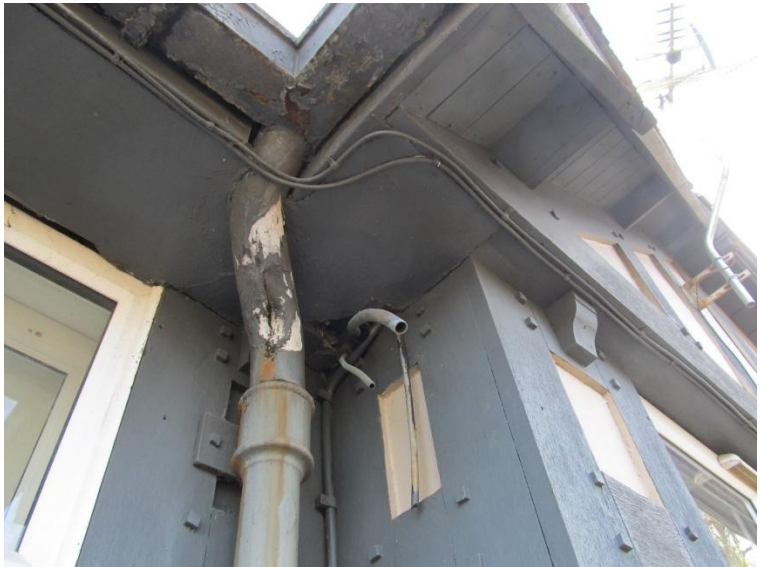
51. Rear (Western) Large Flat roof over Dining Room and Elevation to First Floor Bedrooms – split to downpipe and corrosion at joint with guttering.

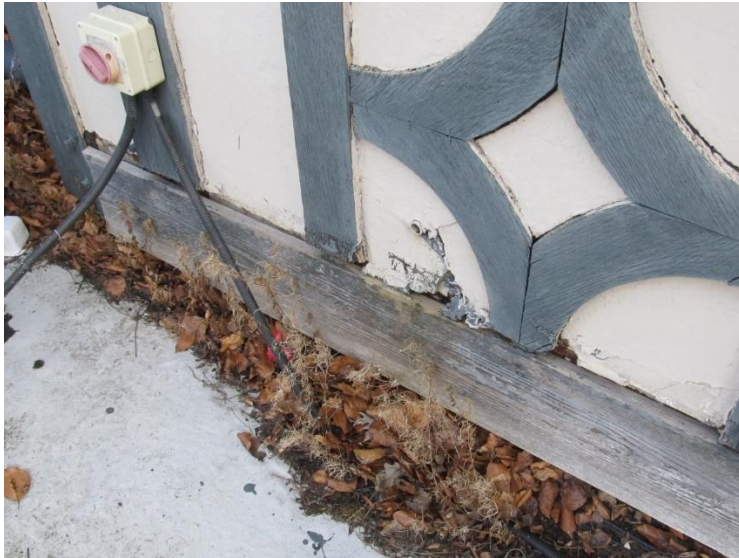
56. Rear (Western) Large Flat roof over Dining Room and Elevation to First Floor Bedrooms – further examples of deterioration to the boarding and panels of painted rendering.

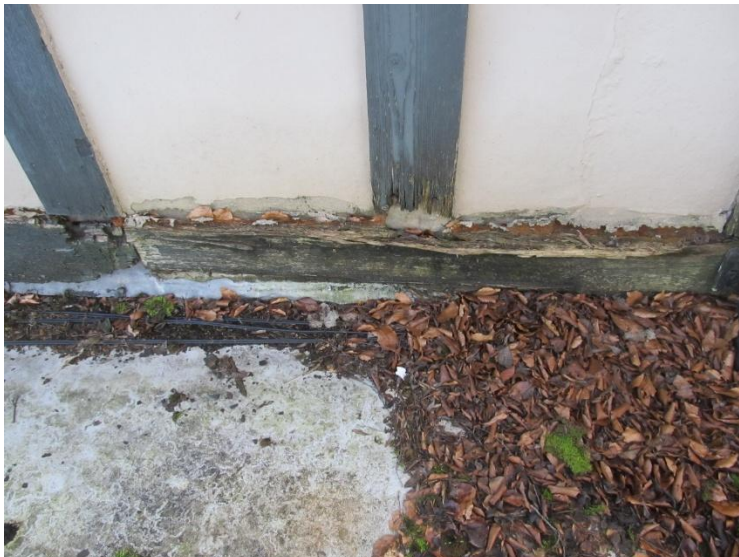
57. Rear (Western) Large Flat roof over Dining Room and Elevation to First Floor Bedrooms – as above; decay to planted on decorative timber panelling.

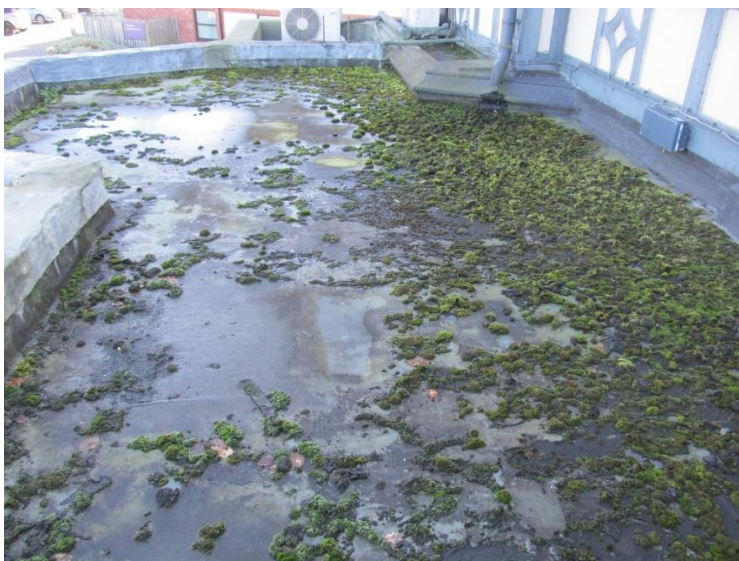
58. Front Flat Roof – notably “spongy” underfoot. A provisional sum will need to be set aside for timber deck repairs.

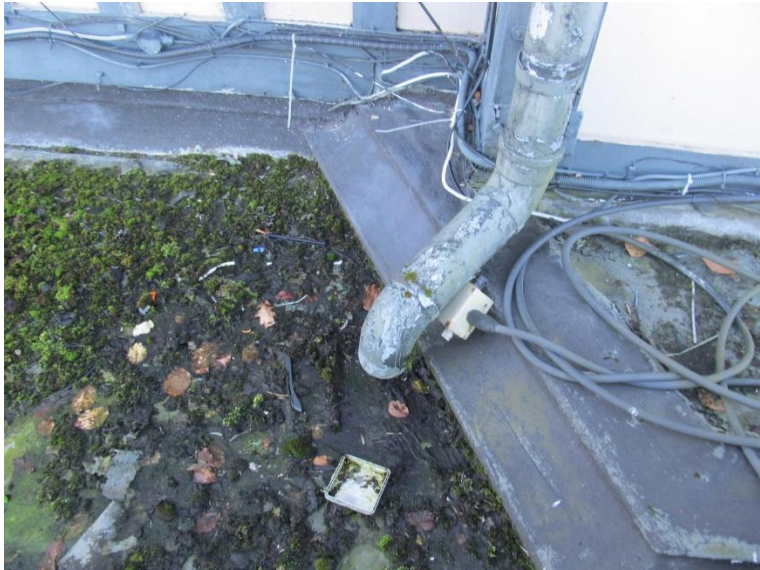
59. Front Flat Roof – significant build-up of silt and mosses due to poor drainage.

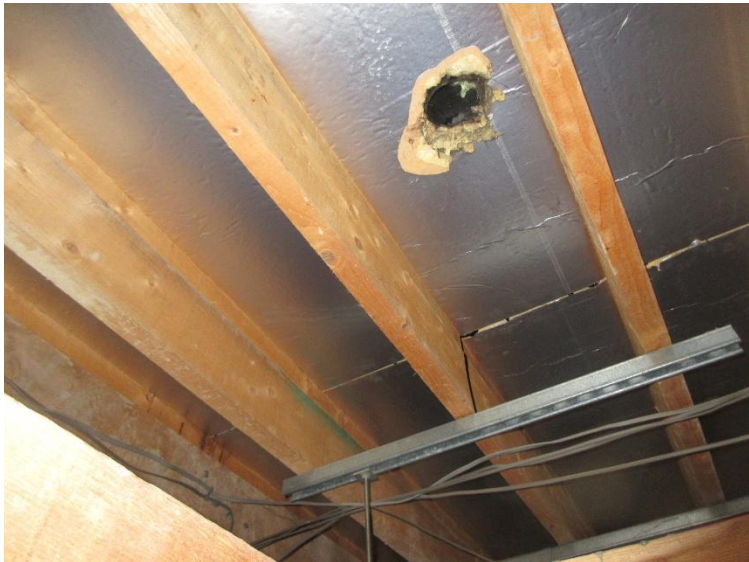
60. Front Flat Roof – timber joist and insulation board visible within ceiling void. The deck was noticeably spongy (deflecting) underfoot.

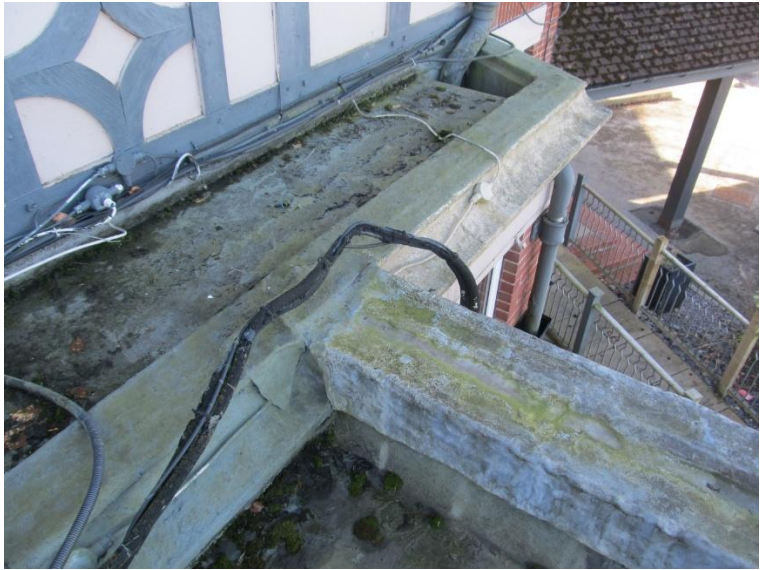
62. Front Flat Roof – leadwork dressed to parapets.

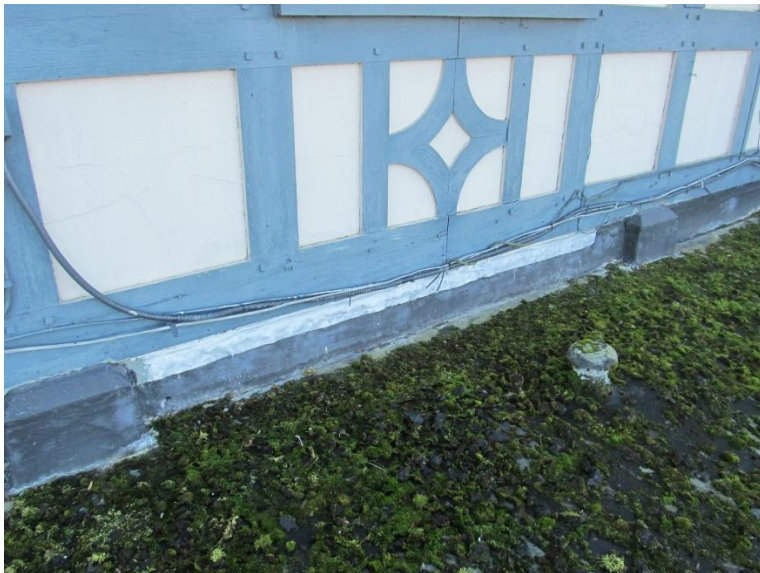
63. Front Flat Roof – skirting and upstand detail to base of Front Elevation.

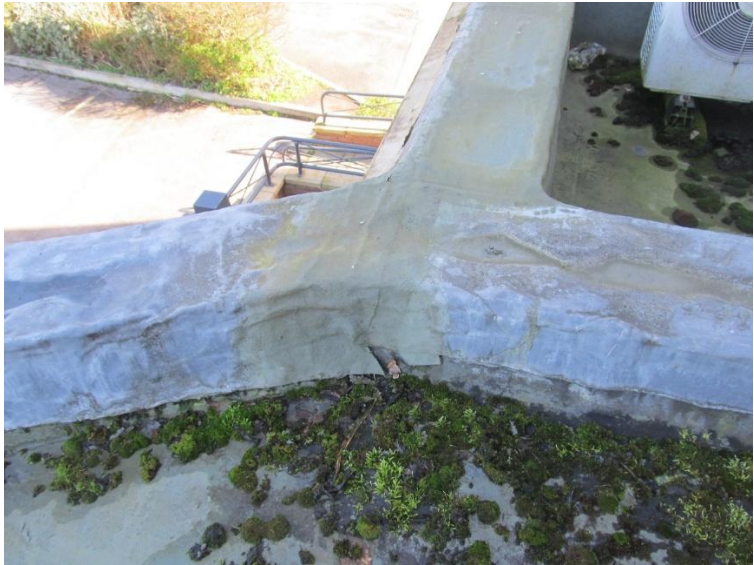
65. Front Flat Roof – example of temporary patch repair to the lead capping where this has split .

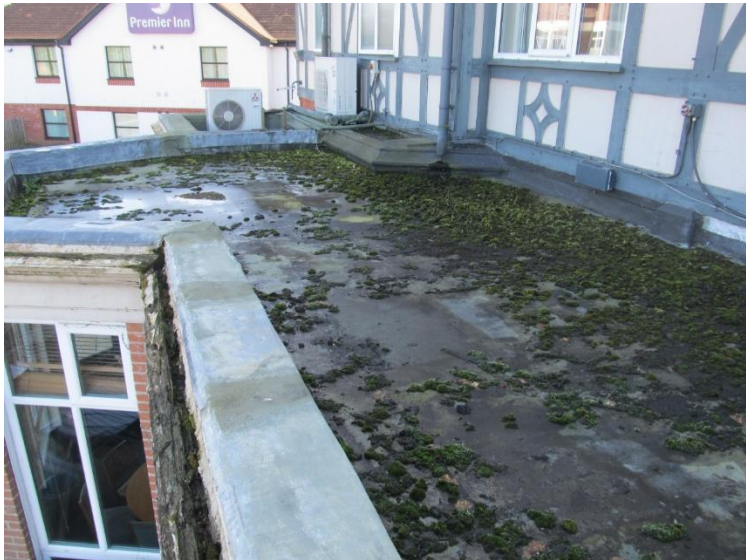
| 69. | Front Flat Roof – as above. | |

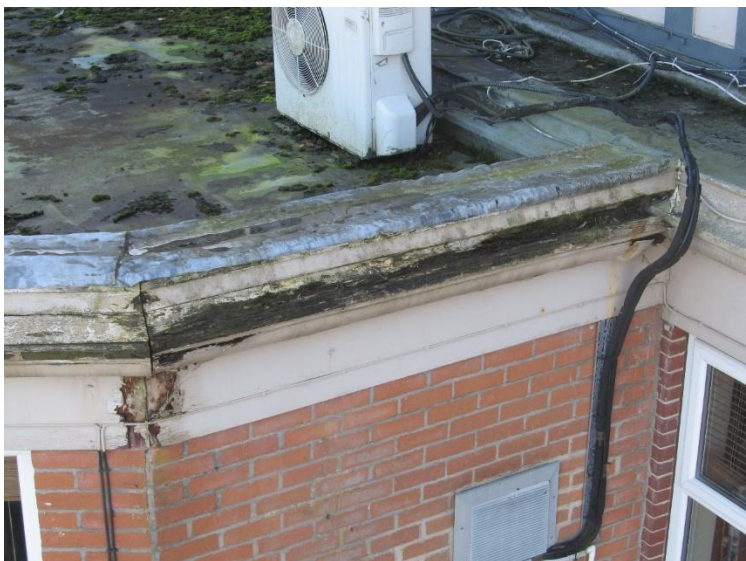
| 70. | Front Flat Roof – as above. | |

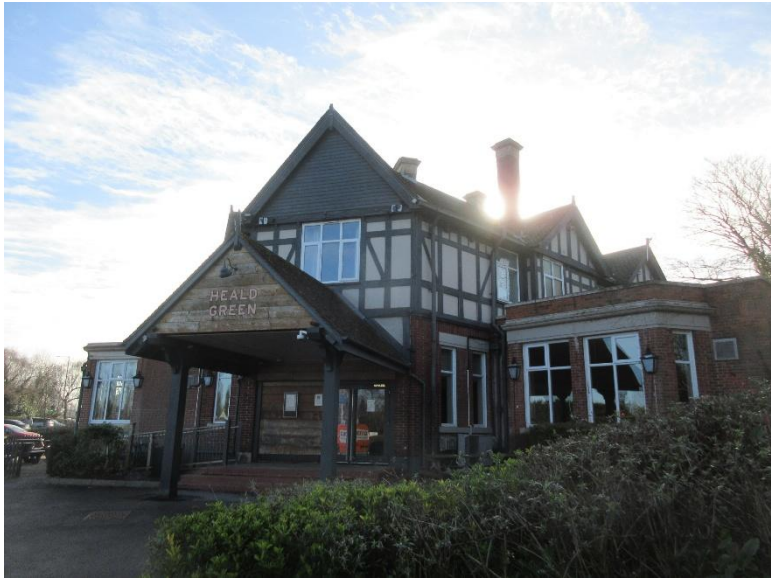
71. Entrance to the northwest corner of the building.

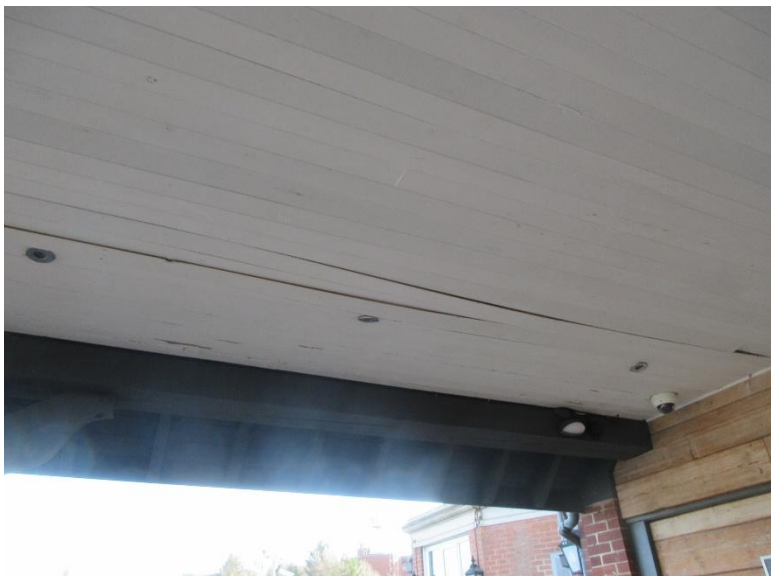
73. Timber boarding hanging down to the entrance canopy soffit.

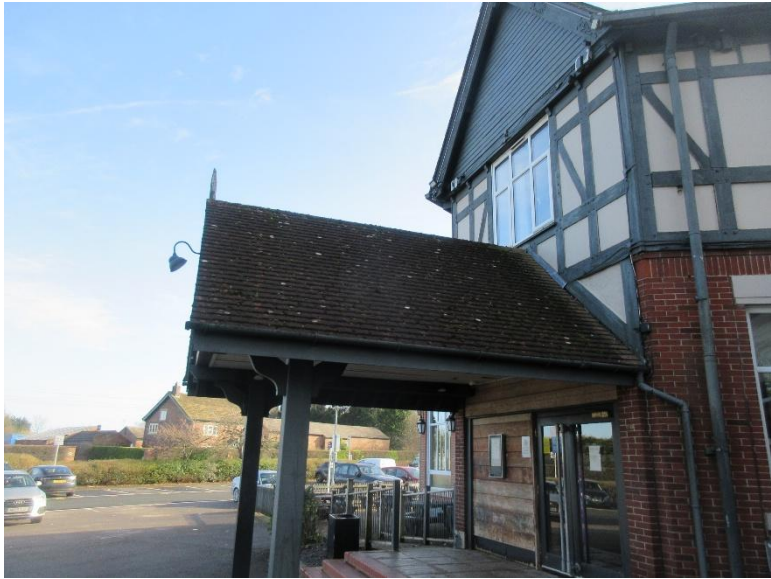
| 74. | Moss growth to the entrance canopy roof. | |

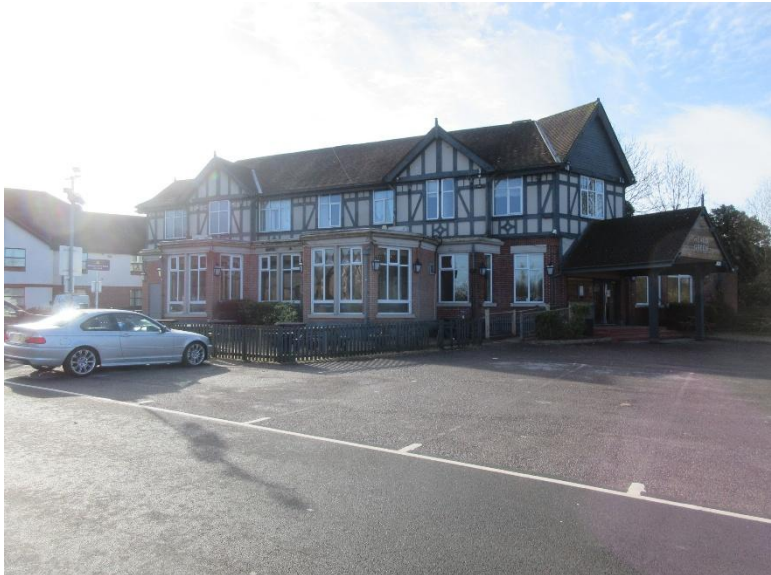
| 75. | North Elevation. | |

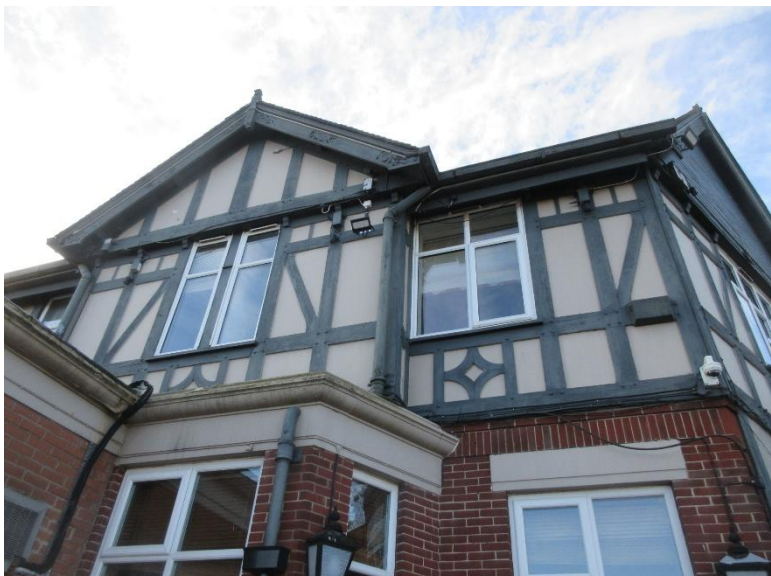
| 76. | North Elevation – painted render and joinery at First Floor level. | |

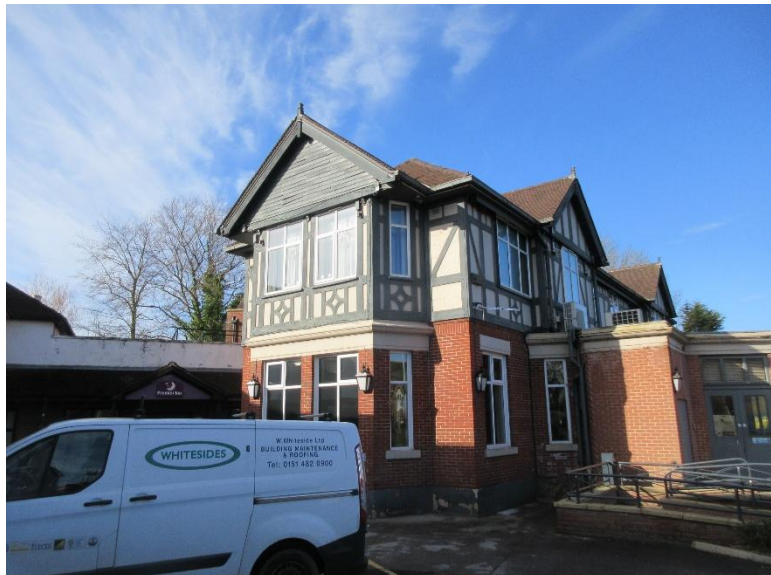
| 81. | East Elevation. | |

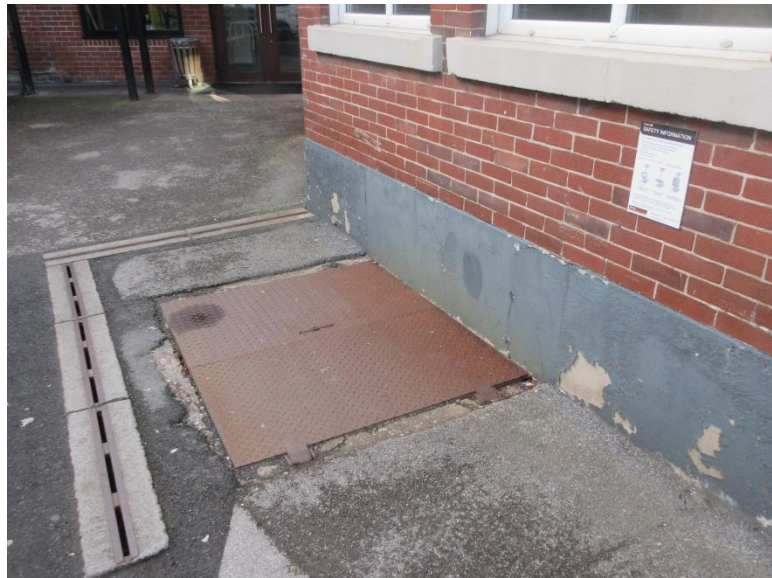
83. East Elevation – cellar barrel drop point and further peeling paint finishes to the low-level masonry.

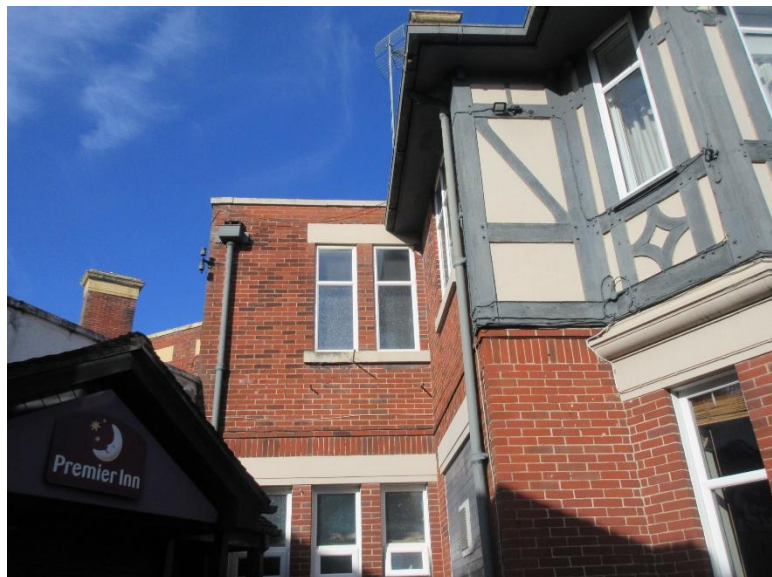
84. East Elevation adjacent to the hotel entrance.
