## CONDITION SURVEY

Premier Inn Manchester Airport (Heald Green)  
Hotel, Finney Lane, Heald Green, Cheadle  
SK8 3QH

31 March 2026

BSC03722

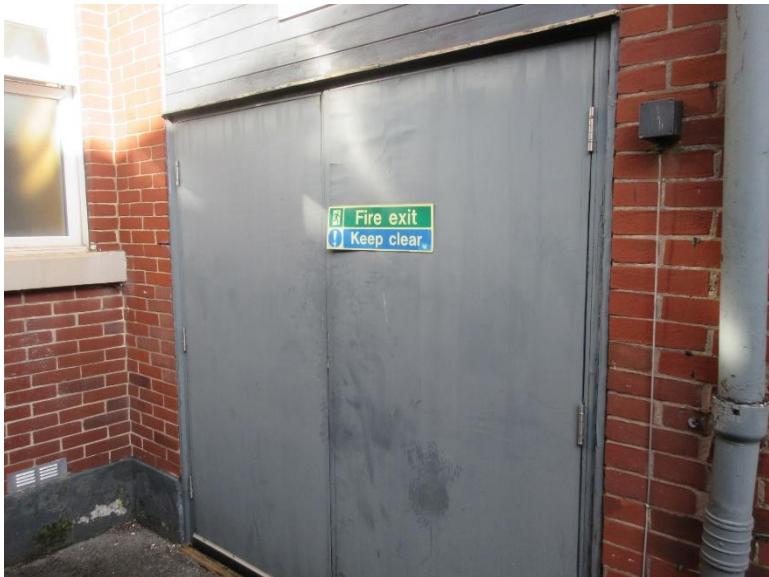
87. East Elevation – warping and splitting to the outer face of the RHS timber door.

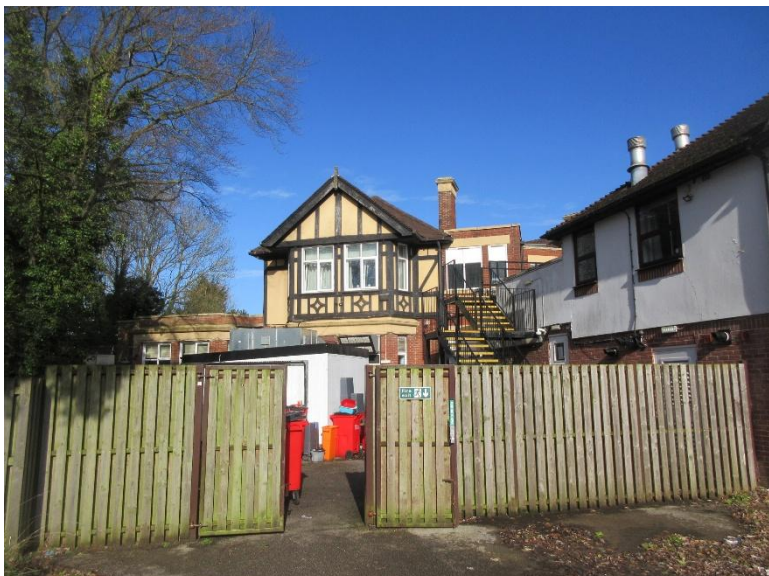
88. South Elevation.

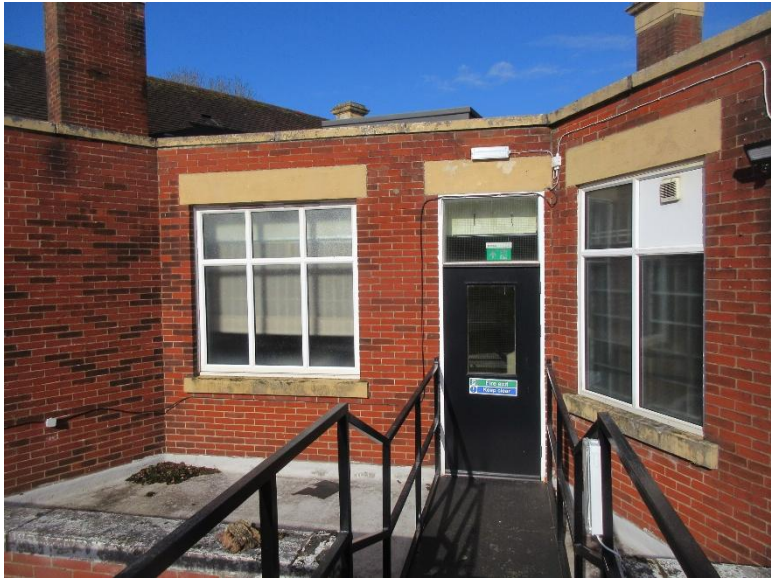
89. South Elevation at high level.

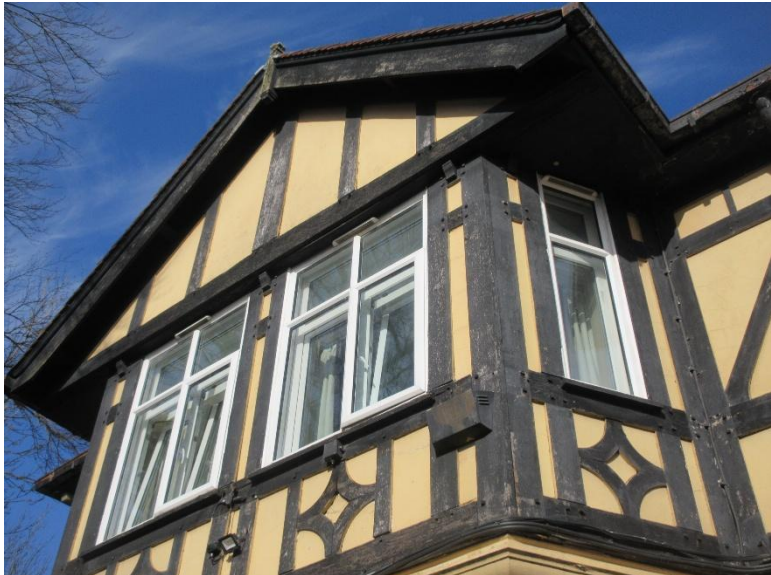
93. South Elevation – cyclical redecoration is now due.

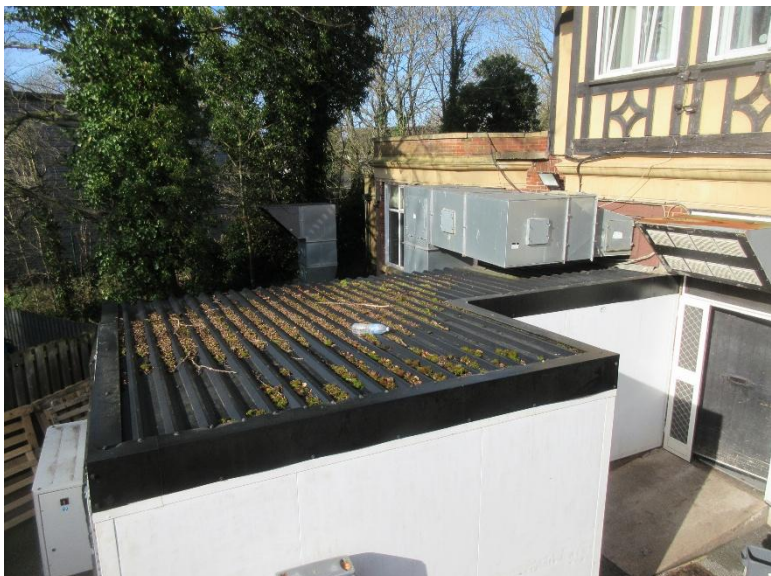
94. South Elevation – walk in fridge and ductwork adjoining the elevation.

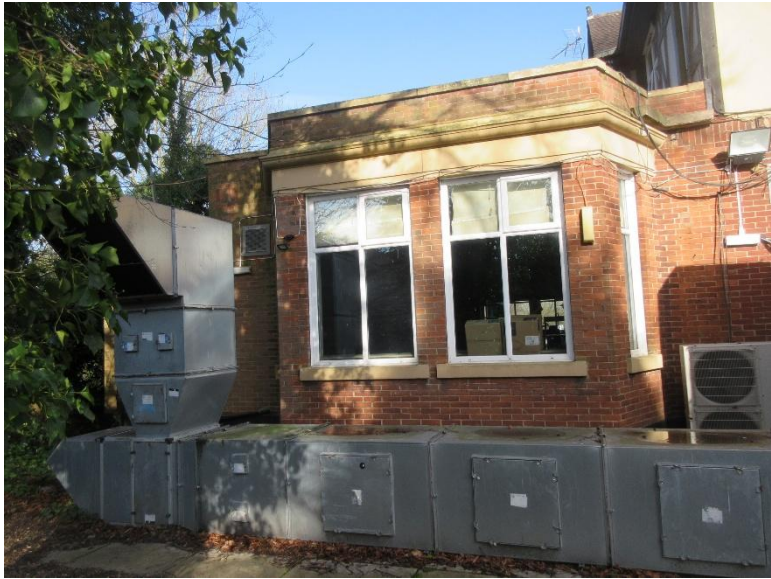
95. South Elevation – single storey bay window.

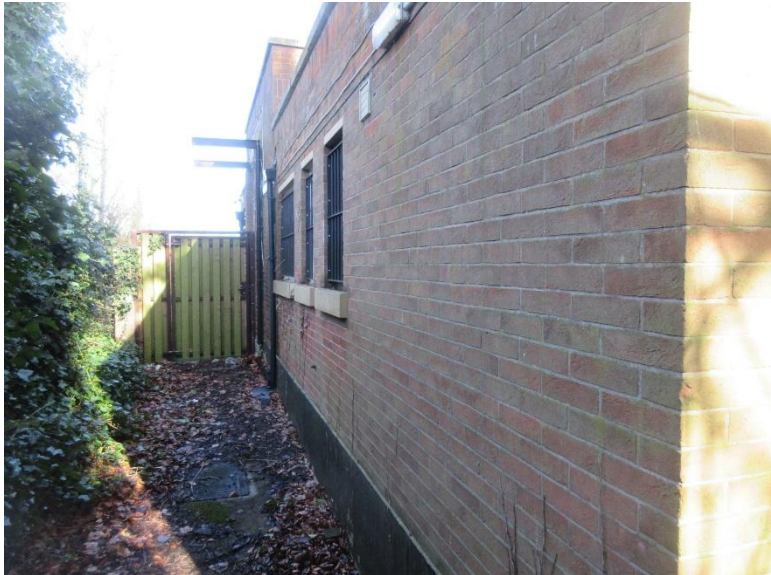
96. West Elevation.

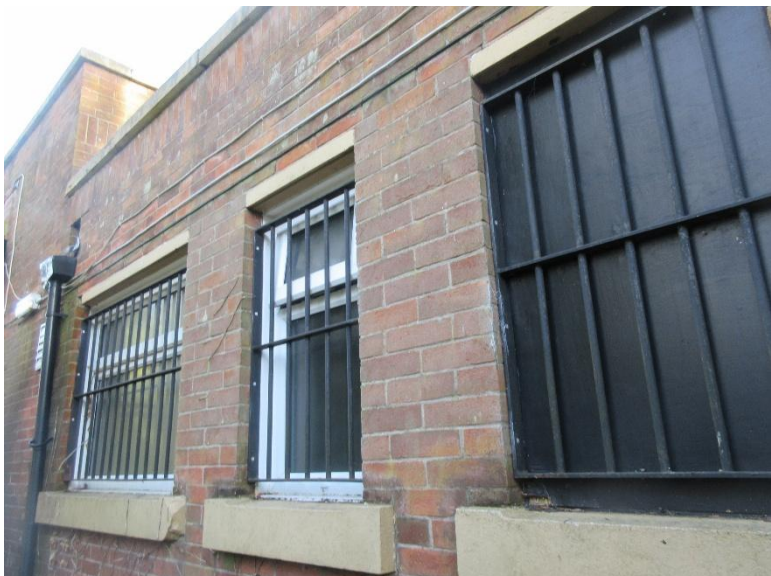
97. West Elevation – window bars in place.

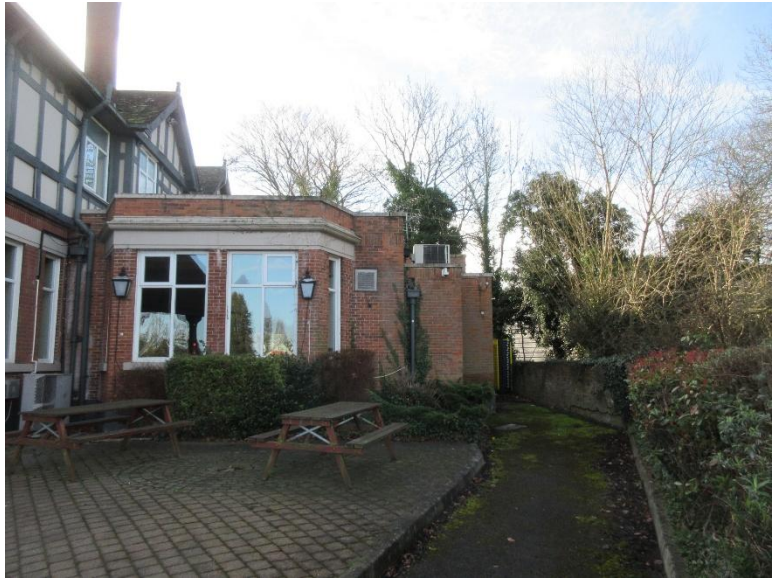
101. West Elevation – bay window to the single storey return with ivy growth to the RHS.

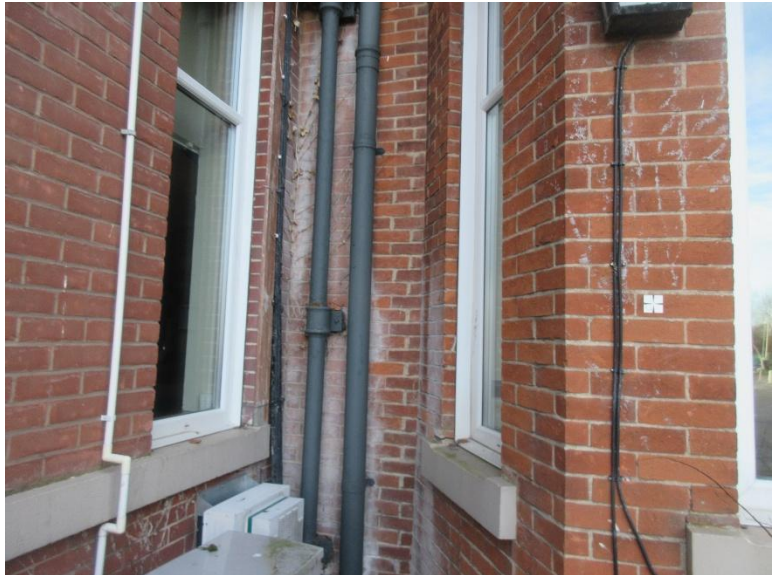
102. West Elevation – efflorescence adjacent to the downpipes.

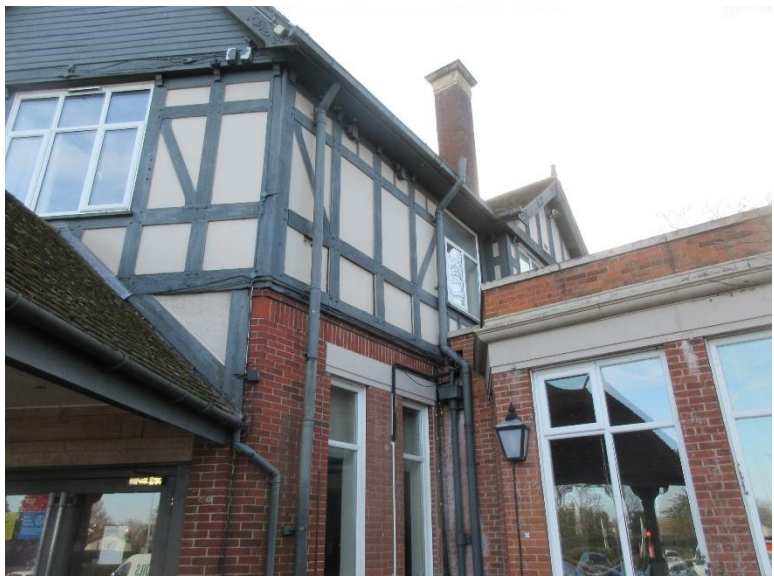
103. West Elevation – there is an indentation / hole to the render adjacent to the LHS downpipe and the timber cladding has come away from the wall at low level.

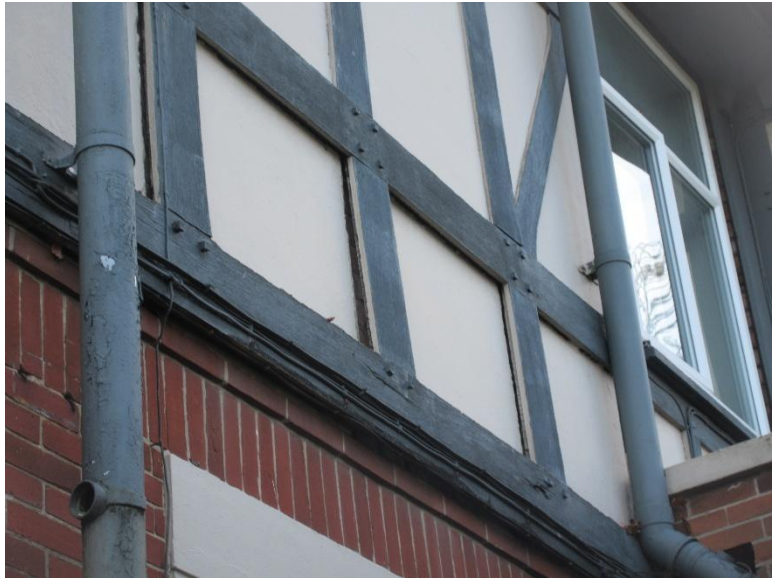
104. West Elevation – timber cladding coming away from the brickwork substrate.

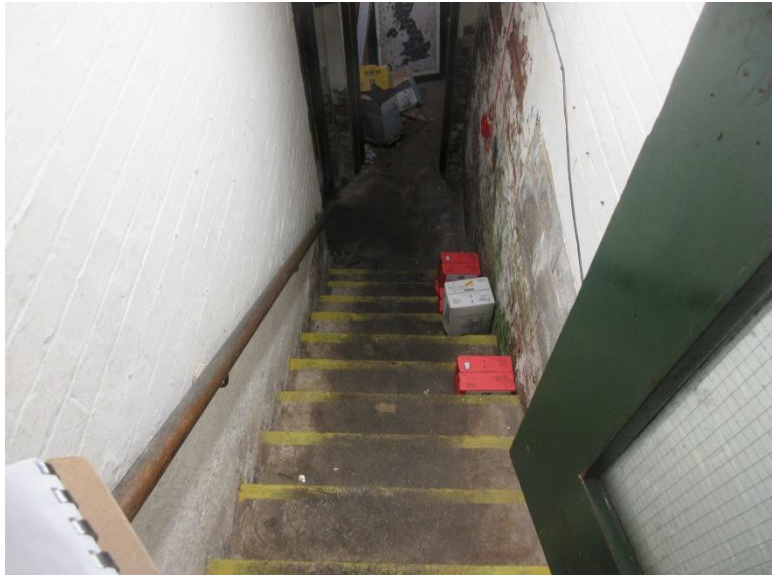
105. Steps leading to the cellar.

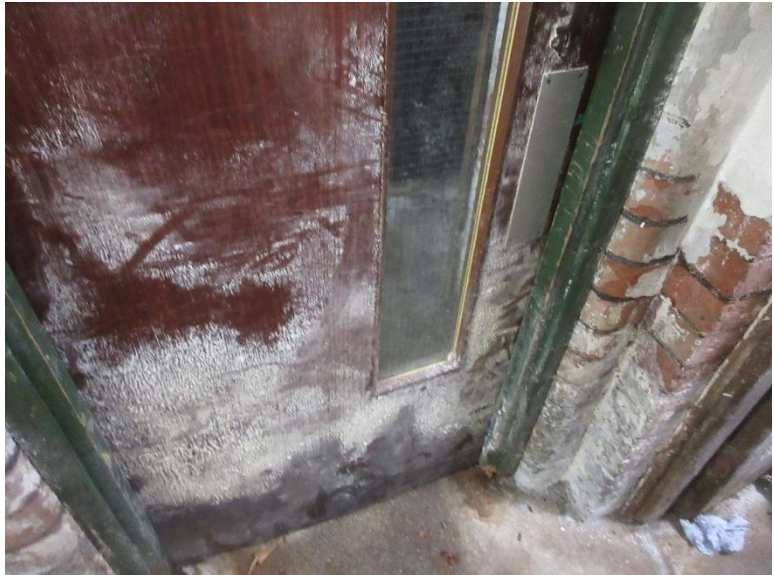
108. Cellar – typical example of mould growth to surfaces.

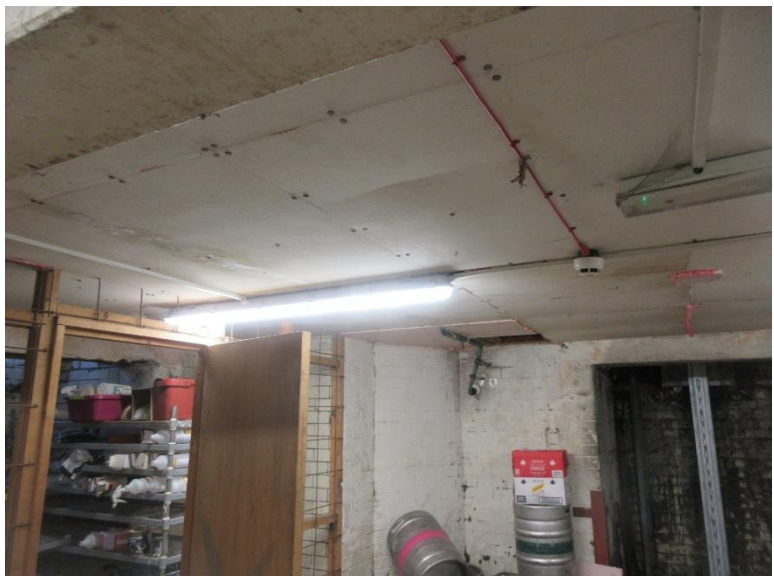
109. Cellar – boarding in place to the Ground Floor soffit in part.

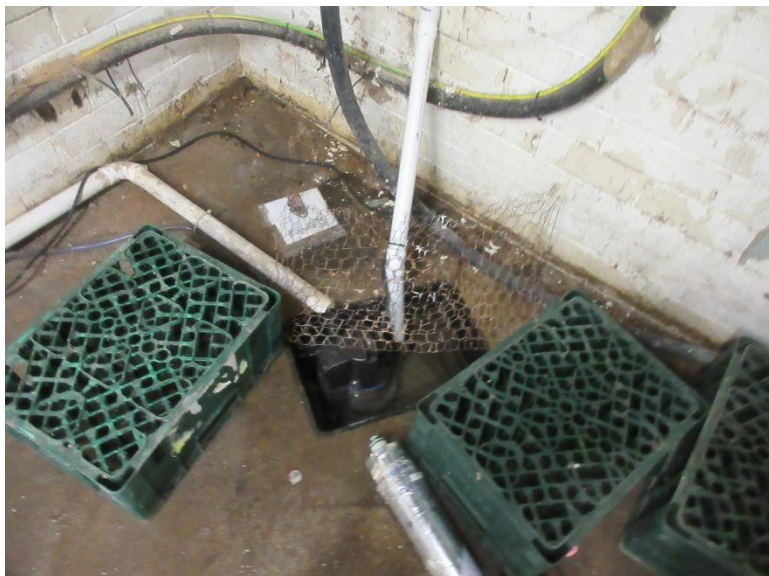
112. Cellar – sump pump.

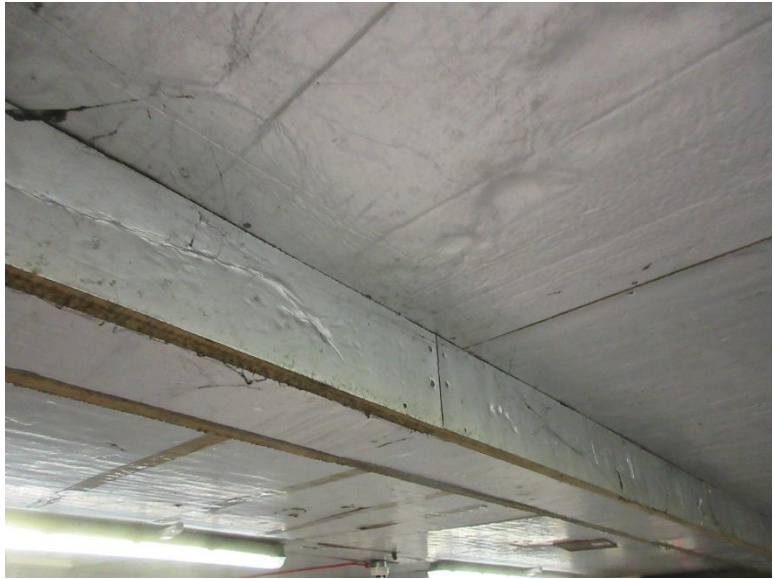
116. Cellar – presumed combustibile insulation to the Ground Floor slab soffit in part.

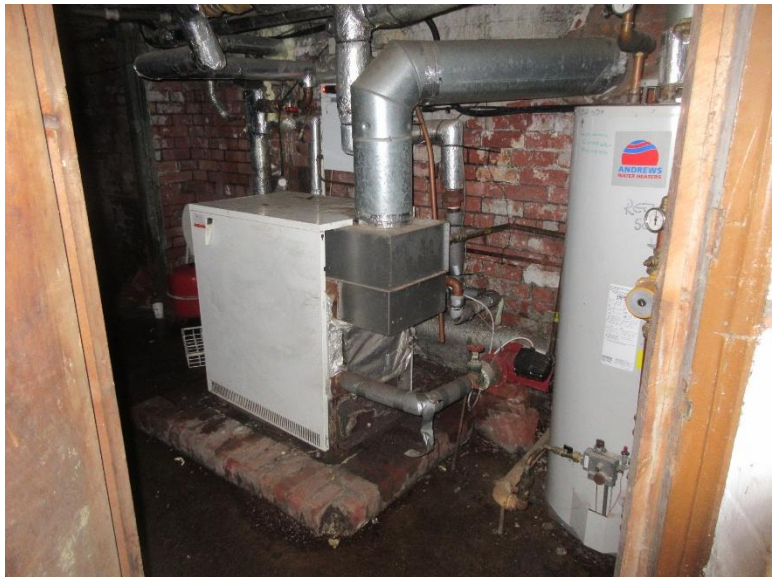
117. Cellar – mothballed boiler.

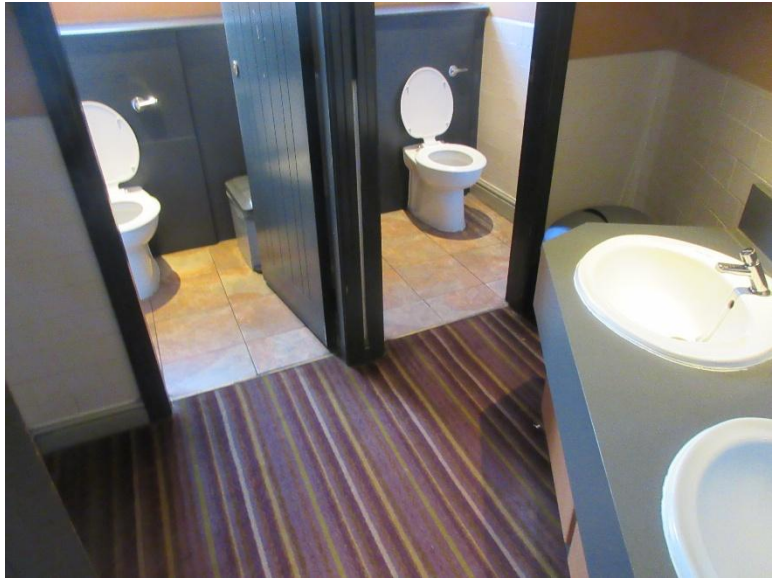
125. Ground Floor Female WC adjacent reception.

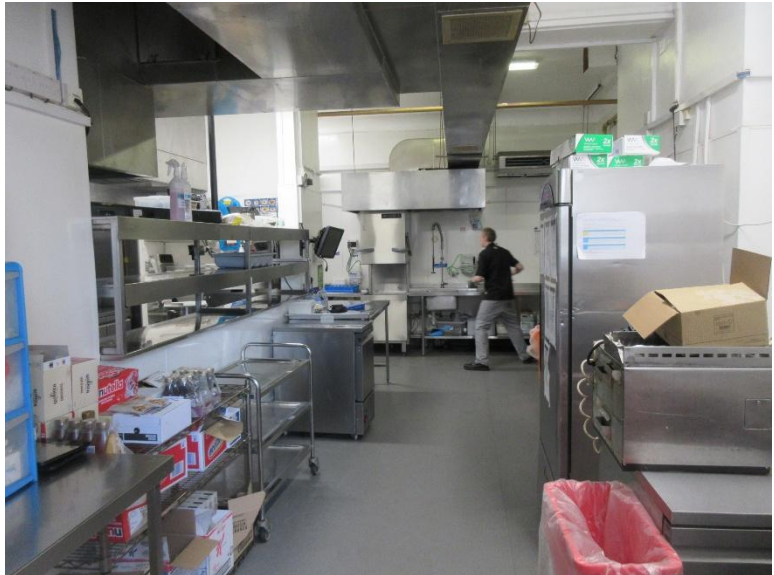
126. Ground Floor Kitchen.

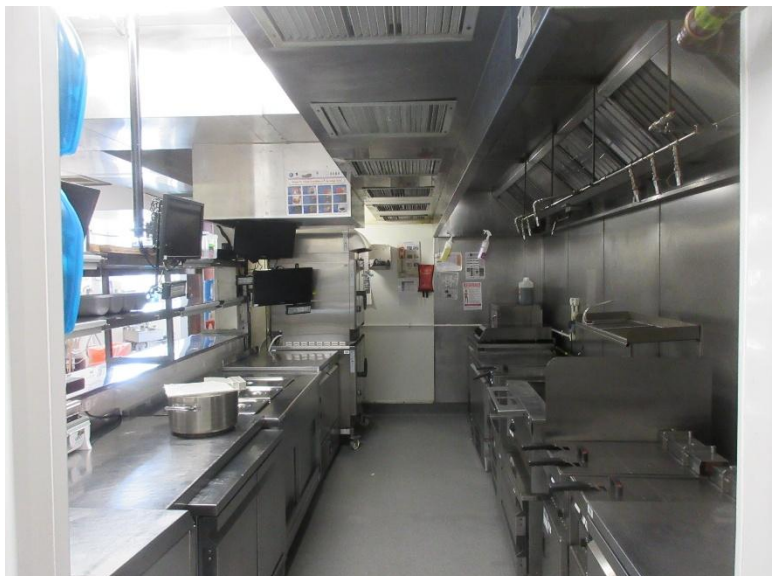
127. Ground Floor Kitchen – fire suppression to the grill area.

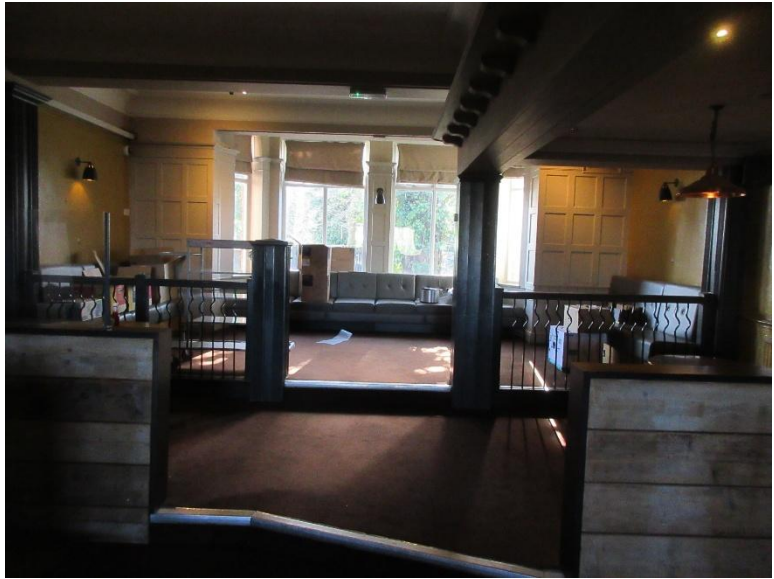
128. Ground Floor Restaurant and Bar Area.

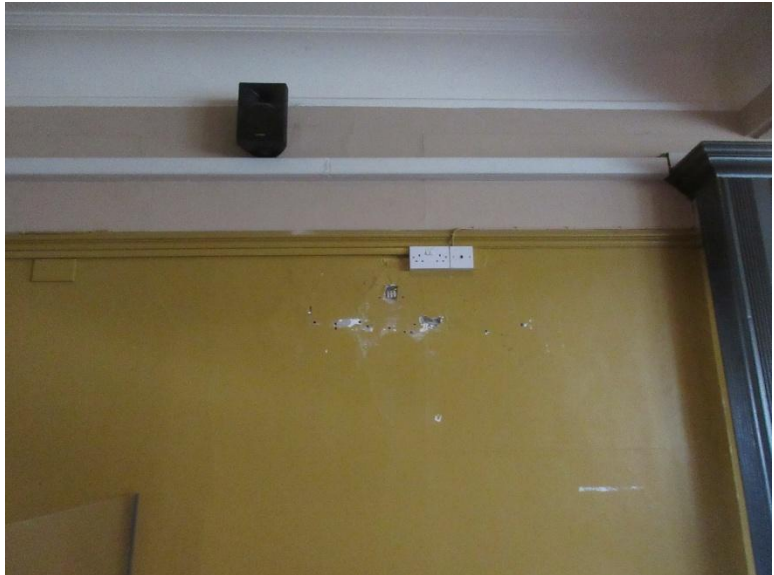
129. Ground Floor Restaurant and Bar Area – fixing holes to perimeter walls.

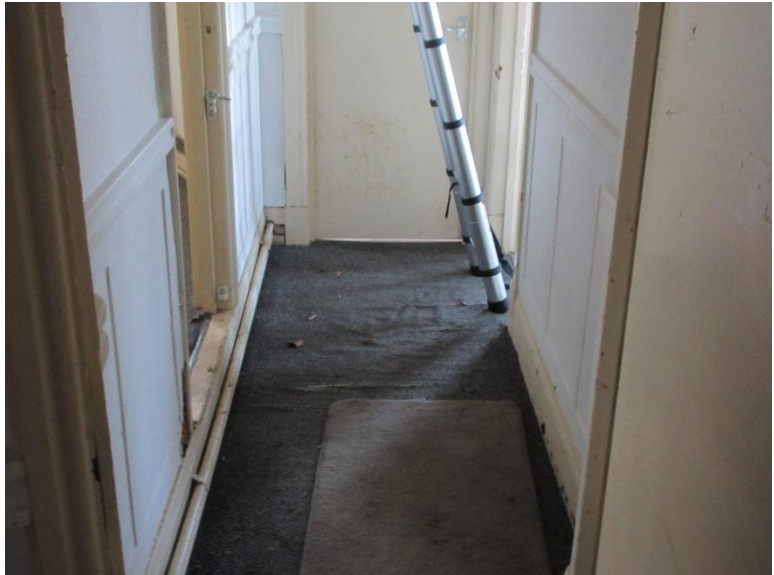
144. First Floor Apartment – torn and ridged carpet.

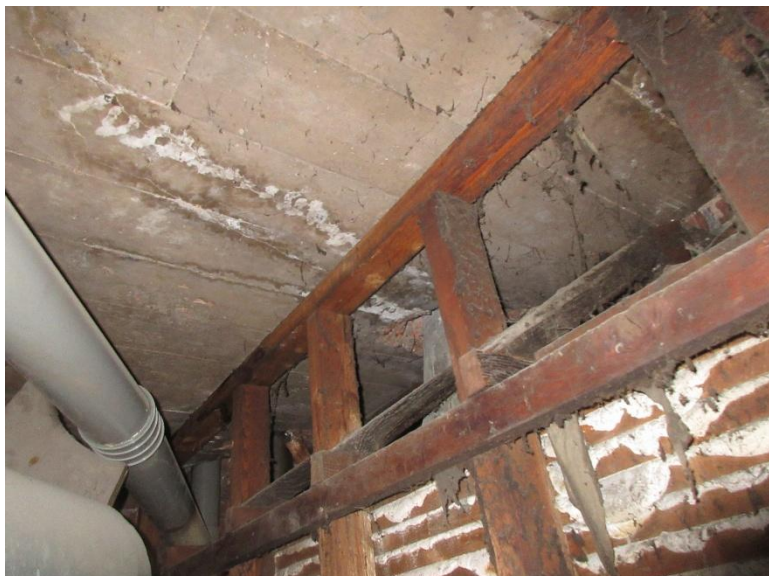
148. Insitu concrete First Floor slab viewed from the Female WC adjacent to reception.
